South Buffalo Creek Water Quality and Habitat Improvement Project

A Decade of Lessons Learned and Applied
Using Adaptive Management and Design

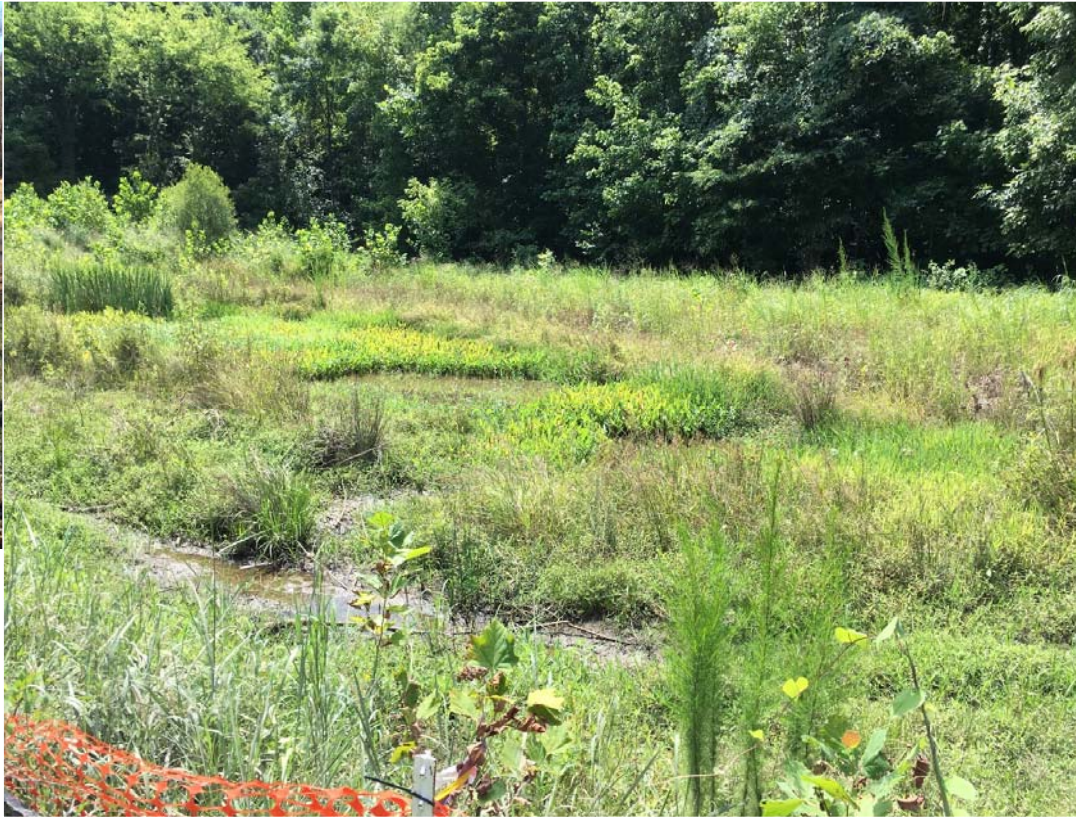
Late Spring 2014 with sediment deposition

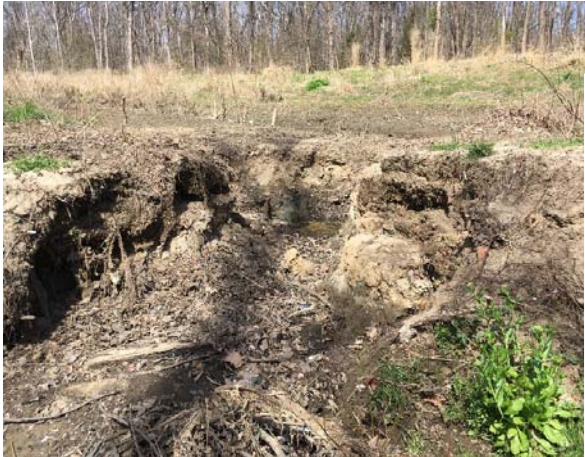
Damage from beaver activity

Kersey Tributary Repair During Phase IV

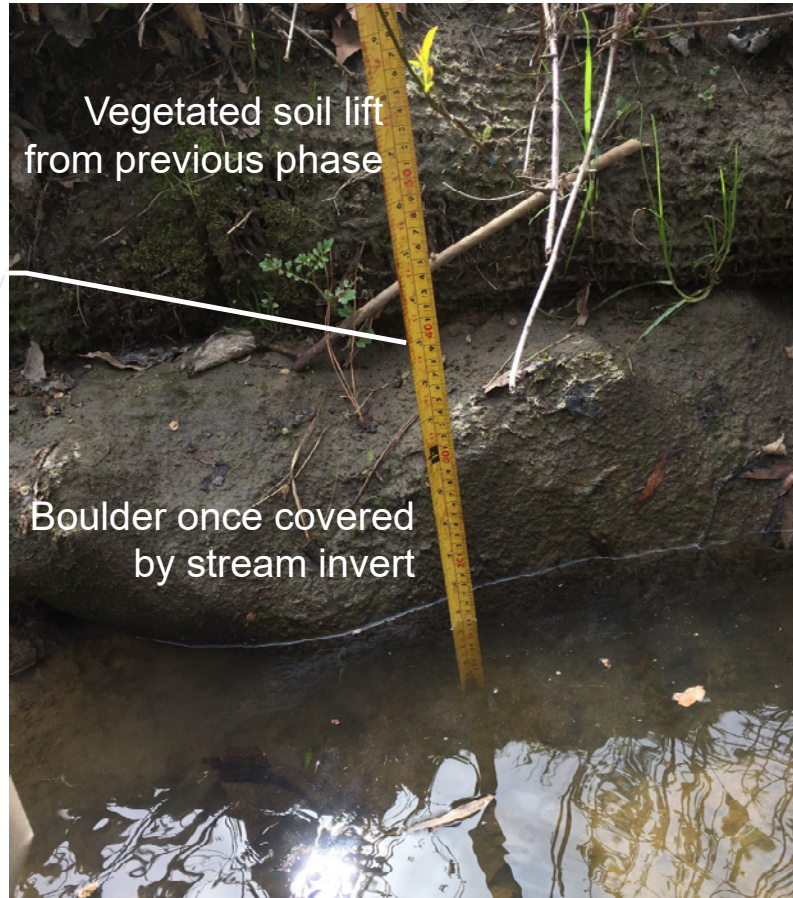
Incision of South Buffalo Creek

Approximately 1.5 feet of incision
from Phase III construction to
Phase IV design

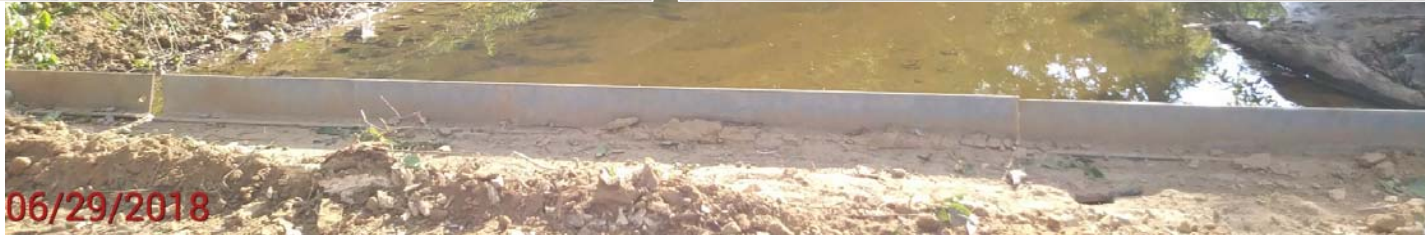
South Buffalo Creek left bank looking downstream, immediately before construction of toe wood
