**Paper Number: 032303**  
**An ASAE Meeting Presentation**

## **A North Carolina Field Study to Evaluate Greenroof Runoff Quantity, Runoff Quality, and Plant Growth**

Written for presentation at the  
2003 ASAE Annual International Meeting  
Sponsored by ASAE  
Riviera Hotel and Convention Center  
Las Vegas, Nevada, USA  
27- 30 July 2003

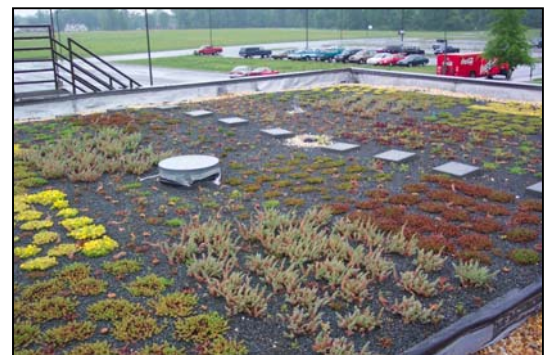
The greenroof at Wayne Community College (WCC) in Goldsboro, NC, was constructed in May 2002 and is approximately 70 m<sup>2</sup> (750 ft<sup>2</sup>). This essentially flat greenroof (see Figure 3) took approximately 50 person-hours to construct. The original rooftop of this storage building was divided into two equal halves for research purposes; one half remained unchanged and became the control for the experiment and the other half was transformed into the WCC Greenroof. Two soil media depths are being studied at this site; half the greenroof has a soil depth of 5 cm (2 in) and the other half of the greenroof has a soil media depth of 10 cm (4 in). The media depths have been arranged to resemble a checkerboard pattern with each matching soil substrate depth diagonally across from the other. The plant species researched at this site include *delosperma nubigenum*, *sedum reflexum*, *sedum sexangulare*, *sedum album*, *sedum acre*, *sedum album chloroticum*, and *sedum album murale*, *sedum spurium fuldaglut*, *sedum grisebachil*, and *delosperma cooperi*.

**Figure 3.** WCC Greenroof in Goldsboro (April 2003).

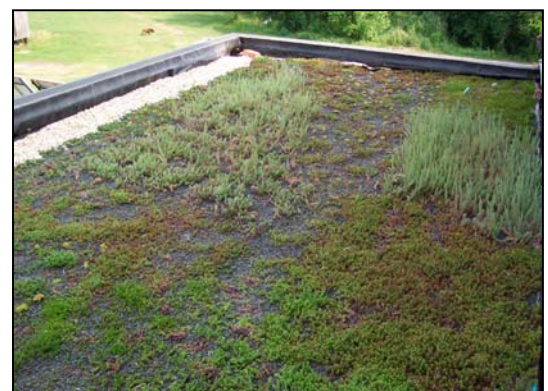
The approximate 27 m<sup>2</sup> (290 ft<sup>2</sup>) greenroof at the Neuseway Nature Center in Kinston, NC, was constructed in April 2002 (see Figure 4). The greenroof was constructed atop an additional room that was built onto the Nature Center during its renovation and construction phase. This greenroof took approximately 40 person-hours to construct. The most time consuming task is transporting the soil media to the rooftop; very primitive techniques using buckets transported the soil medium to the rooftop. As more greenroofs are built throughout the country, more efficient methods for transporting media to the rooftop are expected to develop. The Neuseway Nature Center Greenroof has a 3% pitch greenroof consists of 10 cm (4 in) deep soil media and is planted with the same variety of plants used at the WCC Greenroof. This greenroof is also be compared with the remaining 180 m<sup>2</sup> (1820 ft<sup>2</sup>) of the rooftop of the Nature Center.

**Figure 4.** Neuseway Nature Center Greenroof (May 2003).

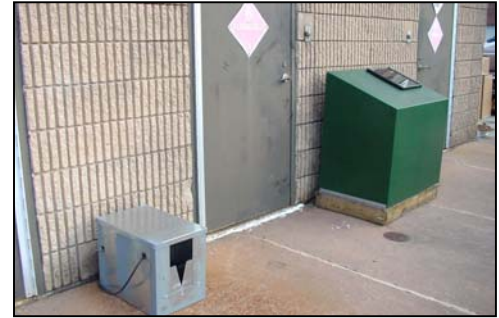
Figure 5 is a photograph of the green box and the weir box for the control roof at the WCC Greenroof. Each weir box in Goldsboro stores approximately 0.05 m<sup>3</sup> (0.5 ft<sup>3</sup>) before rainwater begins to flow over the laboratory tested 30° sharp crested weir. The greenroof weir box in Kinston has a storage volume of 0.009 m<sup>3</sup> (0.33 ft<sup>3</sup>) before rainwater flows over the 23° weir; the control weir box in Kinston stores approximately 0.035 m<sup>3</sup> (1.25 ft<sup>3</sup>) of rainwater before rainwater flows over its 30° weir.

**Figure 5.** Sampling equipment for WCC control roof. Weir box is on left side; green sampler storage box is on right.

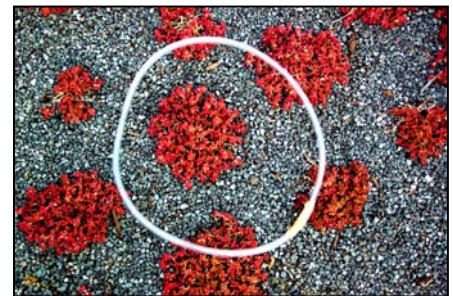
Percent coverage of several plant species at the WCC Greenroof was determined in May 2003, one year after the initial planting in May 2002. This roof was used to measure plant growth instead of the greenroof at the Neuseway Nature Center in Kinston because different soil media depths could be studied here to reflect the plant growth in relation to the soil media depth. A comparison between plant growth of the 5 cm (2 in) and the 10 cm (4 in) soil depth was observed and recorded. Figure 7 illustrates the technique used to measure percent coverage; this photo is of *delosperma nubigenum* coverage in 5 cm (2 in) soil. A circular tube of an approximate diameter of 40 cm (16 in) was randomly placed on each section of species for the respective soil depth, this was repeated so 3 measurements were recorded for each species. Plant growth was estimated among 3 different species. Three students recorded individual estimates, and after all estimates were taken, the three estimates for each plant species were averaged to determine the percent coverage for each species for each soil depth.

**Figure 7.** *Delosperma Nubigenum* in 5 cm Soil Media (January 2003).

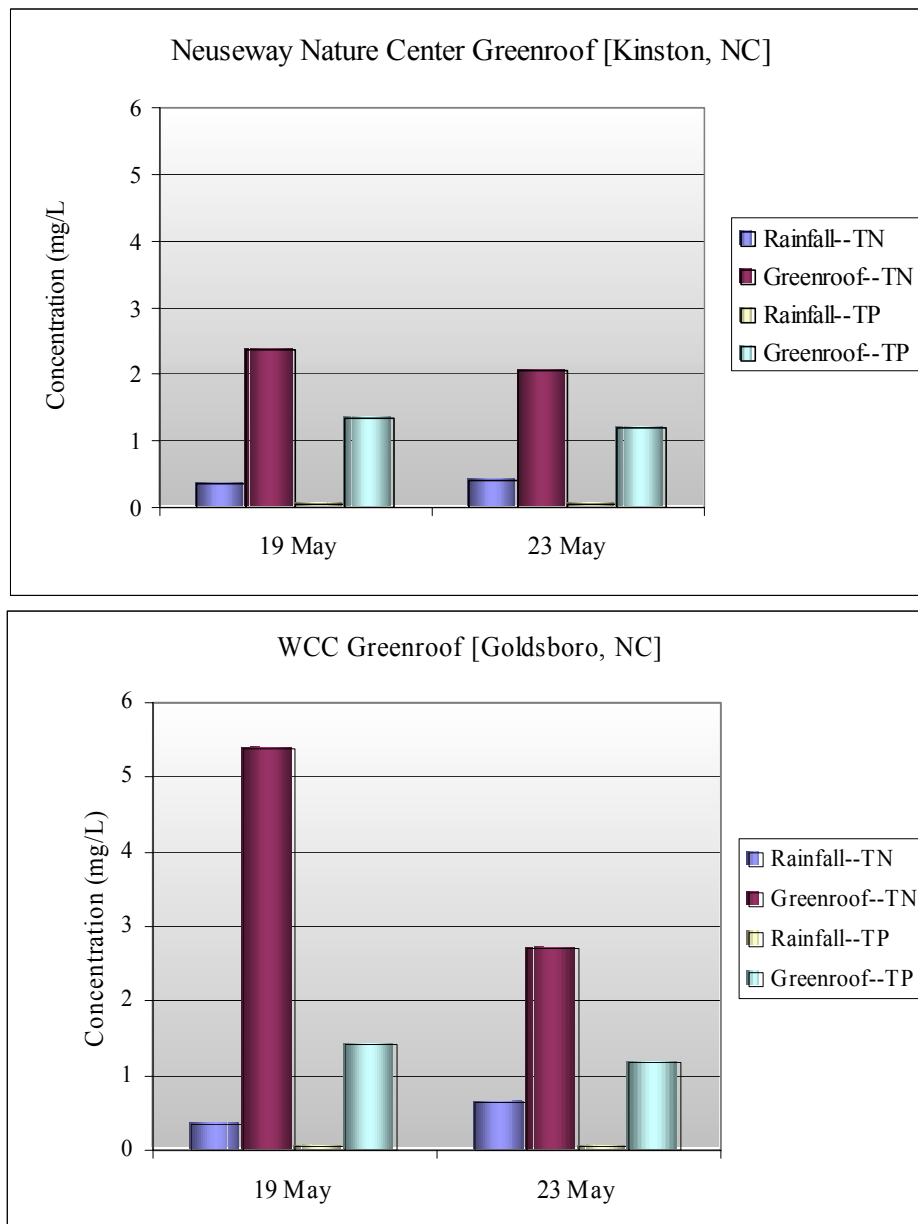
The first rain event on 19 May 2003 had a cumulative rainfall of 1.96 cm (0.77 in) in Goldsboro, NC and 4.72 cm (1.86 in) in Kinston, NC. The second rain event on 23 May 2003 had a total rainfall of 3.46 cm (1.36 in) in Goldsboro, NC and 6.05 cm (2.38 in) in Kinston, NC. Figure 8 displays the preliminary water quality results for the two rain events at each research site. This preliminary data shows higher concentrations of nitrogen and phosphorus are present in the greenroof runoff than the rain inflow from each site. For example, in Kinston on 19 May, the inflow of TN was 0.35 mg/L and the outflow from the greenroof was 2.4 mg/L; on 23 May, the inflow of TP was 0.05 mg/L and the outflow from the greenroof was 1.2 mg/L. The same trend was also seen in Goldsboro at the WCC Greenroof: on 19 May the inflow of TP was 0.36 mg/L and the outflow was 5.4 mg/L; on 23 May the inflow of TP was 0.05 mg/L and the outflow from the greenroof was 1.2 mg/L.

**Figure 8.** Preliminary water quality results for Goldsboro and Kinston, NC research sites. Results from May 2003. (Top: Neuseway Nature Center; Bottom: WCC Greenroof)

One of the main causes of this may be leaching of nutrients from the compost present in the Stalite Soil Mix; data suggesting this has also been seen at Pennsylvania State University (Berghage, 2003). The soil mix used at the WCC Greenroof and the Neuseway Nature Center has 15% compost cow manure. This initial presence of compost in the soil media indicates a significant level of nutrients present in the soil at the time of construction. However, this organic matter will leach from the soil over time. If levels of nutrients present in greenroof gradually decrease over time, this indicates the level of nutrients present within the soil media is decreasing (i.e. the nutrients are leaching from the soil). This trend of nutrients leaching through soil media has been observed in the City of Portland with decreasing phosphorus concentrations over time (Liptan, 2003). It is possible that future analysis may show supporting evidence that less nutrients emit from the greenroof over time as more nutrients are leached through the soil media.

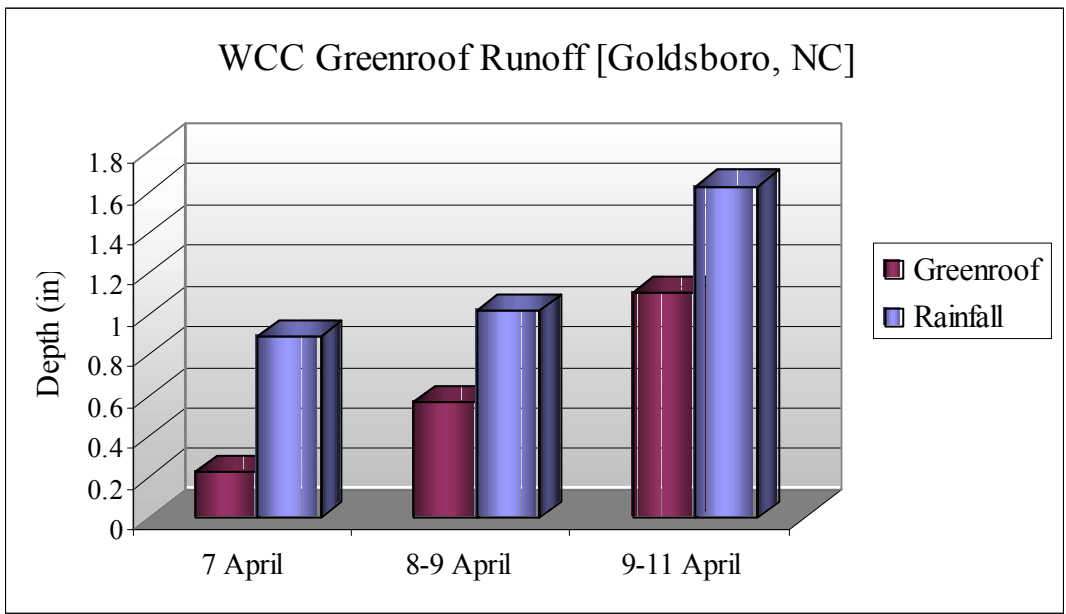
Hydrologic data began collection in Spring 2003; results are shown in this report for April and May 2003 in Figures 9 and 10. Three rain events are shown for April 2003 in Figure 9, all within a period of five days. The first rain event on 7 April 2003 had a total rainfall of 2.3 cm (0.89 in) with runoff from the greenroof of 0.56 cm (0.22 in); the second storm on 8 and 9 April 2003 had a cumulative rainfall of 2.6 cm (1.02 in) and a runoff amount of 1.45 cm (0.57 in) from the greenroof. The third rain event [separated from the second rain event by approximately 12 hours] of 9, 10, and 11 April 2003 had a total rainfall of 4.2 cm (1.63 in) and a greenroof runoff amount of 1.32 cm (1.11 in). Table 1 displays the hydrologic retention of the April rain events for the WCC Greenroof.

**Figure 9.** Hydrologic Retention for the WCC Greenroof in April 2003.

As shown in Table 1, the percent retained for each storm decreased with each respective rain event. However, as the percent retained decreased, the amount of rainwater retained was approximately 1.38 cm (0.55 in) for all three rain events. Therefore, these early results suggest the greenroof can retain an approximate rain event of 1.38 cm (0.55 in) or less.

Figures 9 and 10 illustrate the amount of rainwater retained by the WCC Greenroof in Goldsboro, NC. In addition to retaining rainwater, the greenroof also reduced the peak flow. Figure 11 illustrates the reduction in peak flow for April 2003; the three rain events are the same three displayed in Figure 9 and Table 1. Through Figure 11, the reduction in peak flow of the greenroof from the flow of rainfall is visible, as well as the delay in runoff. A typical rooftop would have runoff immediately during the event, but the greenroof delays runoff; the peak flow and the time to peak are both reduced.

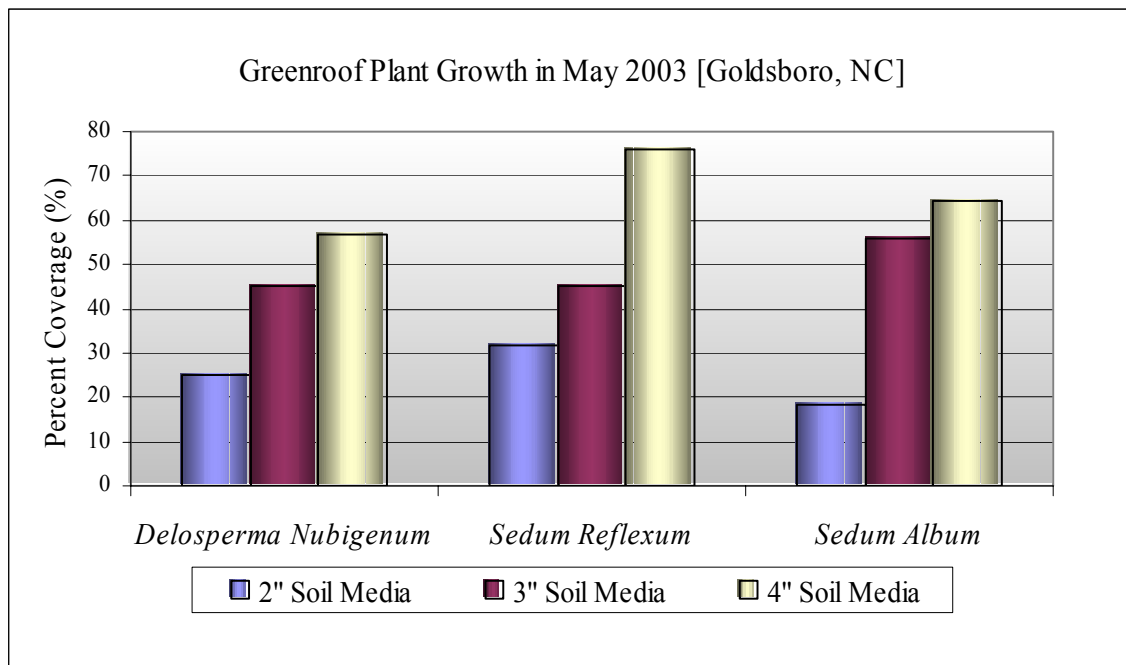
Figure 13 displays the results of the percent coverage comparison of *delosperma nubigenum*, *sedum reflexum*, and *sedum album* after one year of growth in May 2003. On average, there was a 40% difference in percent coverage between the 5 cm (2 in) and the 10 cm (4 in) soil media depth, with more coverage on the deeper soil. On average, between the three selected species, there was a 23% difference between the 5 cm (2 in) media depth and the 8 cm (3 in) media depth; a 17% difference was seen between the 8 cm (3 in) and the 10 cm (4 in) media depth. On average, plant coverage in the 8 cm (3 in) media depth is closer to coverage in the 10 cm (4

in) than the 5 cm (2 in) media depth. While the results described above are based on an average, the results for the individual plant species are slightly different, as shown below in Figure 13. Figure 13 illustrates that while the percent coverage of *delosperma nubigenum* increases approximately 30% from 8 cm (3 in) to 10 cm (4 in). Unlike *sedum reflexum*, sedum album has a large increase from 5 cm (2 in) to 8 cm (3 in) of approximately 40% with only an increase of approximately 10% from 8 cm (3 in) to 10 cm (4 in). This shows that some species may have the same approximate growth rate for 8 cm (3 in) and 10 cm (4 in), but others may not have such a closely related growth rate. For example, if high percent coverage is desired for the first year in 8 cm (3 in) deep soil media, *Delosperma Nubigenum* and *Sedum Album* would both be good choices. *Sedum Reflexum*, however, would be a much better selection for 10 cm (4 in) than 8 cm (3 in).

**Figure 13.** Plant growth after one year at the WCC Greenroof in Goldsboro, NC. Original plant spacing is 30-45 cm on center. May 2003.
