North Carolina Section 319(h) NPS Program
Final Report

Project Title: Toisnot Creek Stormwater BMP Project

DWQ Project Number: EW-02003

Eagle Farms Bioretention Areas: Overview

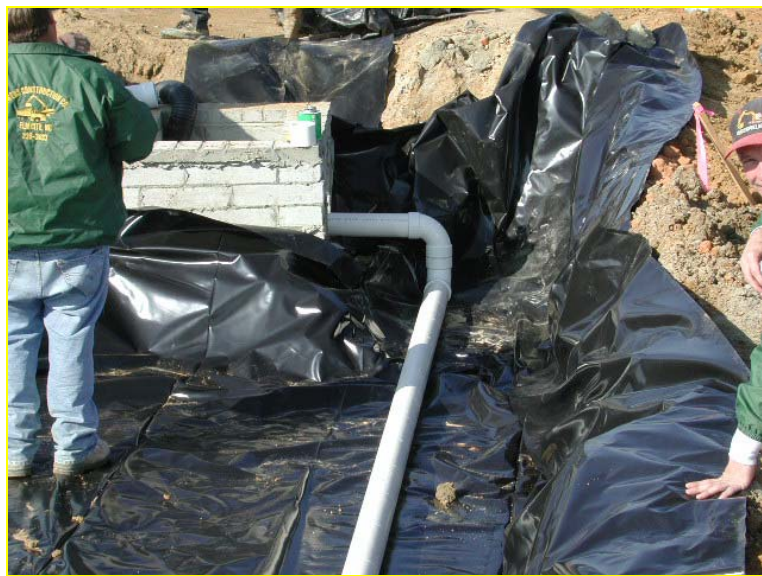
Figure 2. An upturned elbow in the underdrain pipe created an anaerobic zone in two of the four bioretention cells tested in Wilson.

was employed in four of the eight cells (and two of the four bioretention cells monitored) (as seen pictorially in Figure 1). Anaerobic configuration was created by putting an elbow in the underdrain pipe, forcing a saturated zone to form (Figure 2). The carbon amount within the bioretention soil was kept to approximately 10% by adding peat during construction.

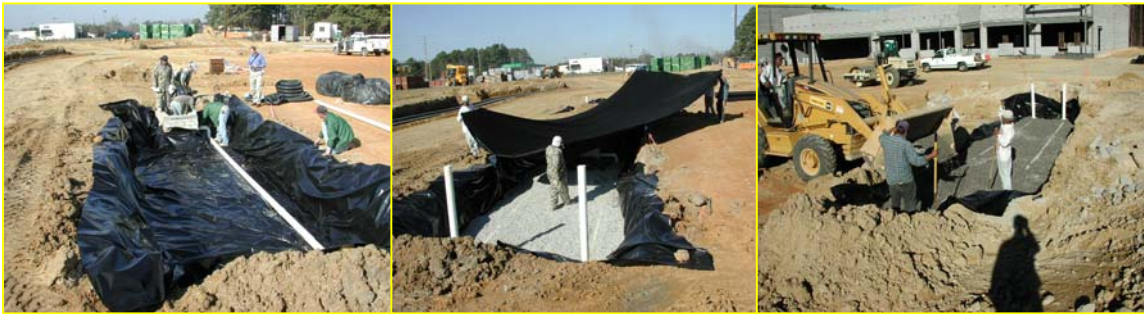
Figure 4. Bioretention construction in November and December in Wilson, NC. Pictured above are three phases from left to right: (1) installation of impermeable liner and drawdown pipes, (2) gravel drawdown layer with permeable geofabric about to be placed over it, and (3) fill soil being added to the device.

First phase of bioretention construction (through soil installation) was completed in Wilson (pictured above in Figure 4). Parking lot construction inexplicably stalls. The parking lot was not to be completed – and relatively stable – until March 2002. Rainfalls continued to transport sediment into the bioretention devices, causing them to clog, as seen in Figure 5.

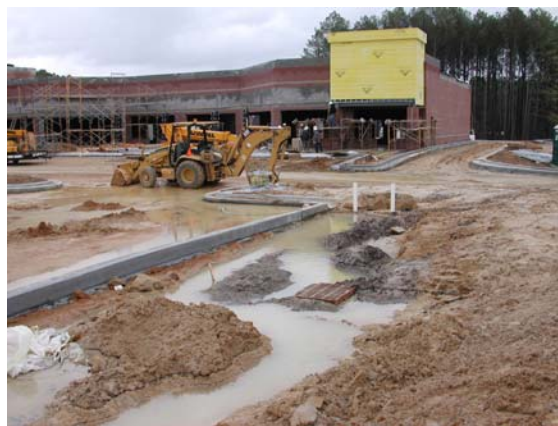
Figure 5. Sediment clogged the bioretention areas for long periods during the parking lot construction.

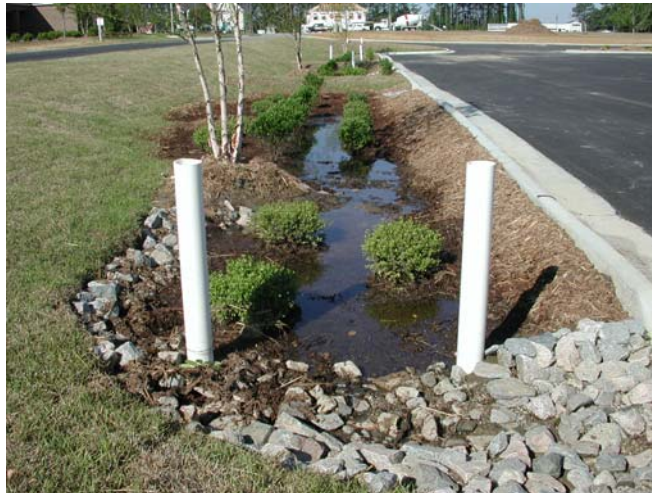
Figure 6. Four of the cells on the eastern side of the Wilson Parking lot pictured immediately after construction. These were the same bioretention cells pictured in Fig. 5.

Wilson parking lot was finally completed, as seen in Figure 6. All bioretention cells were clogged. The top 75 mm (3 in) of soil were removed in an effort to unclog the cells. Site stabilization began. Sod was added to protect exposed banks. Vegetation including river birch (*Betula nigra*), dwarf yaupon (*Ilex vomitoria*), and Virginia sweetspire (*Itea virginica*) trees was planted in bioretention cells.

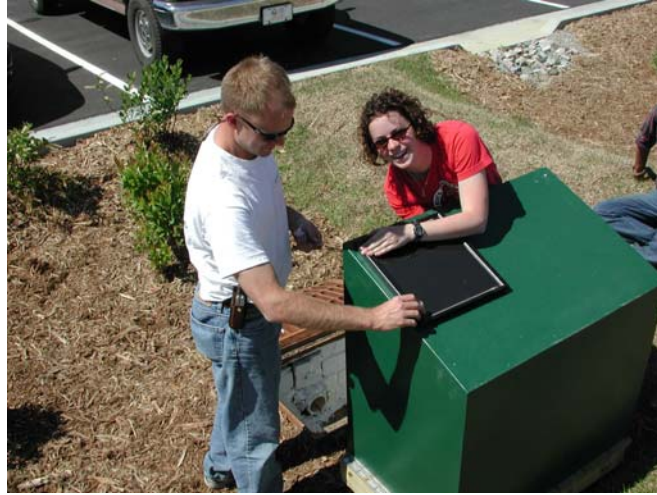
Figure 9. Monitoring equipment including automatic samplers was installed in Wilson during Summer 2002.

Many of the samplers floated and toppled over, allowing water to penetrate the display panel. Of the eight samplers, four were damaged and needed to be returned to the manufacturer. By the end of September, most of the Wilson automated samplers were ready again.

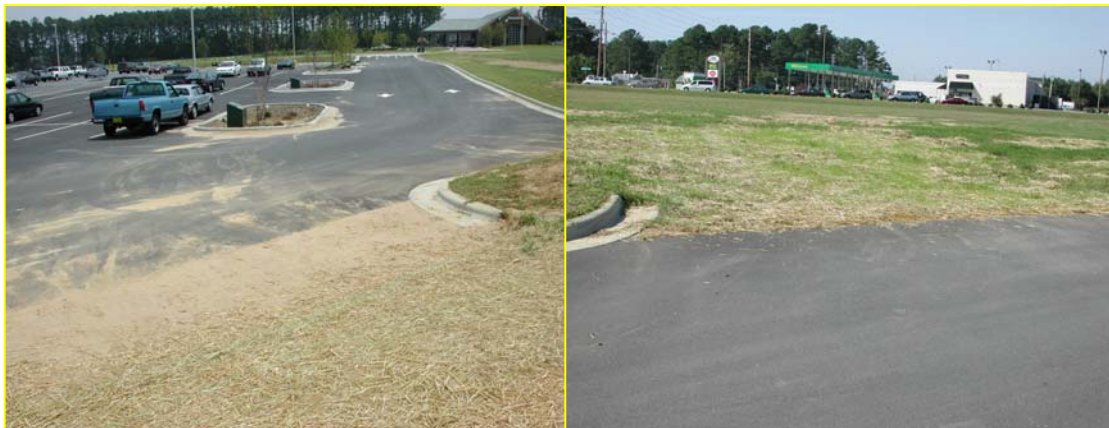
Figure 10. The watershed remained unstable for several months. Sediment from the unstable areas found its way into two of the basins, as seen in the picture to the left. The entranceway was seeded and reseeded throughout the summer and fall of 2002. By November and December of 2002, the entranceway was deemed stable.

The unstable and eroding areas of the parking lot began to stabilize (Figure 10). Ample rainfall in September accounted for this stabilization.

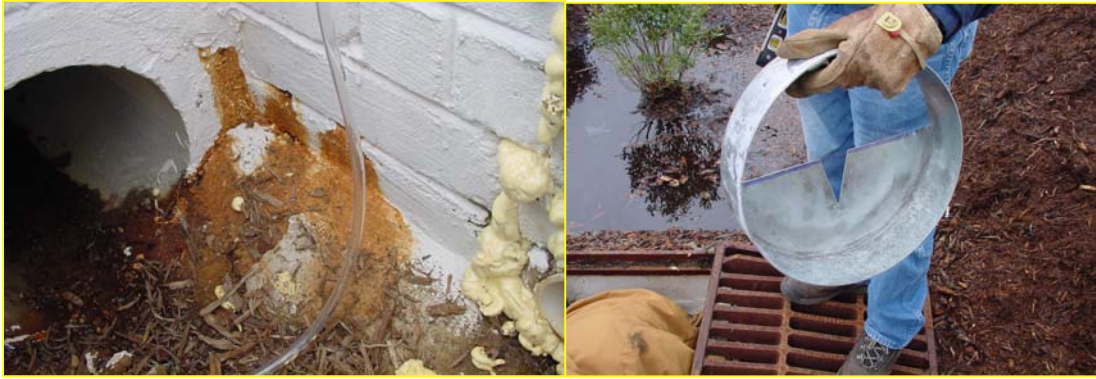
Figure 11. Each of the inlets leaked, as evidence in the picture in the left hand side of the figure. Flow sensors installed in an outlet would not capture all the flow leaving the bioretention cells. V-notch weirs, as shown on the right hand side were installed to measure flow leaving each of the cells.

Wilson outlets were outfitted with v-notch weirs to determine quantities of water leaving each of the bioretention cells. Initially, flow was to be measured at the end of each underdrain pipe. However, leaks continued to be observed after several attempts to seal the inlet boxes. It was decided to avoid attempting to measure flow from the underdrains and thus to measure at the outlet of each box in each cell. Three weirs were installed on each side of the bioretention devices (Figure 11). A final effort was taken to unclog the last bioretention device.

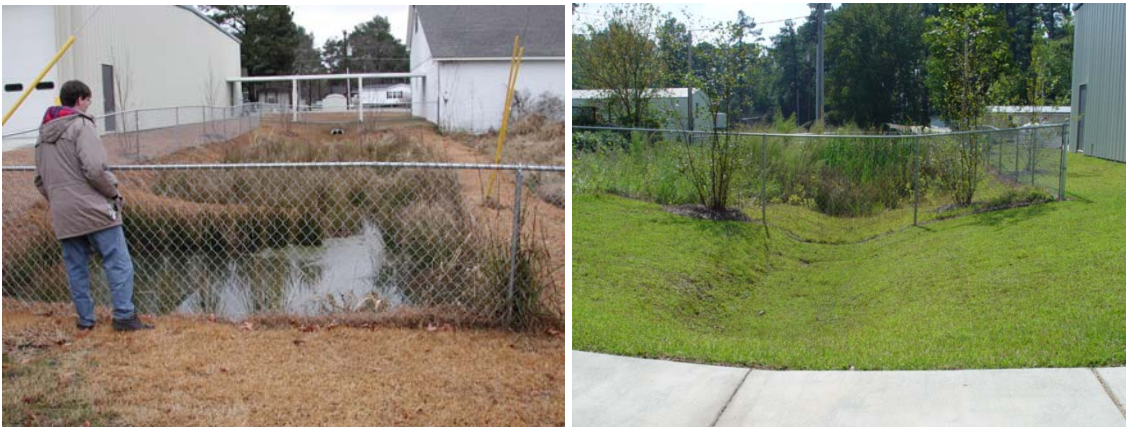
Figure 13. *Spring Lake VFD Pocket Wetland. Left view is from the rear of the wetland in the winter. Right view is the front of the small wetland in early fall.*

The Silver Lake Volunteer Fire Department wanted to expand its fire station in 2001, giving an opportunity to install a retrofit stormwater BMP in the City of Wilson. The small, or pocket, stormwater wetland would be the first stormwater wetland on government property in the city. A request for assistance came to Bill Lord, Neuse Education Team member for Wilson County, by the fire department's consulting engineer, Ron Sutton of PLT Construction. Following a site visit, plans were drawn up for a small stormwater wetland to be installed to serve as a demonstration for the Toisnot Creek. A stormwater wetland was chosen for the site because of the site's high water table (no less than 18 inches from the surface). Because there was such a limited space for a BMP, conditions for constructing a wetland were "tight." However, the wetland was designed to serve such a small watershed (2 acres) that only a small space was needed on the lot for a BMP. The stormwater wetland was designed to both (1) control stormwater outflow, and (2) more importantly the need to reduce N and P concentrations of stormwater flowing through the site from a residential trailer park located just above the fire department. A small serpentine wetland was designed with baffles separating treatment cells. Plants installed include *Juncus sp.*, *Carex sp.*, *Sagittaria*, and *Pontederia cordata*. The wetland is approximately 600 sq. ft. in size, draining a 2 acre watershed, 15% of which is impervious surface. The wetland has acclimated to the site and is functioning very well. It has been used for a number of tours and stormwater demonstrations to illustrate the use of small stormwater wetlands. The wetland served a solely demonstration purpose as no data has been collected from this site. Figure 13 shows pictures of the stormwater wetland. The success of this small wetland helps dispel the belief that watersheds of at least 10-15 acres are needed for a stormwater wetland to succeed.

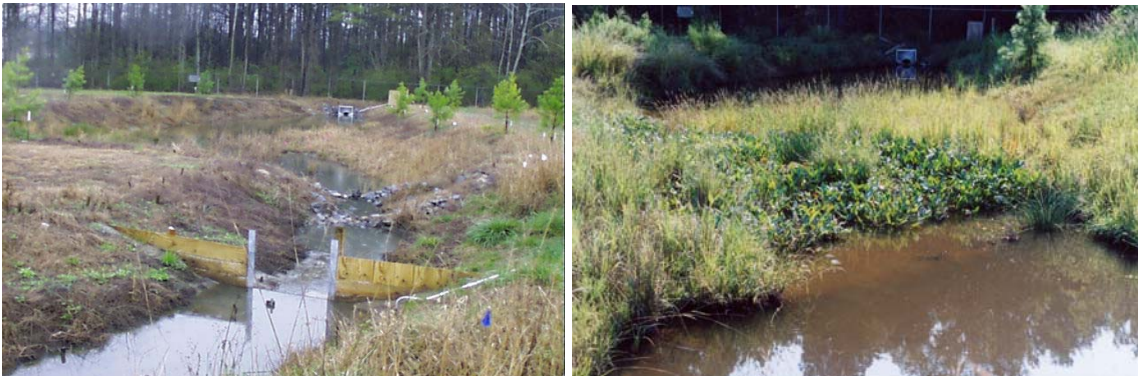
Figure 14. Stormwater Wetland at Wilson DOT CMY immediately after construction (left) and after two years of growth (right).

The treatment wetland was constructed in July and August, 2001 by widening a stormwater drainage ditch (figure 6) using DOT equipment and personnel and under Bill Hunt's (NCSU) design and construction guidance. Wetland vegetation was planted sometime after construction under the guidance of DOT personnel. In October, 2001, during visits to install monitoring equipment, observation indicated volunteer vegetation in the standing water areas of the wetland, but few viable wetland plants. The design submitted by NCSU recommended 500 Pickerel weed, 200 Arrow arum, 100 *Juncus effuses*, 20 open water lilies, and an assortment of other wetland plants. However, observation indicated that only 2-3 water lilies, several *Juncus* along one side, and some Arrow arum along the same side survived until October of 2002 (Figure 14). The scarcity of viable plants may have been the result of fewer plants than recommended actually being planted, planted vegetation was not hardy, an extended period of drought resulted in plant mortality, or plants were improperly planted or in the wrong location given the water depths.

The lack of viable plants likely made the wetland act more like a wet detention pond during the first 8 months of monitoring than a wetland because most stormwater could flow through the wetland with very little contact with vegetation. In order to improve this situation, on June 7, 2002 NCSU and DOT planted 50 water lilies, 200 Pickerel weed, 50 arrow arum, and several lotus plants in the wetland. The plants were concentrated in the shallower water, middle area of the wetland to maximize their chance
