National Monitoring Program (NMP)

Long-Term Monitoring Projects to Document
Water Quality Improvements from BMPs

USEPA Section 319 National Monitoring Projects (NMP)

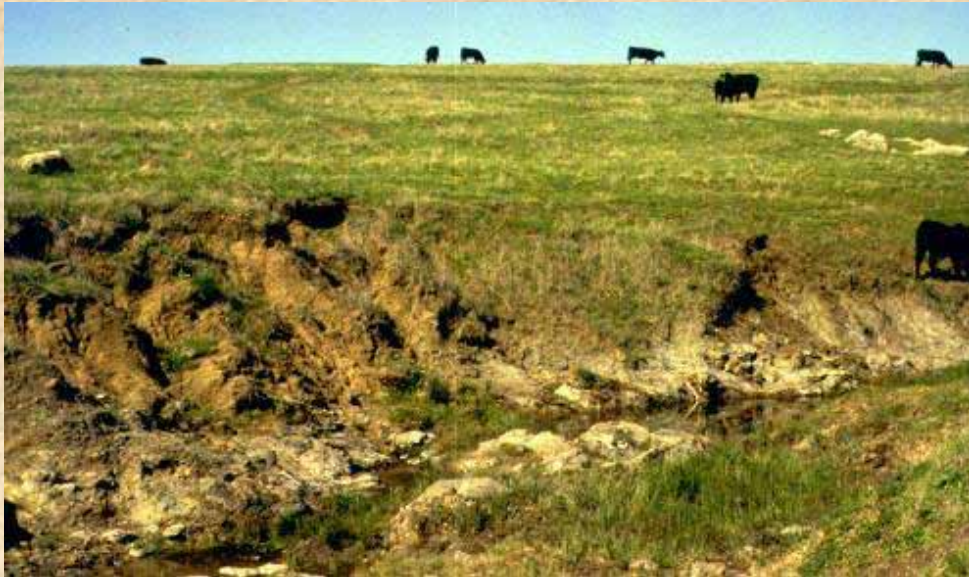
Morro Bay, California

Chumash Creek Treatment Watershed Grazing Management & Riparian Fencing ,
Paired Watershed Study

49% reduction in turbidity
– during storm events

- Increased infiltration
- Delayed peak flow
- Decreased fluctuations in DO
- Decrease in temperature

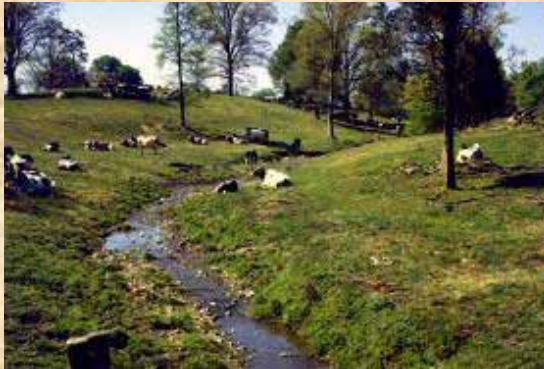
Long Creek, NC NMP - Upstream-Downstream/ Before-After BMP Implementation

BMPs: livestock exclusion (fencing, alt. water, crossings, riparian plantings, nutrient waste mgt)

Pollutant	Load Decr.	Conc. Decr.
TSS	83 %	74 %
Turbidity		69 %
TP	76 %	
Fecal Coli/step		85/ 81 %

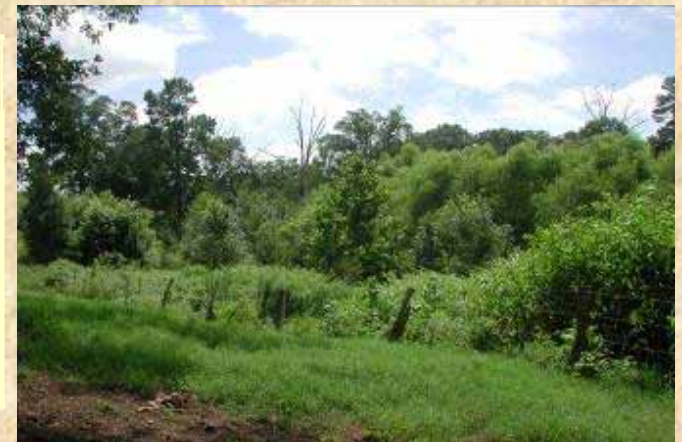
Decrease flashy / high values

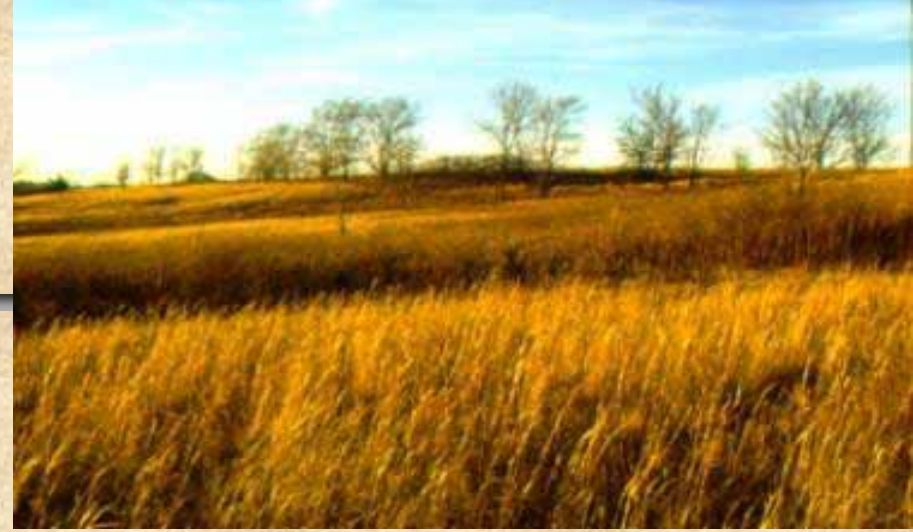
2. Lag Time Walnut Creek, IA

13,000 acre (12 digit HUC) Treatment Watershed

Lag factors: low permeable soils near stream; root establishment; soil reserves; upstream cropland sources

- **Paired Watershed w/ Covariates:** Control watershed, upstream, discharge, season
- **10 years:** 1.2 mg/l decrease in $\text{NO}_3\text{-N}$ over (10%)

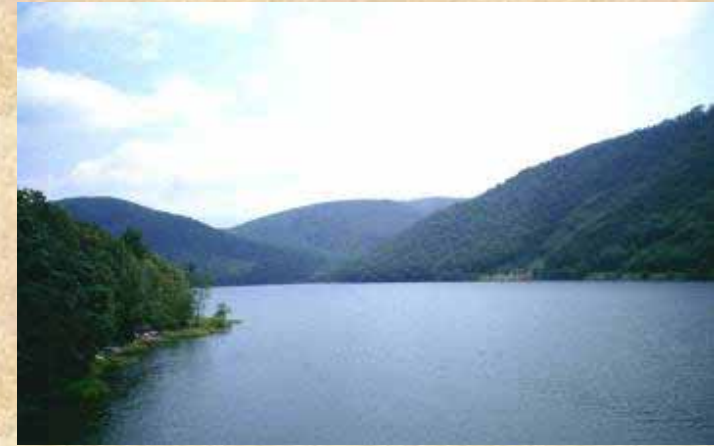
New York City Watershed, NY

- Reduce P imports to farm in purchased feed
- Feed & home-grown forages analyzed for nutritional content & diets adjusted
- Dietary input of P reduced 25%
- Excretion of P reduced 33%

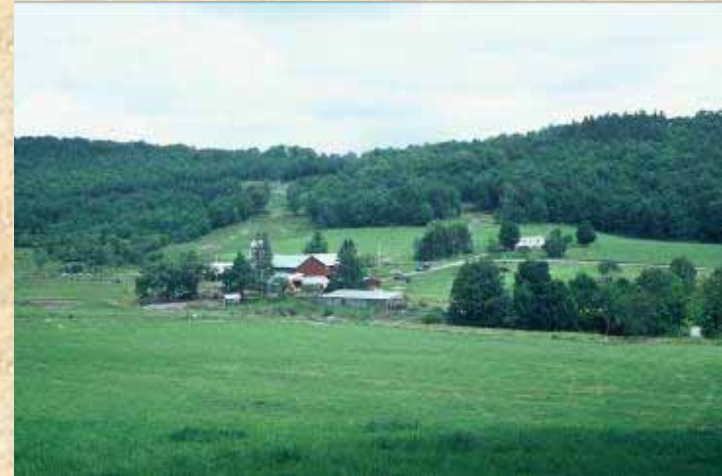
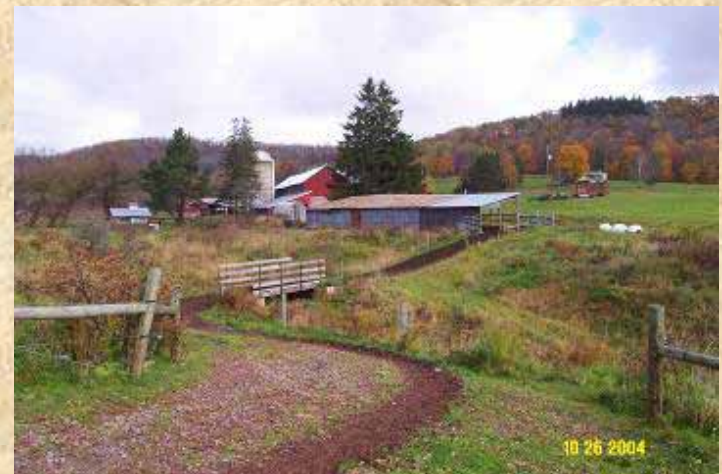
New York City Watershed

- 64% NH₃
 - 53% TDP
 - 36% PP
 - 28% TSS
 - 23% NO_x
- Improved farm P mass balance
 - Slowed net soil P accumulation

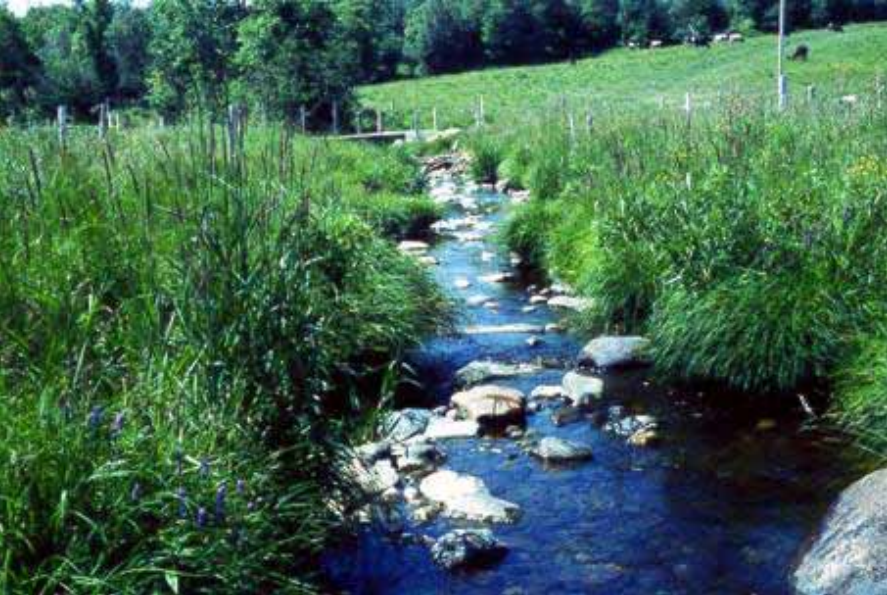
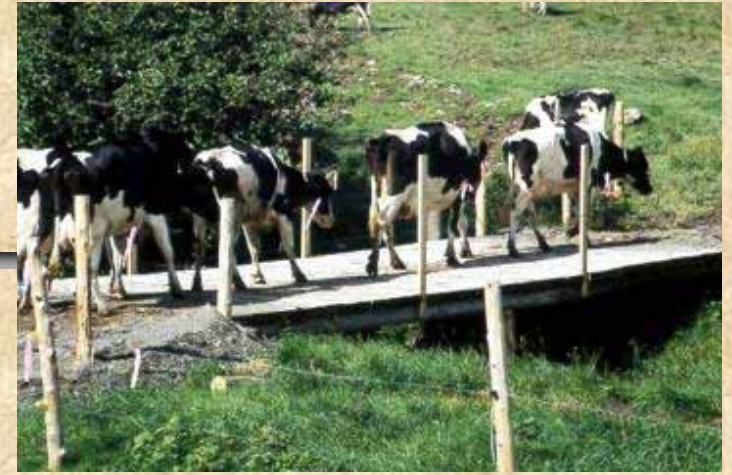
Lake Champlain Basin, VT

- Riparian buffers cost-effective
- 50% decrease in bacteria & TP (greater reduction at high loading rates)

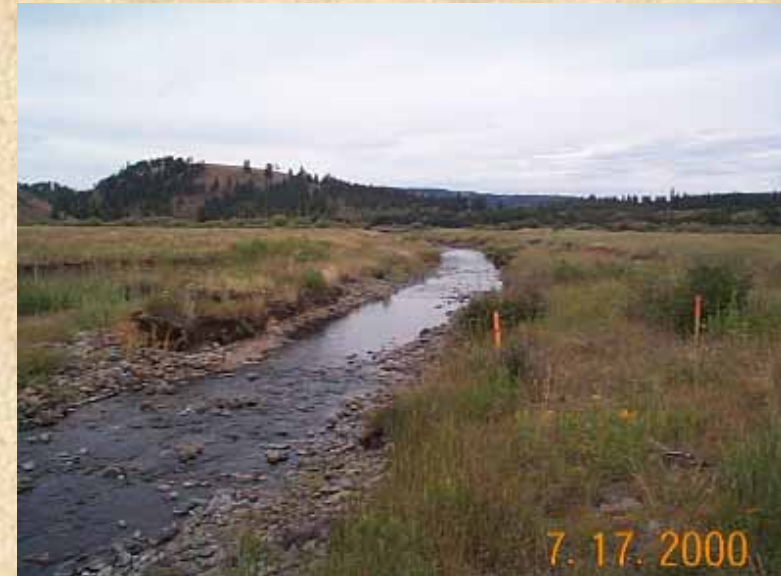
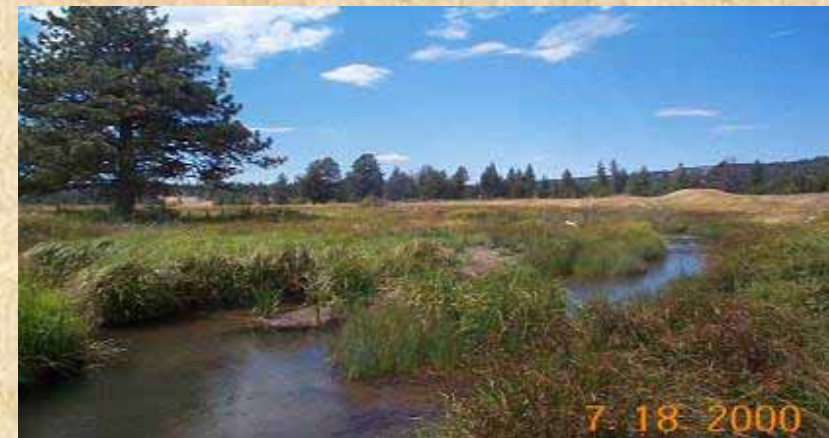
Upper Grande Ronde River, OR

Channel Restoration, Cattle Exclusion/Fencing

- Improved slope, W/D ratios, sinuosity, pools, cool water habitat
- Improved number of trout

- Livestock exclusion alone is not enough to recover sensitive aquatic life if stream channel & habitat remain degraded
- Pool habitat provided critical temperature refugia

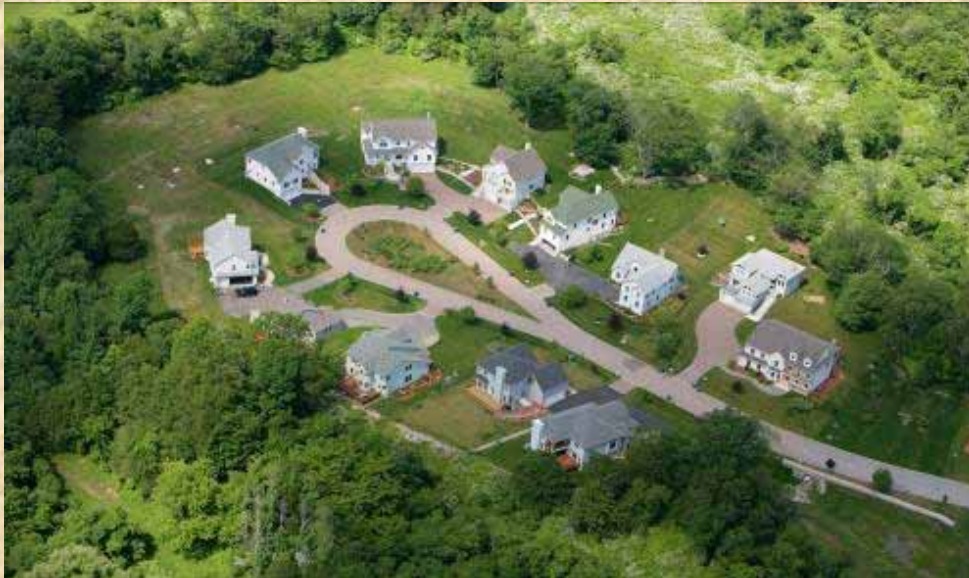
BMP Subdivision

- Cluster design with shared open space
- Minimization of impervious surfaces (narrow road, shared driveways)

- Basement excavations
- Phased grading
- Immediate seeding of stockpiled topsoil & proposed lawn areas
- Sediment detention basins & swales

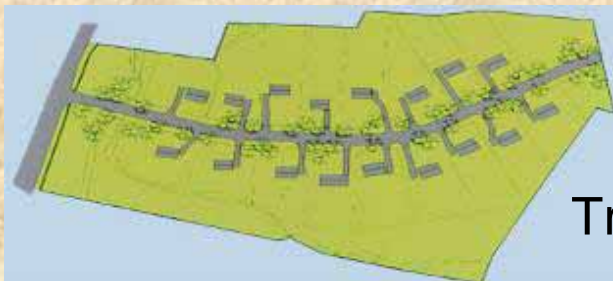
Site Design

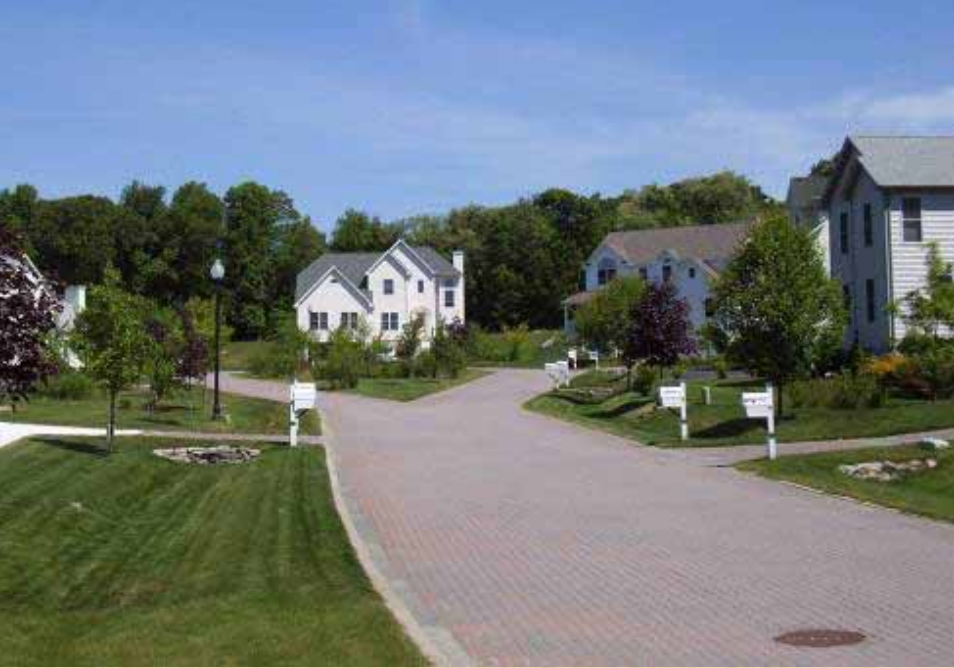
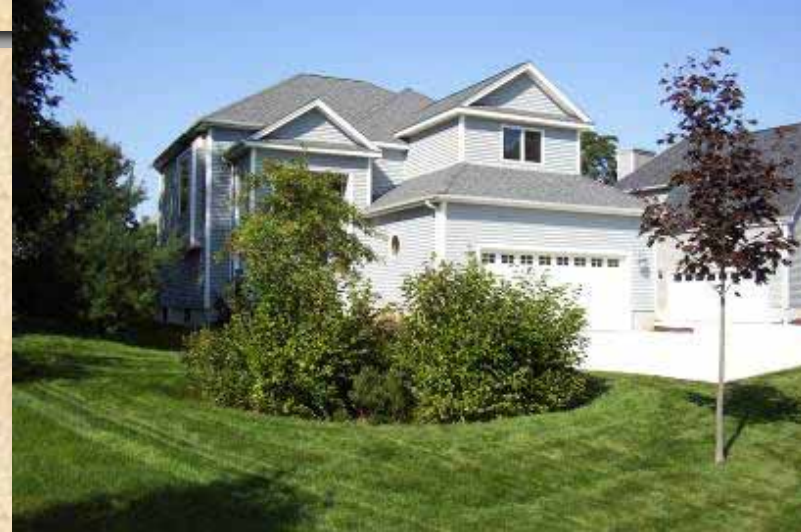
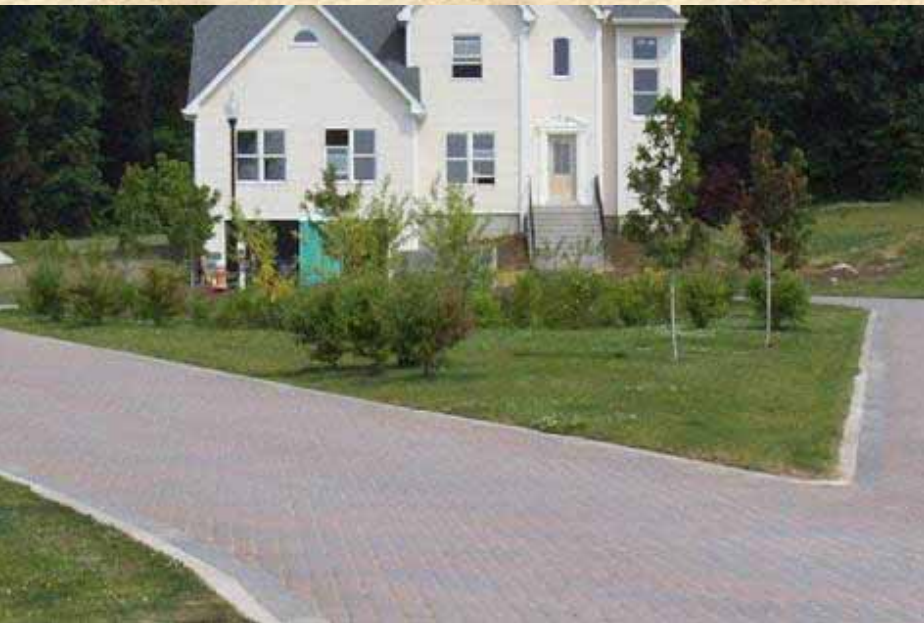
Jordan Cove, CT

Structural & Non-structural BMPs

- Grassed swales (not curb & gutter)
- Pervious roads & driveways
- Rain gardens (bioretention basin)
 - Individual house lots
 - Cul de sac
- Pet waste management
- Homeowner fertilizer management plans

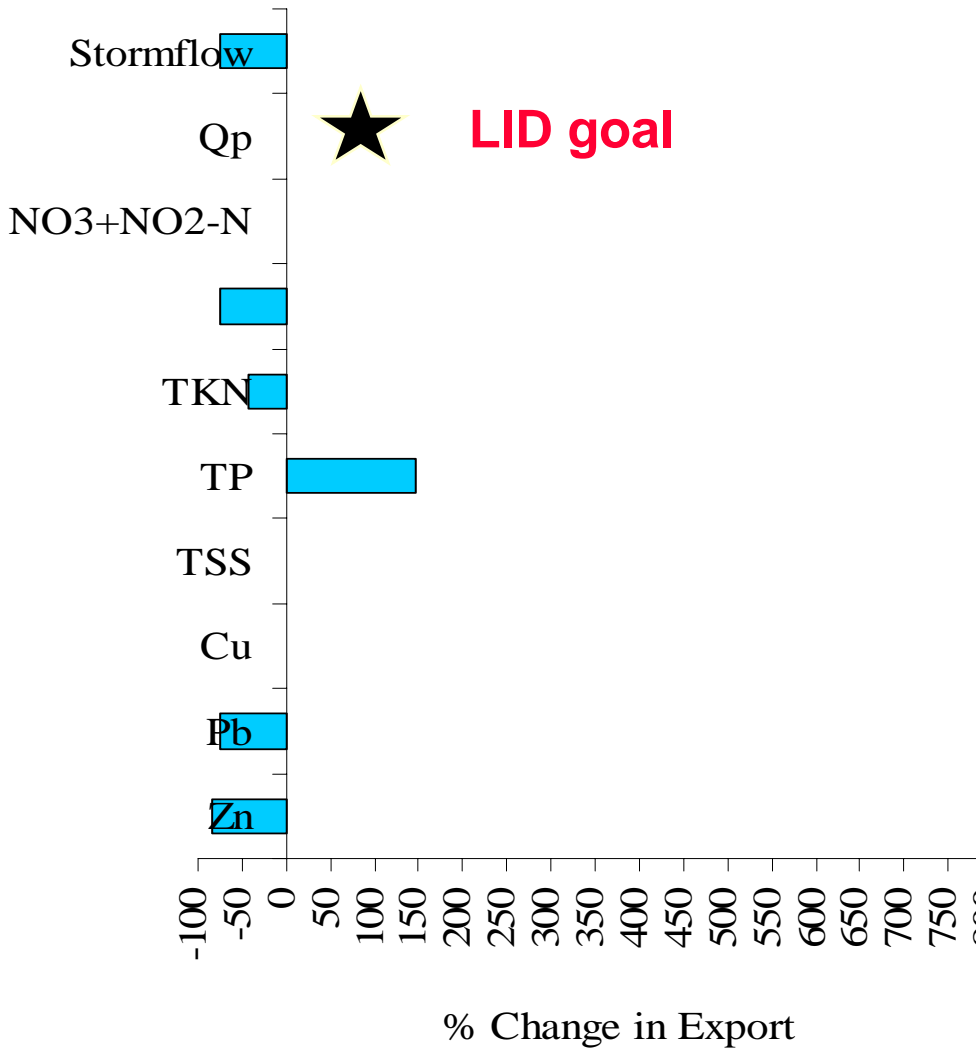
BMP Watershed

Post-construction – flow & export
