Demonstrating and Evaluating Low Impact Development Techniques

Contract Number EW06036
Project Period: 10/1/05 to 9/30/08

D.E. Line, J. Blackwell, M. Shaffer, and J. Spooner
NCSU Biological and Agricultural Engineering Dept.
Box 7637
Raleigh, NC 27695

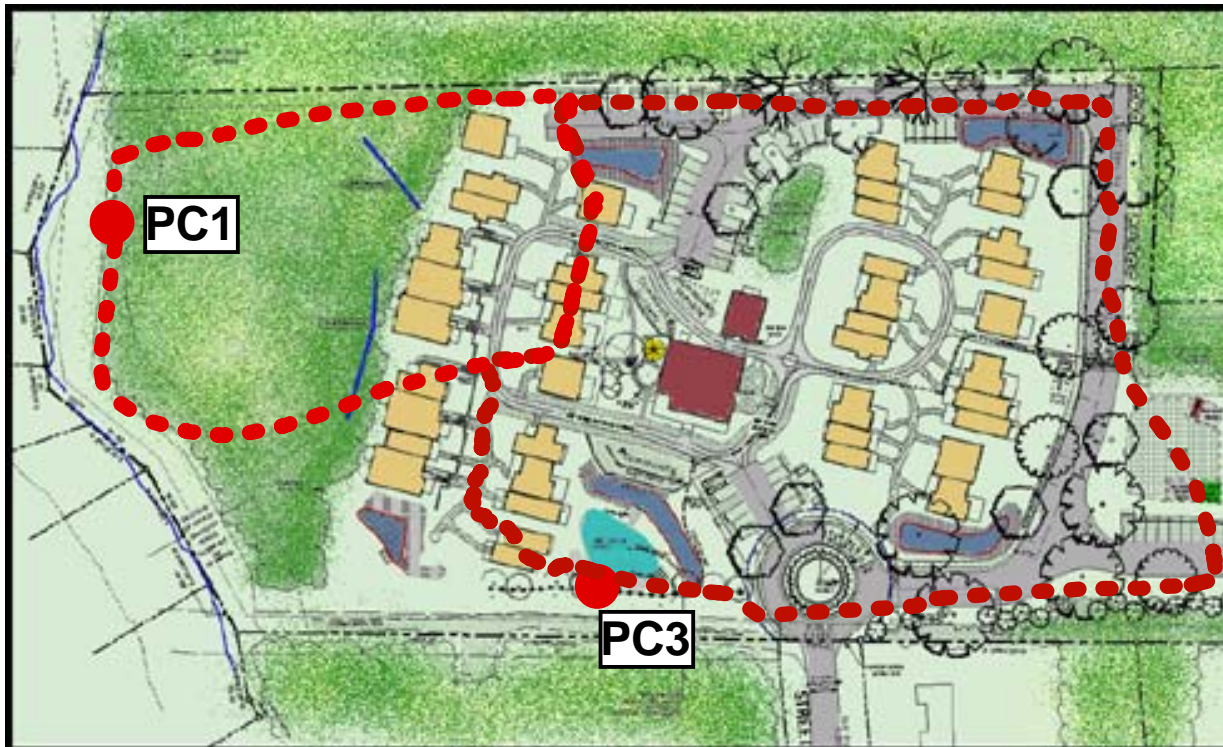
Figure 2. Map of drainage areas to monitoring stations post-construction.

The PC3 monitoring station was installed in December, 2007 to monitor discharge from the detention/irrigation pond. By this time, the stormdrain system was fully functioning transporting most of the runoff from the development to the pond (fig. 2). Because the pond had both a normal and emergency outlets, two discharge monitoring weirs and flowmeters were installed. A 90 deg. v-notch weir box was installed on the end of the outflow riser pipe, while a 3ft rectangular weir and wingwall was installed across the emergency spillway. A flowmeter was used to monitor water height for each weir and standard weir equations were used to convert the measured heights to discharges. Discharge from both outlets was then summed to obtain the total discharge.

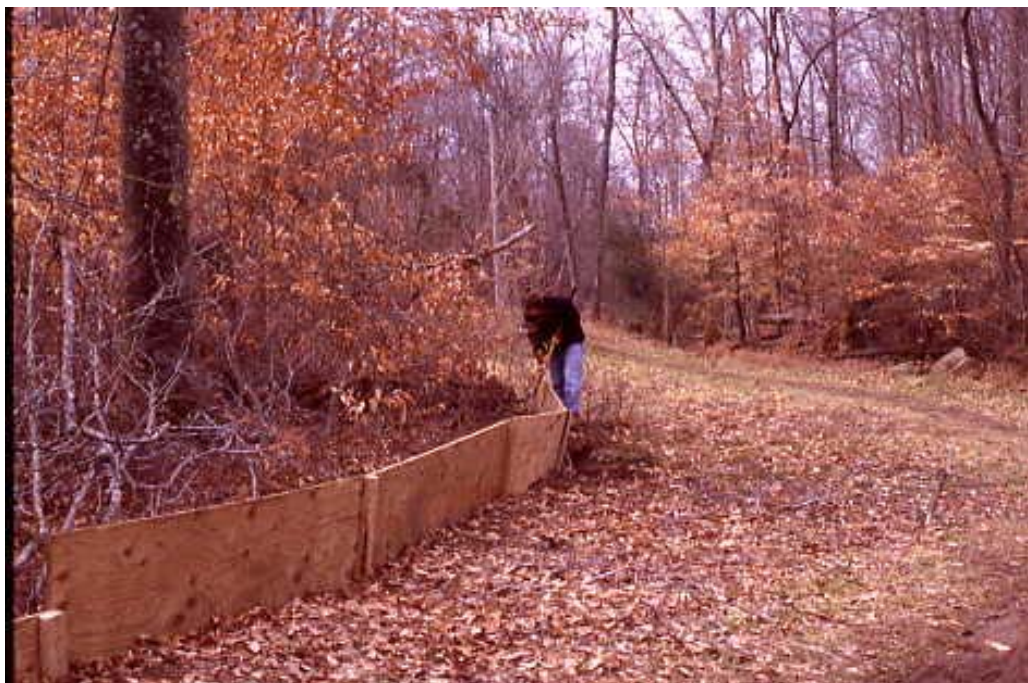
Figure 3. Plywood diversion near the PC1 monitoring site.

Monitoring stations: The PC1 monitoring stations was installed and maintained under a previous grant from March 15, 2003 to March 31, 2004. The monitoring equipment was reinstalled on May 10, 2005 under this grant with the first storm occurring on May 12, 2005. The station consisted of a 2 ft rectangular weir and an automated sampler with an integrated flowmeter to continuously measure water depth over the weir. A 0.5-1.5 ft high plywood diversion wall (fig. 3) had been

installed previously to direct the runoff from the wooded hillslope to the weir for monitoring purposes. This diversion was necessary because there was no well-defined channel through the wooded riparian buffer; hence, runoff often meandered through the woods using several different paths.

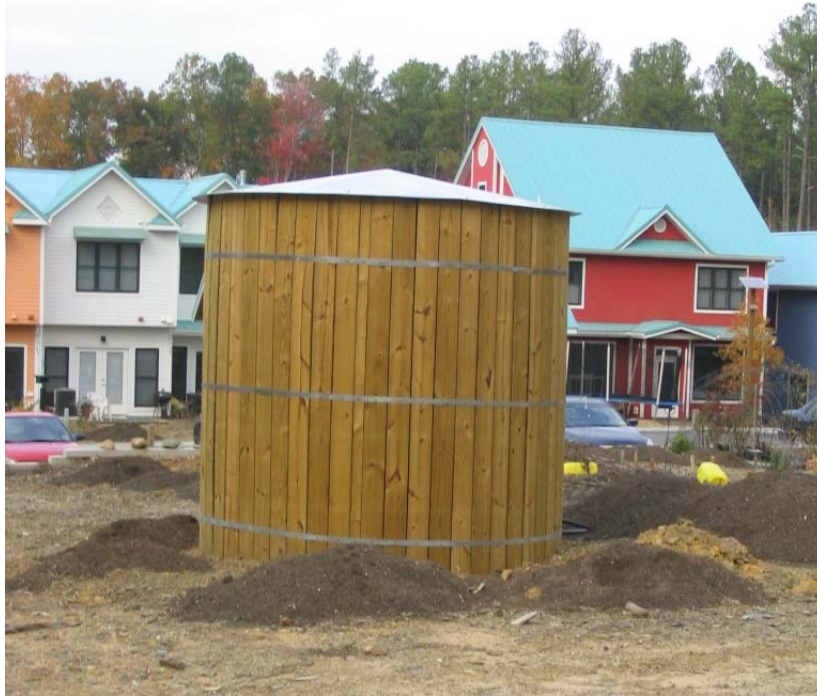
Figure 4. Community garden cistern

There were many LID management measures implemented by the developer including permeable concrete for walkways and parking spaces, permeable pavers for walkways, grass pavers, rainwater roof runoff collection and reuse, vegetated swales, bioretention areas, level spreaders, and minimizing impervious surfaces through reduced length parking spaces, smaller footprint homes, and narrow roads. The only LID measure implemented with cost share from this grant was a solar-powered pump and cistern system to facilitate using harvested rainwater roof runoff to irrigate a community garden (fig. 4). Pictures of many of the other LID measures are on the website
