# Evaluation of Level Spreaders in the Piedmont of North Carolina

## *Final Report*

*Jon Hathaway, EI and William F. Hunt PE, PhD*  
Department of Biological and Agricultural Engineering  
North Carolina State University  
July, 2006

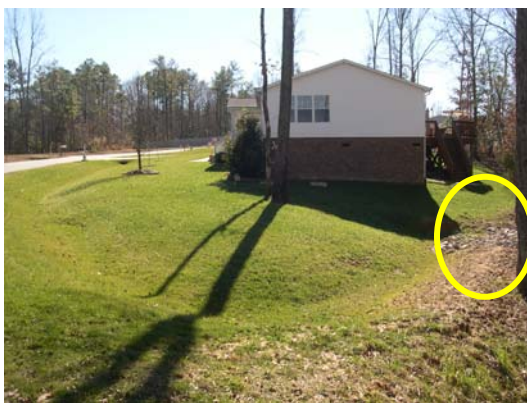
Figure 5: Swale leading to Level Spreader – Level Spreader Circled

Three of the 24 level spreaders were not constructed properly. Two of these systems were constructed with rip rap level lips. The level lips were not adequately tied into the adjoining soil, allowing stormwater to bypass the level lip, passing between the edge of the level spreader and the bordering soil (Figures 5 and 6). In the third system, silt fence was used downslope of the level spreader during site construction and was never removed. The silt fence provided a barrier between the level spreader and the riparian buffer, causing reconcentration of the stormwater.

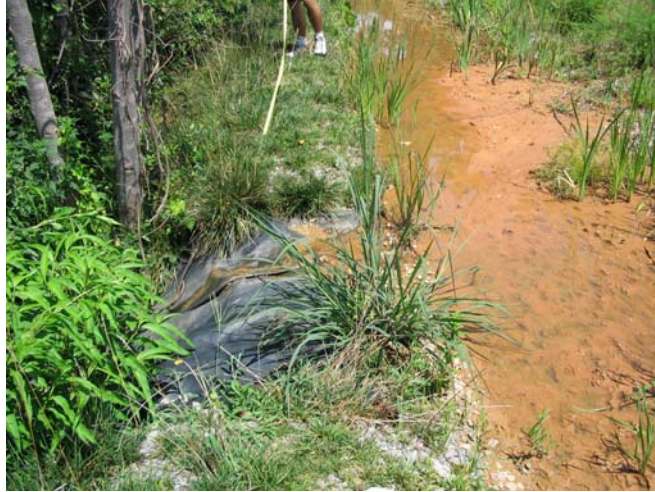
Figure 8: Breach on ABC stone level spreader

All 6 of the level spreaders constructed of earth or ABC stone were breached. These systems are unable to handle the erosive velocity of the stormwater passing over the level spreader (Figure 8). In three of four cases, the breach in the level spreader was on the lower side of the level spreader. It is possible that an increase in flow over one side of the level spreader resulted in higher erosive velocities and, thus, a head cut on the level lip.

Based on this study, some conclusions and design recommendations can be made, these are summarized in Table 4. The most obvious need regarding level spreader systems is a stable level spreader lip that can not be eroded. The most stable systems that were visited were made of concrete. Concrete level spreaders can be built with minimal slope and are more resistant to erosion than earthen/gravel systems. If a flow larger than the design flow is routed over a level spreader made of concrete, the level spreader lip will not be damaged. This study indicates that earthen/ABC stone level spreaders should not be used in *any* applications, as they routinely fail.

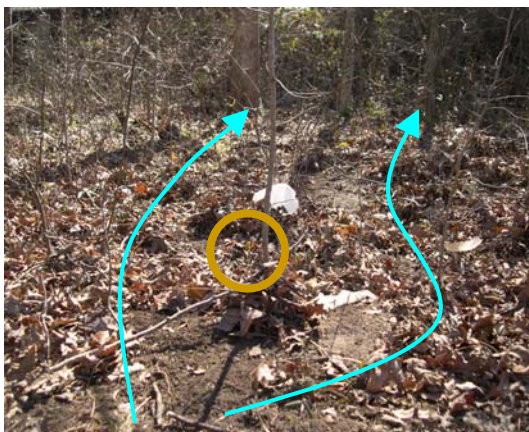
Figure 9: Large vegetation downslope causes concentrated flow

Throughout the course of the study, it was observed that the topography and the vegetative content of the riparian buffer impacted overall system effectiveness. Stormwater reconcentration due to passage through forested areas (Figure 9), natural swales (Figure 10), and natural wetland areas was common. At least 11 of the 24 level spreader – riparian buffer systems showed some failure due to riparian buffer topography. Additionally, incised stream banks may prove to be an obstacle to non-erosive overland flow from the level spreader to the stream. Incised streams typically have steeply sloped banks, overland flow could flow over these banks, causing a head cut to develop. Please note, though, that bank headcuts was not thoroughly investigated in this study.

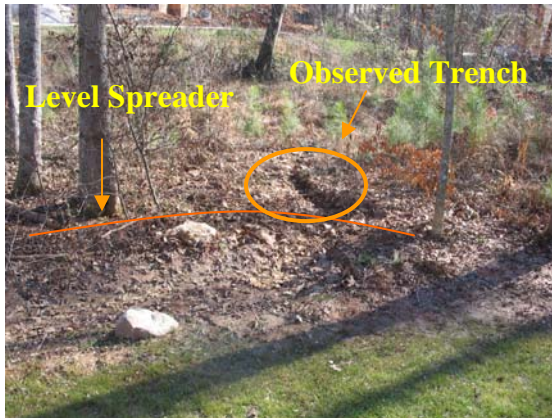
Figure 11: Earthen level spreader with channel

There were two instances of human interference observed. In one case, a ditch appeared to have been hand-dug from the level spreader through the riparian buffer to the stream (Figures 11 and 12). In the second case, a 4 inch corrugated plastic pipe, which was carrying stormwater intended for the level spreader, was draped over the structure allowing the discharge to bypass the level spreader (Figure 13).

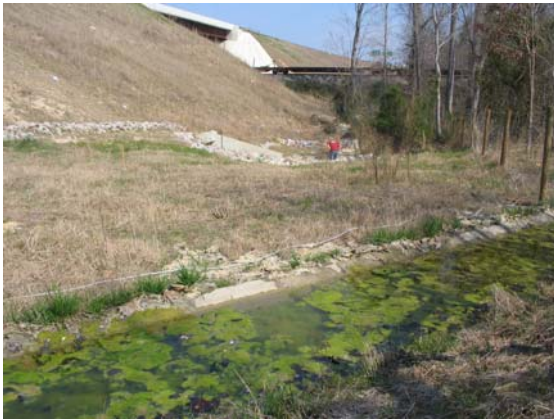
Figure 15: View of protected bank from back of level spreader

As discussed in Section 3.2.3, a potential detriment to water quality identified during this project was stream bank erosion. As water passes over an incised stream bank, a head cut can form and travel from the stream into the buffer. At one project site, rip rap was added to the stream bank in the location where the majority of the level spreader runoff would reconcentrate (Figures 15 and 16). This allowed the level spreader runoff to enter into the stream without eroding the bank. This practice would help eliminate erosion of the stream bank and reduce the risk of a head cut. Materials such as erosion control mat could be used instead of rip rap. Identifying the probable location of reconcentration at the stream bank may not always be possible, but would result in less soil loss from the bank. Use of rip rap or any channel liner, however, must be balanced by other design needs such as temperature mitigation and stream habitat that vegetated banks provide.
