# **STUDY ON THE SURFACE INFILTRATION RATE OF PERMEABLE PAVEMENTS**

E. Z. Bean<sup>1</sup>, W. F. Hunt<sup>2</sup>, and D. A. Bidelspach<sup>3</sup>

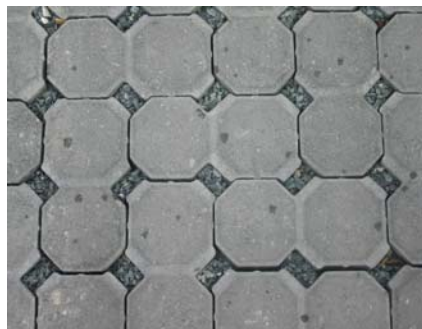
**Figure 1: PICP**

Figures 1 and 2, below, show examples of permeable interlocking concrete pavers (PICP) and concrete grid pavers (CGP). PICP are concrete block pavers that create voids on the corners of the pavers. Photo-analysis was used to determine that open, or void, space is at least nine percent (9%) of the surface area. Most research that has been conducted has examined these block pavers as test surfaces (Balades et al., 1995; Pratt 1995; Gerritts and James, 2002). CGP paving systems are comprised of concrete blocks with voids inside and between the blocks. Photo-analysis was used to determine that open, or void, space is approximately (30%) of the surface. In this study, the sites examined had voids either filled with sand or No. 78 stone (ASTM D 448).

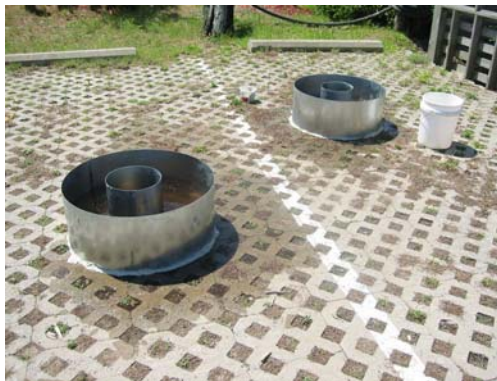
**Figure 3.** Double-ring-infiltrometer tests.

This study used ASTM D 3385, is the Standard Test Method for Infiltration Rate in Field Soils Using Double-Ring Infiltrometer, as a basis to measure infiltration rates. This test measures infiltration rates for soils with a hydraulic conductivity between  $10^{-6}$  cm/s to  $10^{-2}$  cm/s. The test used during this study modified some of the methods and materials in ASTM D 3385 to operate more efficiently in this study’s environments and resources. The double ring infiltrometers used in this study consisted of two 16 gauge galvanized steel rings. The inner rings had a diameter between 28 cm and 30.5 cm. The outer rings had diameters between 76 cm and 91 cm, or approximately three times the diameter of the inner rings.

Once locations were somewhat randomly selected for testing at each site, the infiltrometer rings were sealed to the surface using plumber’s putty. The inner ring was then filled with water to a depth of approximately 50 mm above the testing surface to determine if there was any leakage to the outer ring. Once all leaks – if any - were plugged, both the inner and outer rings were filled to a depth between 125 mm and 175 mm. The initial level of water in the inner ring, outer ring, and current time (effectively time 0) were then recorded. Water was then allowed to infiltrate freely. During infiltration, inner and outer ring water levels were measured from a fixed point on the top of the ring down to the water level and then recorded with the time

approximately every five minutes. Water was only added to the outer ring when it had dropped more than 10 mm below the inner ring water level to equalize hydraulic heads. A test was considered complete when either the inner ring ran dry or enough time had elapsed to determine the infiltration rate. The time needed to determine the infiltration rate was a minimum of 45 minutes.

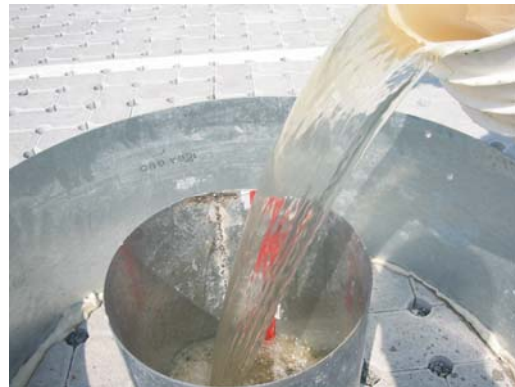
**Figure 4.** Surface inundation test.

Many PICP sites had infiltration rates too high to maintain a hydraulic head using the double-ring infiltrometer test. A modified test, known as a “surface inundation test” (Figure 4) was run at these sites. For the surface inundation test an inner ring of the double ring infiltrometer was sealed to the test surface and a scale was taped inside the ring. Using a five gallon bucket, water was quickly poured into the inner ring. Time was recorded from when the water started pouring in. The time was then recorded when the bucket emptied (along with the peak level of water inside the ring), and then every 30-60 seconds until the ring emptied. If the ring emptied in less than 30 seconds, then the time that the ring emptied was recorded. This test is neither as accurate nor as precise as the double-ring-infiltrometer test. However, this was a means of obtaining a rough of the surface infiltration rate.

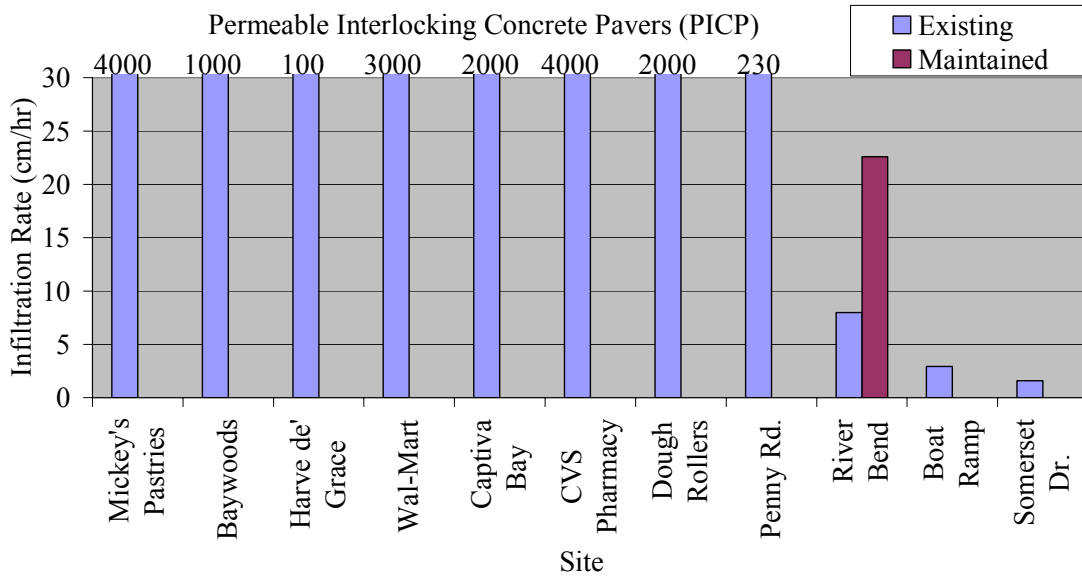
**Figure 6.** Infiltration rates for PICP applications.

Eleven PICP sites were tested; seven in Maryland, three in North Carolina and one in Delaware. Six of these sites were tested using only the surface inundation test, due to their high infiltration rates ( $>150$  cm/hr) Havre de Grace maintained a hydraulic head just enough to fill the double-ring-infiltrimeters for testing, but had an average infiltration rate average of 100 cm/hr. One of the three tests ran at the Penny Rd. site was a surface inundation test, however the other two were a double-ring-infiltrimeter tests. The three remaining PICP sites had surface infiltration rates low enough to maintain a hydraulic head so that standard double-ring infiltrimeter tests were able to be performed. The four sites which used double-ring-infiltrimeter tests were located in close proximity to areas containing exposed fine soil particles, e.g. gravel drive, a river bed, a beach and a construction site. Figure 6 shows measured infiltration rates for permeable pavement applications using PICP or similar products. The last four infiltration rates are the four PICP sites affected by fine soil particles. It has been shown statistically that surface infiltration rates of sites located near fines are substantially lower than those rates from areas free from fines.

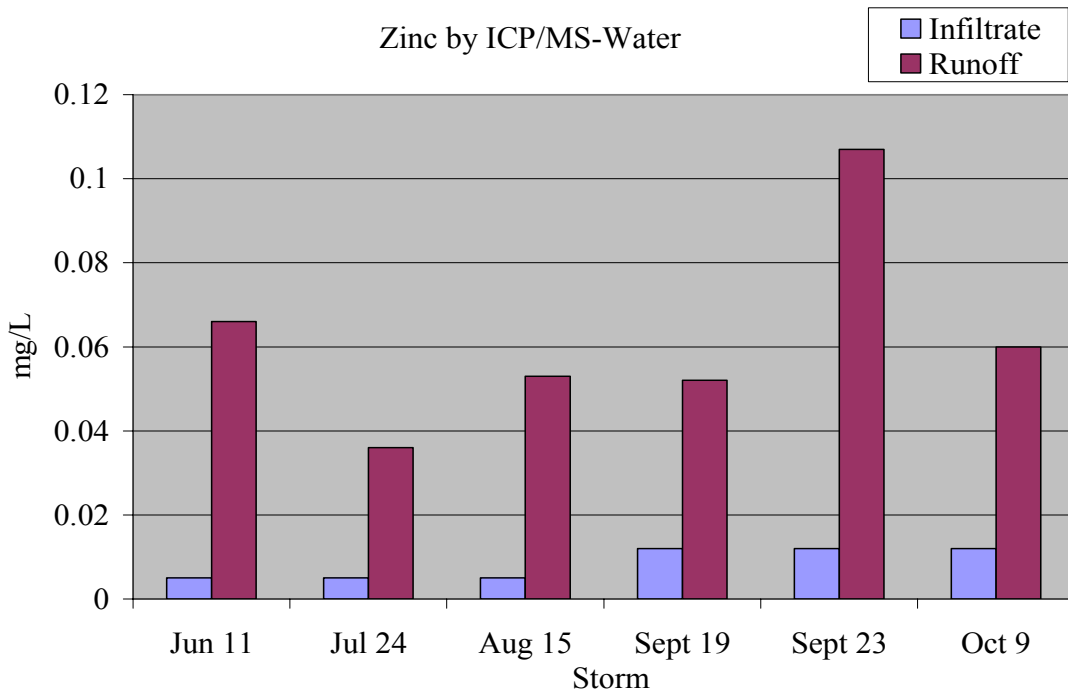
**Figure 7.** Zinc concentrations in runoff and infiltrate from six storms.

For water quality data from Mickey's Pastry Shop, differences in concentrations were determined to be significant if SAS returned p-values for the t-test of less than 0.05. Zinc was the only pollutant to have significantly different concentrations with a p-value of 0.002. Figure 7, below, shows concentration levels for Zinc.

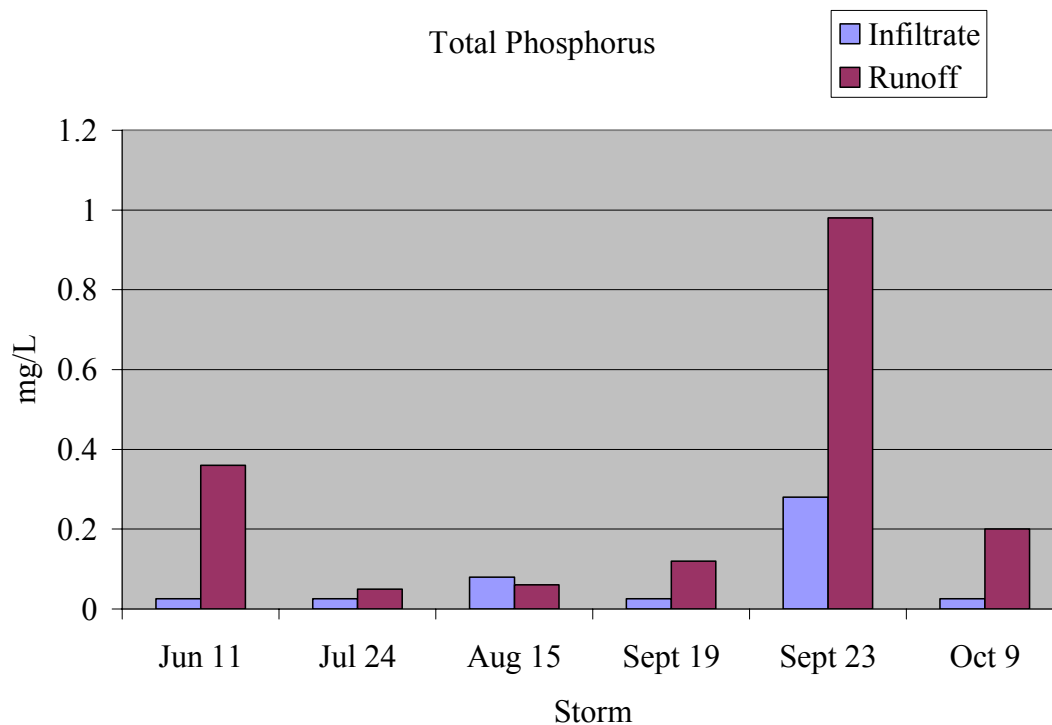
**Figure 8.** Phosphorus concentrations in runoff and infiltrate from six storms.

The other six pollutants monitored were: Cu, NO<sub>x</sub>-N, TKN, TN, TP and TSS. None of them were significant ( $p \leq 0.05$ ), however some showed a removal trend. Phosphorus ( $p = 0.13$ ) showed a strong tendency to have lower concentrations in infiltrate compared to runoff. Figure 8 shows concentration levels of TP. For four of the six storms, infiltrate concentrations of TP were less than half of that of the runoff concentrations, and for four of the storms, the infiltrate TP concentration was less than the minimum detectable value (0.05 mg/L).
