# STUDY ON THE SURFACE INFILTRATION RATE OF PERMEABLE PAVEMENTS

Eban Z. Bean, North Carolina State University, Raleigh, NC

This information was previously presented at ASCE/EWRI Conference in Salt Lake City, UT, in June 2004.

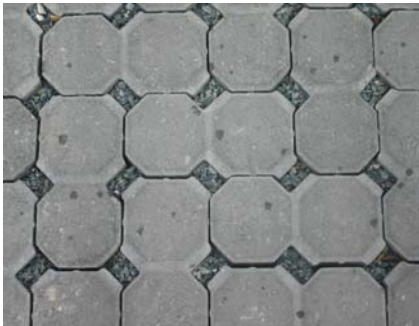
Figure 1: PICP

Figures 1 and 2, below, show examples of permeable interlocking concrete pavers (PICP) and concrete grid pavers (CGP). PICP are concrete block pavers that create voids on the corners of the pavers. Photo-analysis was used to determine that open, or void, space is at least nine percent (9%) of the surface area. Most research that has been conducted has examined these block pavers as test surfaces (Balades et al., 1995; Pratt 1995; Gerritts and James, 2002). CGP paving systems are comprised of concrete blocks with voids inside and between the blocks. Photo-analysis was used to determine that open, or void, space is approximately (30%) of the surface. In this study, the sites examined had voids either filled with sand or No. 78 stone (ASTM D 448).

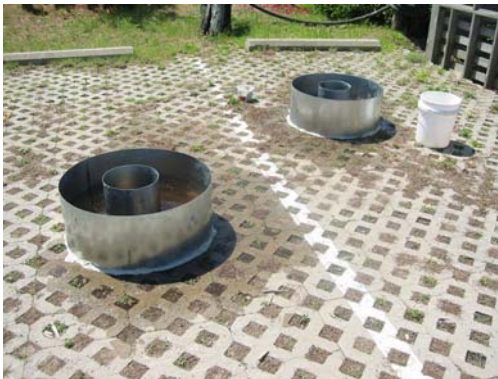
Figure 3. Double-ring-infiltrometer tests.

This study used ASTM D 3385, is the Standard Test Method for Infiltration Rate in Field Soils Using Double-Ring Infiltrimeter, as a basis to measure infiltration rates. This test measures infiltration rates for soils with a hydraulic conductivity between  $10^{-6}$  cm/s to  $10^{-2}$  cm/s. The test used during this study modified some of the methods and materials in ASTM D 3385 to operate more efficiently in this study’s environments and resources. The double ring infiltrometers used in this study consisted of two 16 gauge galvanized steel rings. The inner rings had a diameter between 28 cm and 30.5 cm. The outer

rings had diameters between 76 cm and 91 cm, or approximately three times the diameter of the inner rings.

Once locations were somewhat randomly selected for testing at each site, the infiltrometer rings were sealed to the surface using plumber's putty. The inner ring was then filled with water to a depth of approximately 50 mm above the testing surface to determine if there was any leakage to the outer ring. Once all leaks – if any - were plugged, both the inner and outer rings were filled to a depth between 125 mm and 175 mm. The initial level of water in the inner ring, outer ring, and current time (effectively time 0) were then recorded. Water was then allowed to infiltrate freely. During infiltration, inner and outer ring water levels were measured from a fixed point on the top of the ring down to the water level and then recorded with the time approximately every five minutes. Water was only added to the outer ring when it had dropped more than 10 mm below the inner ring water level to equalize hydraulic heads. A test was considered complete when either the inner ring ran dry or enough time had elapsed to determine the infiltration rate. The time needed to determine the infiltration rate was a minimum of 45 minutes.

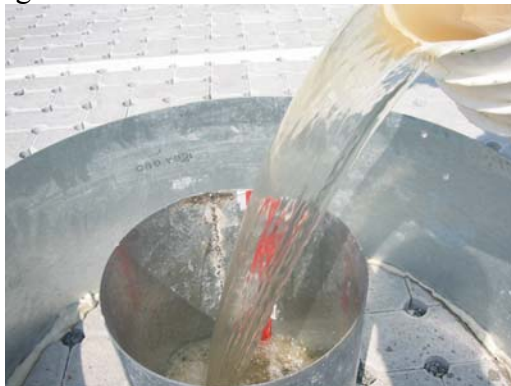
Figure 4. Surface inundation test.

Many PICP sites had infiltration rates too high to maintain a hydraulic head using the double-ring infiltrometer test. A modified test, known as a "surface inundation test" (Figure 4) was run at these sites. For the surface inundation test an inner ring of the double ring infiltrometer was sealed to the test surface and a scale was taped inside the ring. Using a five gallon bucket, water was quickly poured into the inner ring. Time was recorded from when the water started pouring in. The time was then recorded when the bucket emptied (along with the peak level of water inside the ring), and then every 30-60 seconds until the ring emptied. If the ring emptied in less than 30 seconds, then the time that the ring emptied was recorded. This test is neither as accurate nor as precise as the double-ring-infiltrometer test. However, this was a means of obtaining a rough of the surface infiltration rate.

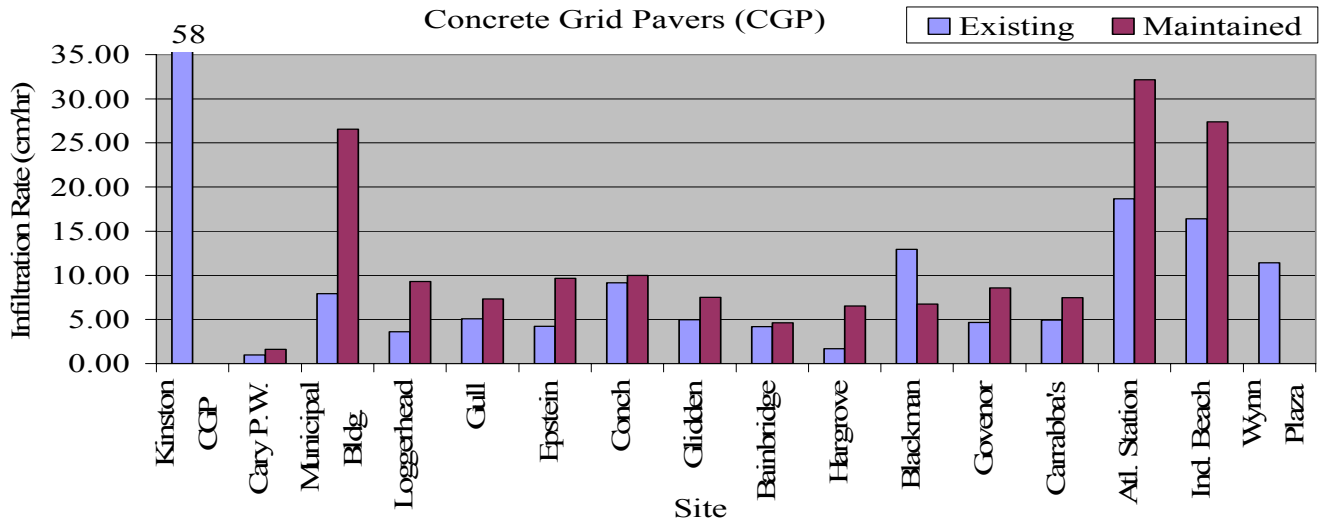
Figure 5. Infiltration rates measured from CGP sites.

Infiltration rates were measured from 16 sites with CGP. Figure 5 is a graphic showing the infiltration rates of the lots tested throughout NC. Of these, 14 sites were "maintained", and had their maintenance infiltration rate measured. (The "existing" or "unmaintained" and "maintained" were defined earlier in the Procedure section.) Of the two sites that did not have maintenance performed, the measured infiltration rate at one site was greater than 25 cm/hr, Kinston TS, and the other had an existing infiltration of 10 cm/hr, Wynn Plaza. The site with the lowest surface infiltration rate, Town of Cary Public Works (1.0 cm/hr), could be the result of a combination of factors (i.e. no maintenance and frequent heavy traffic). This site also was constructed in a clay soil area; however, since the surrounding area is relatively undisturbed, this may not be a significant factor.

Of the sites that had maintenance testing, 13 had noticeably higher infiltration rates than the "unmaintained" pavers. The only site that did not increase its infiltration rate was Blackman Beach Access. This anomaly was potentially due to a high infiltration rate of 22.2 cm/hr for one of the existing tests, while all other tests, existing and maintained, had infiltration rates less than 10 cm/hr. The mean and median average existing surface infiltration rates, where both rates were recorded, were 7.1 cm/hr and 5.0 cm/hr respectively; the mean and median average maintained surface infiltration rate was 11.8 cm/hr and 8.0 cm/hr, respectively. Comparing means, maintaining the lots increased the permeability by

66%.

There are several observations that can be drawn from this study. The first is that parking lot maintenance is a key to maintaining infiltration rates on pavements comprised of CGP, filled with sand. Thirteen of 14 sites had increased infiltration rates after removal of the top layer (1.3 cm typical depth) of accumulated void space material. Without maintenance the median average infiltration rate was 5.0 cm/hr, while with maintenance the median infiltration rate was 8.0 cm/hr. A SAS<sup>TM</sup> (2003) analysis showed that there was a statistically significant difference between existing and maintained infiltration rates to a 99.8% confidence. It can be stated with high confidence that maintenance significantly improved infiltration rates for the CGP sites with sand in this study.

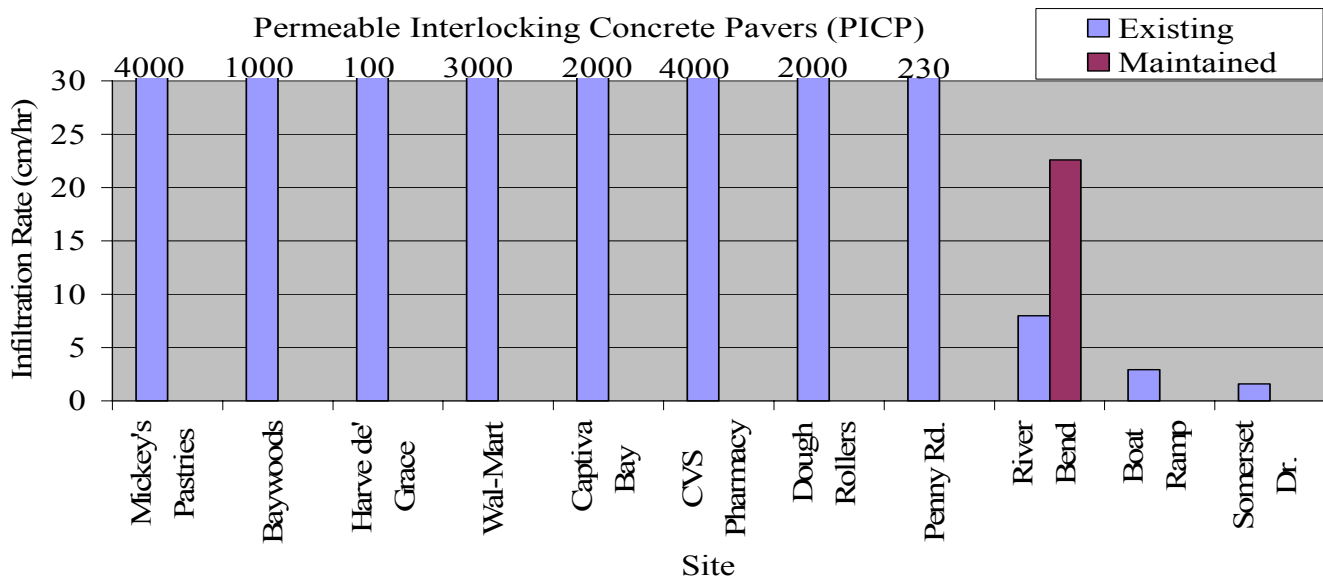
Figure 6. Infiltration rates for PICP applications.

Eleven PICP sites were tested; seven in Maryland, three in North Carolina and one in Delaware. Six of these sites were tested using only the surface inundation test, due to their high infiltration rates (>150 cm/hr) Havre de Grace maintained a hydraulic head just enough to fill the double-ring-infiltrometers for testing, but had an average infiltration rate average of 100 cm/hr. One of the three tests ran at the Penny Rd. site was a surface inundation test, however the other two were a double-ring-infiltrometer tests. The three remaining PICP sites had surface infiltration rates low enough to maintain a hydraulic head so that standard double-ring infiltrometer tests were able to be performed. The four sites which used double-ring-infiltrometer tests were located in close proximity to areas containing exposed fine soil particles, e.g. gravel drive, a river bed, a beach and a construction site. Figure 6 shows measured infiltration rates for permeable pavement applications using PICP or similar products. The last four infiltration rates are the four PICP sites affected by fine soil particles. It has been shown statistically that surface infiltration rates of sites located near fines are substantially lower than those rates from areas free from fines.

Infiltration rates of PICP filled with gravel are not limited by their surface infiltration capacity provided they are sited in areas free of soil disturbances. The average PICP infiltration rate was 2000 cm/hr, while the PICP sites near disturbed soils with fines was 61 cm/hr, a decrease of almost 97%. A SAS<sup>TM</sup> (2003) test was run to determine if there was a significant difference between the infiltration rates of PICP near fines and free of fines. The analysis showed a significant difference in surface infiltration rates at a confidence level of 99.5%. PICP sites free of fines have significantly higher infiltration rates than PICP sites with sandy fines present in this study.

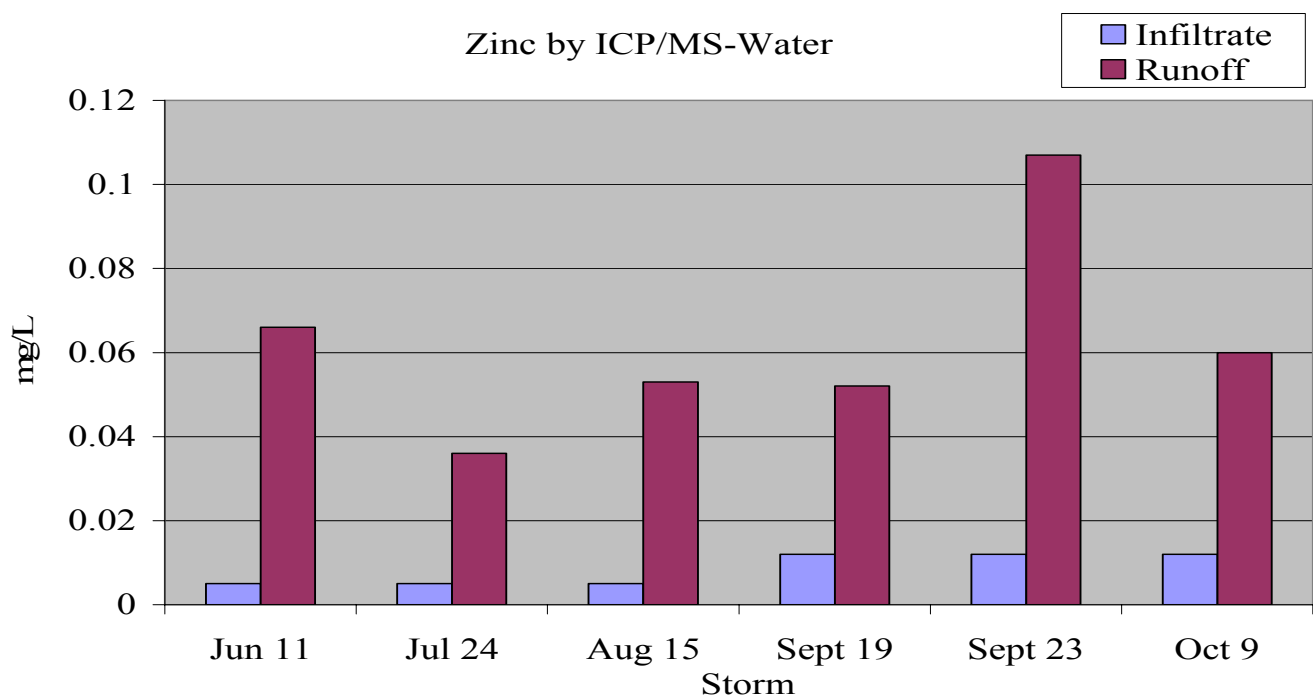
Figure 7. Zinc concentrations in runoff and infiltrate from six storms.

For water quality data from Mickey's Pastry Shop, differences in concentrations were determined to be significant if SAS returned p-values for the t-test of less than 0.05. Zinc was the only pollutant to have significantly different concentrations with a p-value of 0.002. Figure 7, below, shows concentration levels for Zinc.

After six storms, water quality analysis from Mickey's Pastry Shop in Goldsboro, NC, shows that the site had significantly lower concentrations of Zinc in infiltrate as compared to the asphalt runoff. With more storms, this may also be shown with pollutants such as Cu, TSS, TP and TKN. With only six events measured, these pollutants show trends of lower concentrations for infiltrate than runoff.

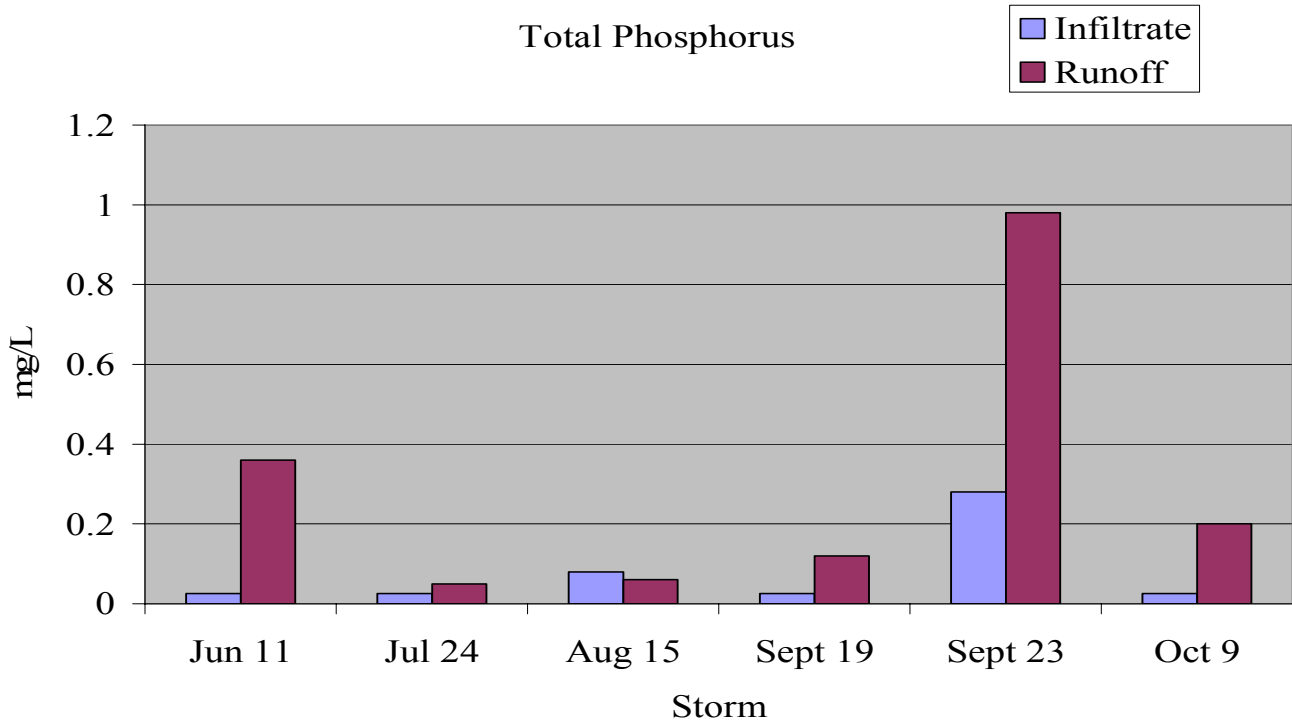
Figure 8. Phosphorus concentrations in runoff and infiltrate from six storms.

The other six pollutants monitored were: Cu, NO<sub>x</sub>-N, TKN, TN, TP and TSS. None of them were significant ( $p \leq 0.05$ ), however some showed a removal trend. Phosphorus ( $p = 0.13$ ) showed a strong tendency to have lower concentrations in infiltrate compared to runoff. Figure 8 shows concentration levels of TP. For four of the six storms, infiltrate concentrations of TP were less than half of that of the runoff concentrations, and for four of the storms, the infiltrate TP concentration was less than the minimum detectable value (0.05 mg/L).
