Benefits of 2D Modeling for Proposed Bank Stabilization

Little Sugar Creek, Mecklenburg County

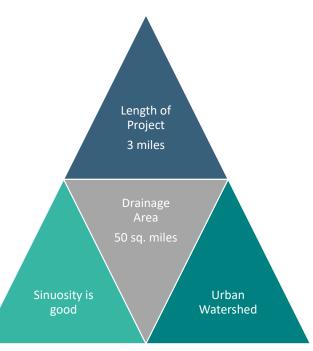
Summary of NC Piedmont Regional Curve Data (50 square mile drainage area)

Predicted Value	Rural Curve ₁	Urban Curve₁
Bankfull Discharge (cubic feet per second)	1,500	3,650
Bankfull Cross- Sectional Area (square feet)	300	760
Bankfull Width (feet)	60	90
Bankfull Mean Depth (feet	5	9

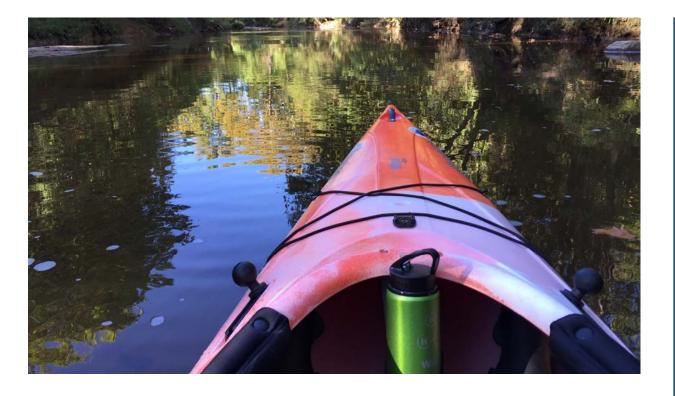
- Due to the size of the drainage area and its urban nature, the flow regime is very dynamic and the hydraulic geometry in these locations does not appear to support this flow diversity (i.e., poor low flow).
- Observed flow went from a few inches to 3+ feet after a rainfall of ~0.7 inches in 24 hours.

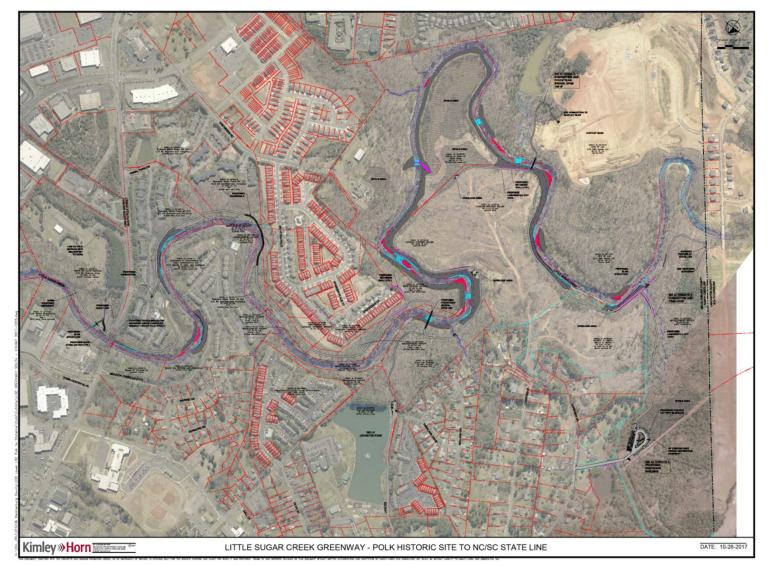
Project Areas and Goals

- Remove Tires and Trash
- Stabilize the most erosive stream banks
- Low-flow channel shaping in areas where bank work is taking place

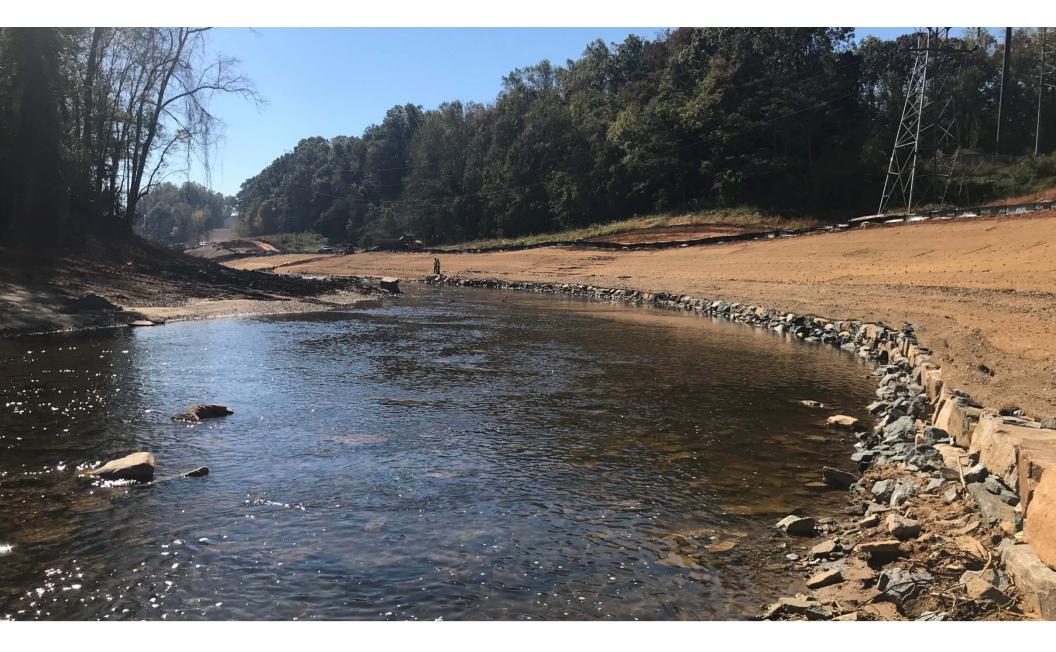
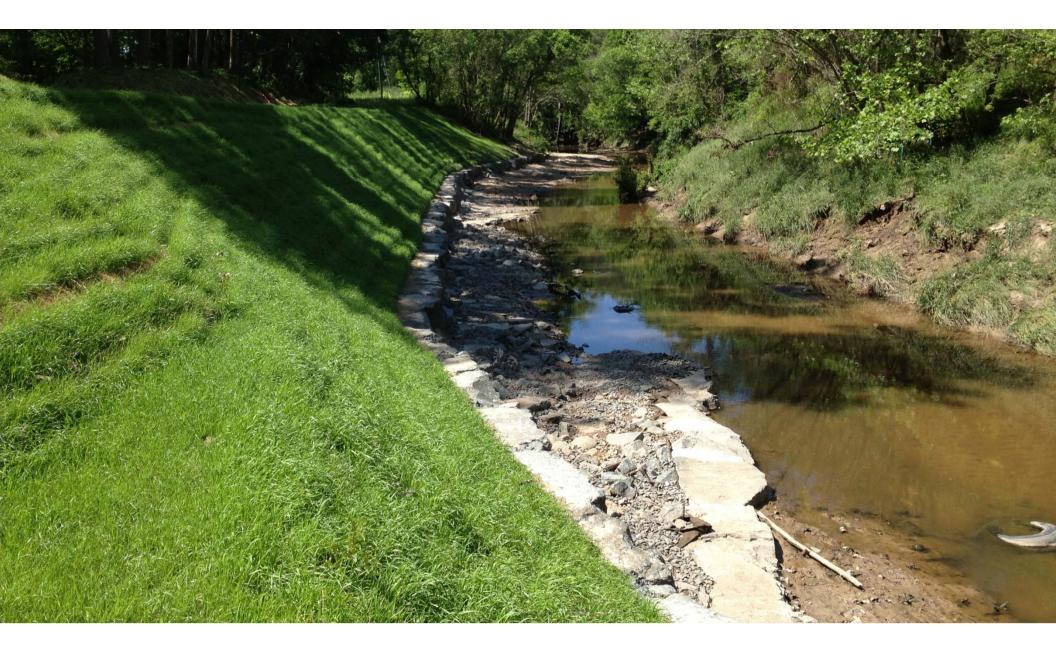
Bank Protection Methods

- $\circ\,$ Bank Grading and Planting
- $_{\rm O}$ Toe Wood
- o Rock Vane
- o Rock Toe
- Shape Low Flow Channel
- Redi-Rock Retaining Wall
