# Evaluating the ecological function of restored streams in Piedmont, North Carolina using the SQT

Sara Donatich<sup>1</sup>, Barbara Doll<sup>1</sup>, & Jonathan Page<sup>1</sup>

<sup>1</sup> NC State University

August 16<sup>th</sup> 2018

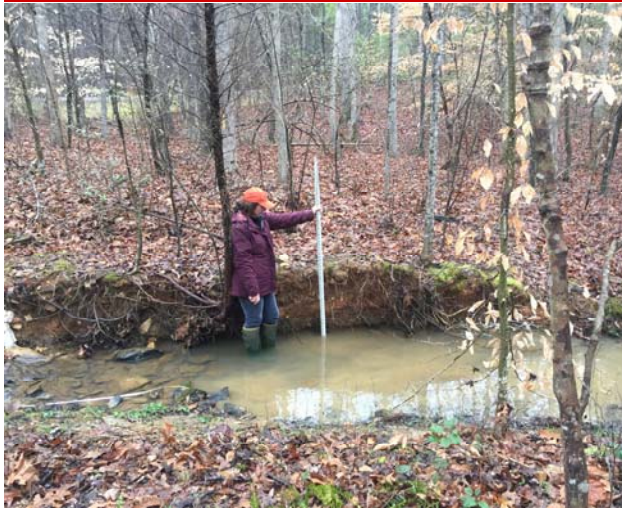
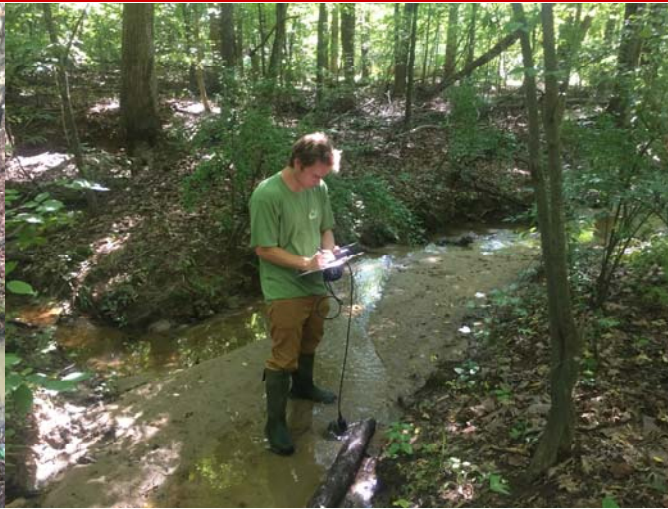
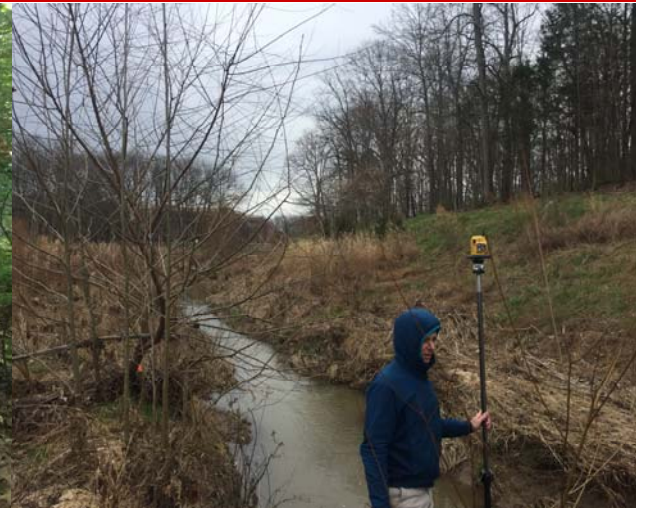
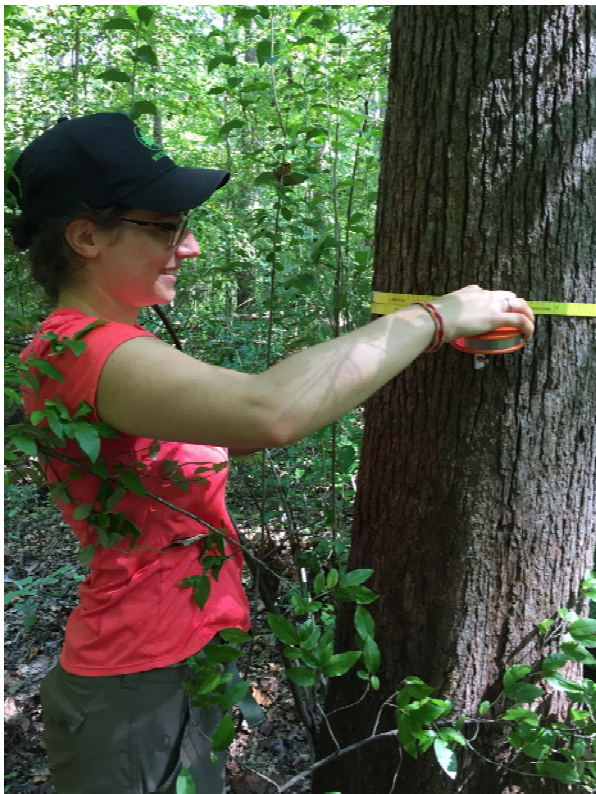
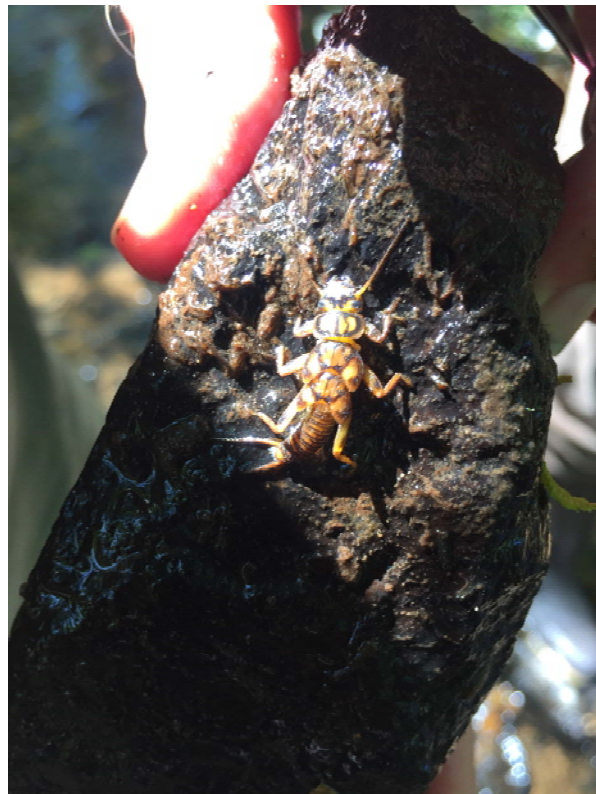
# Data Collection

Functional Category	Measurement Method	Functional Category	Measurement Method
Hydrologic	Curve Number	Physico-chemical	Daily Maximum Summer Temperature (°F)
	No. of Concentrated Flow Points		Dissolved oxygen (mg/L)
	Soil Compaction (Penetrometer)		Specific Conductivity (mS/cm)
	Soil Compaction (Bulk Density)		pH
Hydraulic	Bank Height Ratio		Salinity (ppt)
	Entrenchment Ratio		Total Nitrogen (mg/L)
Geomorphic	LWD Index		Total Phosphorus (mg/L)
	LWD Piece Count		Fecal Coliform (Cfu/100 ml)
	Dominant BEHI/NBS		% Shredders
	Percent Streambank Erosion (%)		Biological
	Canopy Coverage (%)	EPT Taxa Present	
	Buffer Width (ft)	Restoration Potential	Watershed Catchment Assessment
	Basal Area (sq. ft/acre)		
	Pool Spacing Ratio		
	Pool Depth Ratio		
	Percent Riffle		
Sinuosity

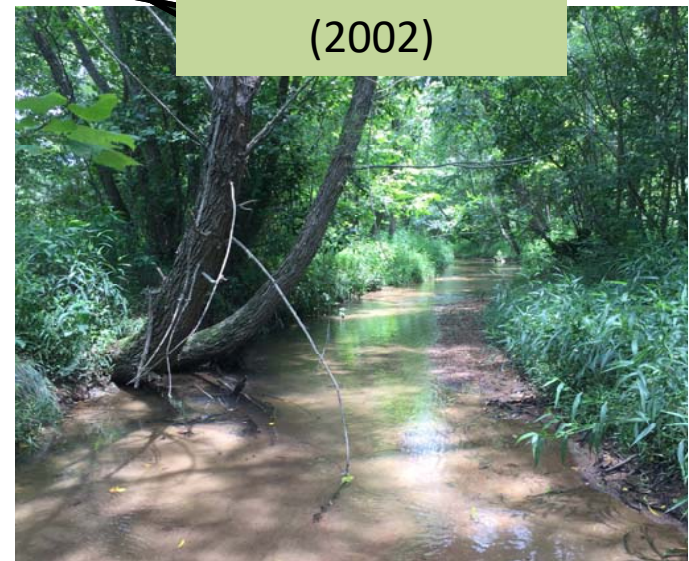
Downstream Restored Reach (2002)

Drainage Area (sq. mi)	Curve Number	Median Particle	Slope (%)	Rosgen Stream Type
3.8	78	Sand	0.39	G5c
8.5	83	Sand	0.19	C5

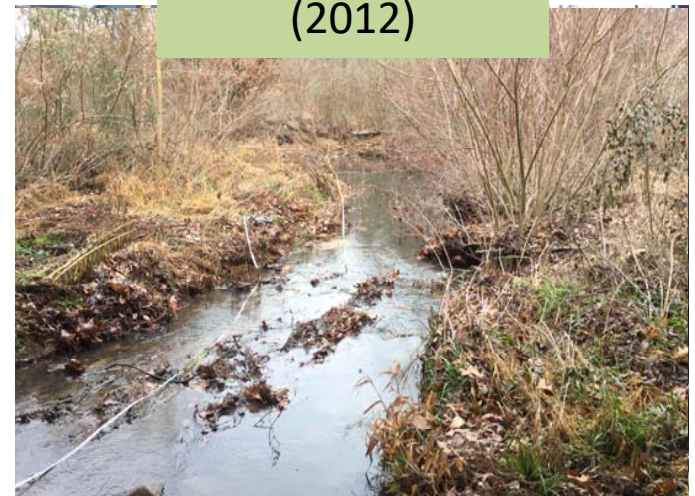
Downstream Restored Reach (2012)

Drainage Area (sq. mi)	Curve Number	Median Particle	Slope (%)	Rosgen Stream Type
0.5	82	Gravel	1.64	G4c
0.9	82	Gravel	0.30	C4

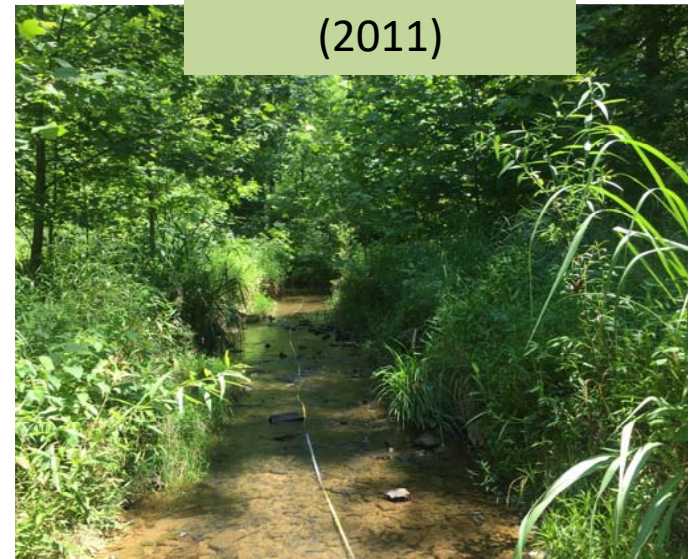
Downstream Restored Reach (2011)

Drainage Area (sq. mi)	Curve Number	Median Particle	Slope (%)	Rosgen Stream Type
0.6	77	Gravel	0.53	E4
1.0	77	Sand	0.57	C5

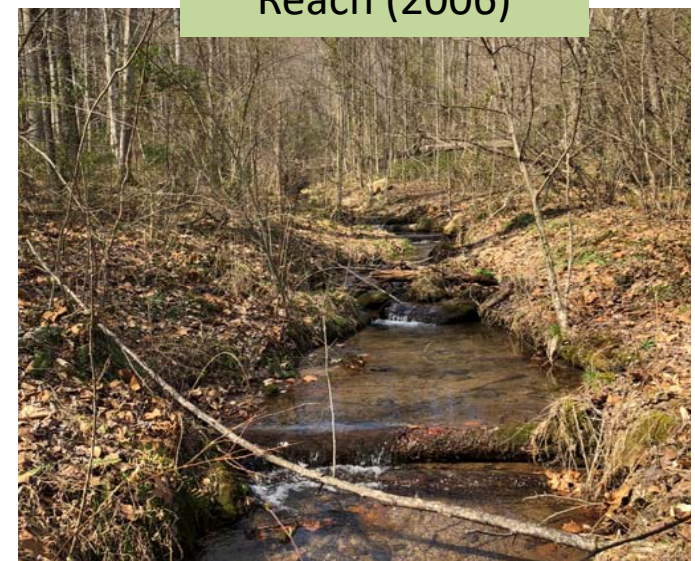
Adjacent Restored Reach (2006)

Drainage Area (sq. mi)	Curve Number	Median Particle	Slope (%)	Rosgen Stream Type
0.2	57	Gravel	2.10	E4b
0.4	58	Gravel	4.60	C4b

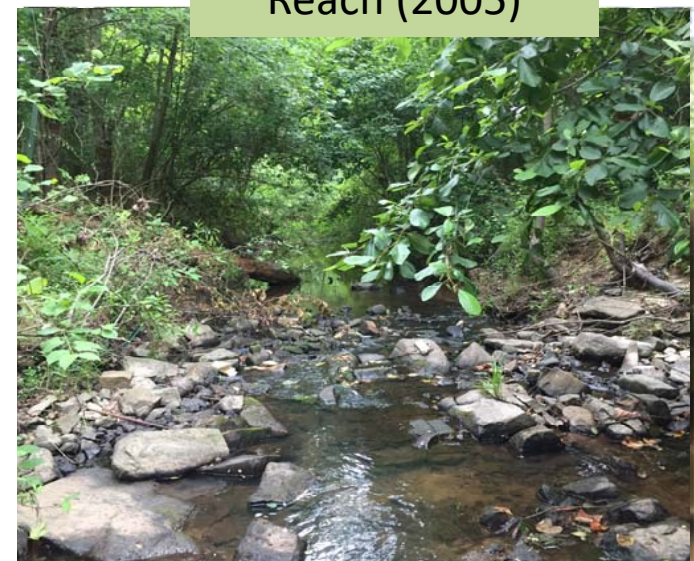
Adjacent Restored Reach (2005)

Drainage Area (sq. mi)	Curve Number	Median Particle	Slope (%)	Rosgen Stream Type
2.0	87	Sand	0.27	F5
1.8	87	Sand	0.23	E5b

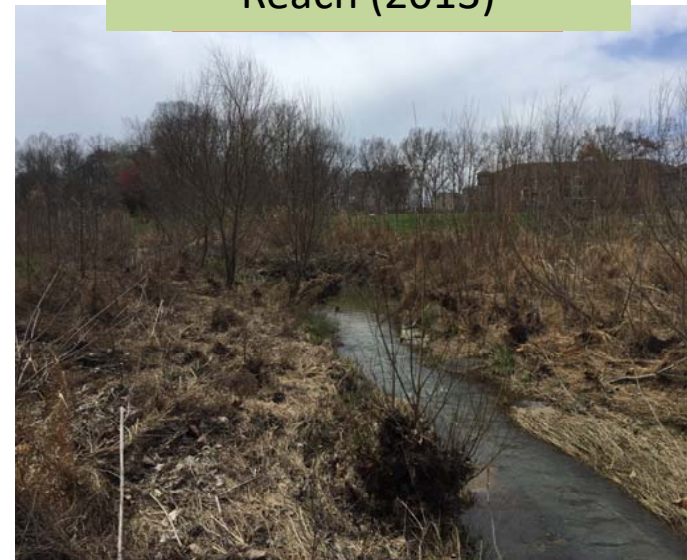
Downstream Restored Reach (2013)

Drainage Area (sq. mi)	Curve Number	Median Particle	Slope (%)	Rosgen Stream Type
0.8	80	Sand	0.62	G5c
3.6	80	Sand	0.36	C5

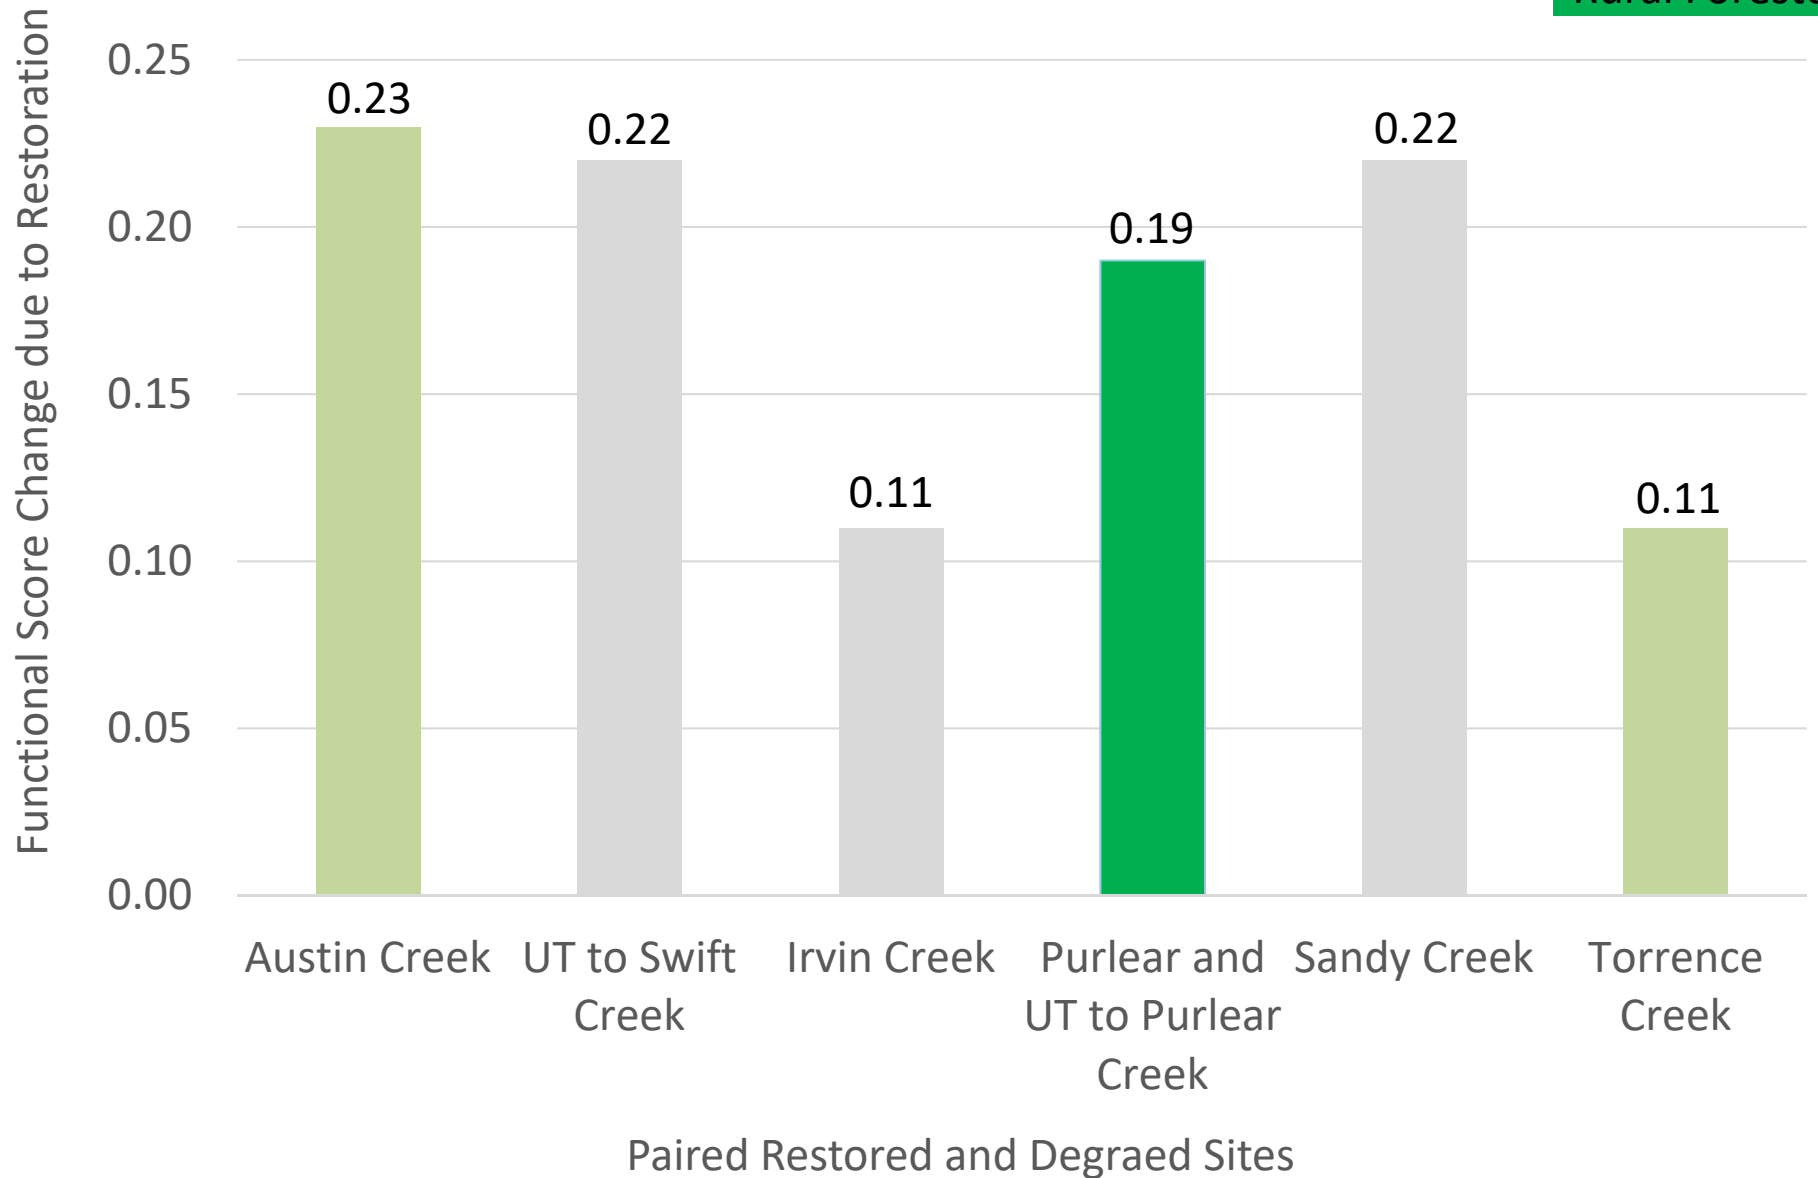
Functional Lift due to Restoration

Site	Overall Functional Change		Functional Lift
Austin Creek	Not Functioning [0.26]	Functioning-At-Risk [0.49]	0.23
UT to Swift Creek	Not Functioning [0.21]	Functioning-At-Risk [0.43]	0.22
Irvin Creek	Functioning-At-Risk [0.36]	Functioning-At-Risk [0.47]	0.11
Purlear and UT to Purlear Creek	Functioning-At-Risk [0.65]	Functioning [0.84]	0.19
Sandy Creek	Not Functioning [0.27]	Functioning-At-Risk [0.49]	0.22
Torrence Creek	Functioning-At-Risk [0.34]	Functioning-At-Risk [0.45]	0.11

- **SQT functional scores** reflect **perceived** stream condition
- **Restored sites** exhibit **functional lift**
  - Lift largely due to improved **hydraulic and geomorphic function** addressed via restoration
- **Geomorphology** category may be **diluted**
  - Improvement in structural function is negated by low-scoring, post-restoration vegetation function
  - Incentivizes monitoring
- **Regionalization** is critical to capture diverse stream systems
  - **Sand-bedded systems** are ripple-dune-run systems; minimal riffles naturally
  - **Percent riffle** metric currently lumps run and riffle lengths together
