The Self-Recovery of Stream Channel Stability in Urban Watersheds Due to BMP Implementation, Carroll County, MD

G. Engle, B. Madigan and M. Covington
Carroll County, Bureau of Resource Management

August 14, 2018

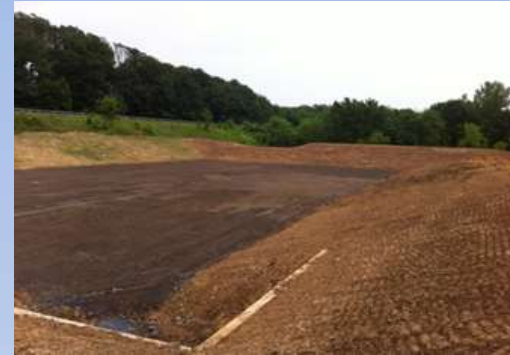
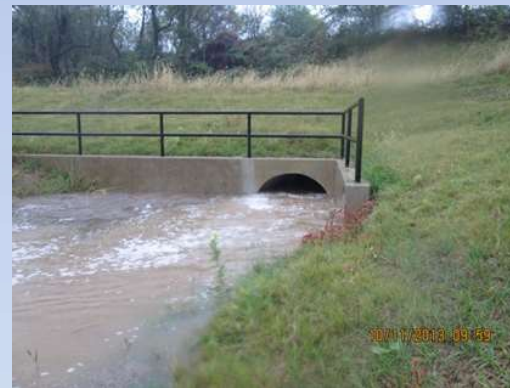
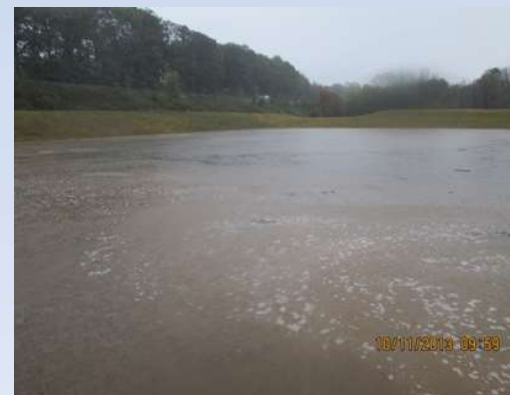
Carroll County Sand Filter Design

Unique Design Characteristics:

- No Riser - all design flows through sand control
- Drop Structures and Level Pipes
 - Turbulent to laminar flow
- Total Capture of 2 year storm, “difference in 10 year runoff volume”
 - Direct runoff difference – Meadow and Impervious
- Sand layer seeded w/ MDE mix
 - Prevents cracking/short circuiting of filter

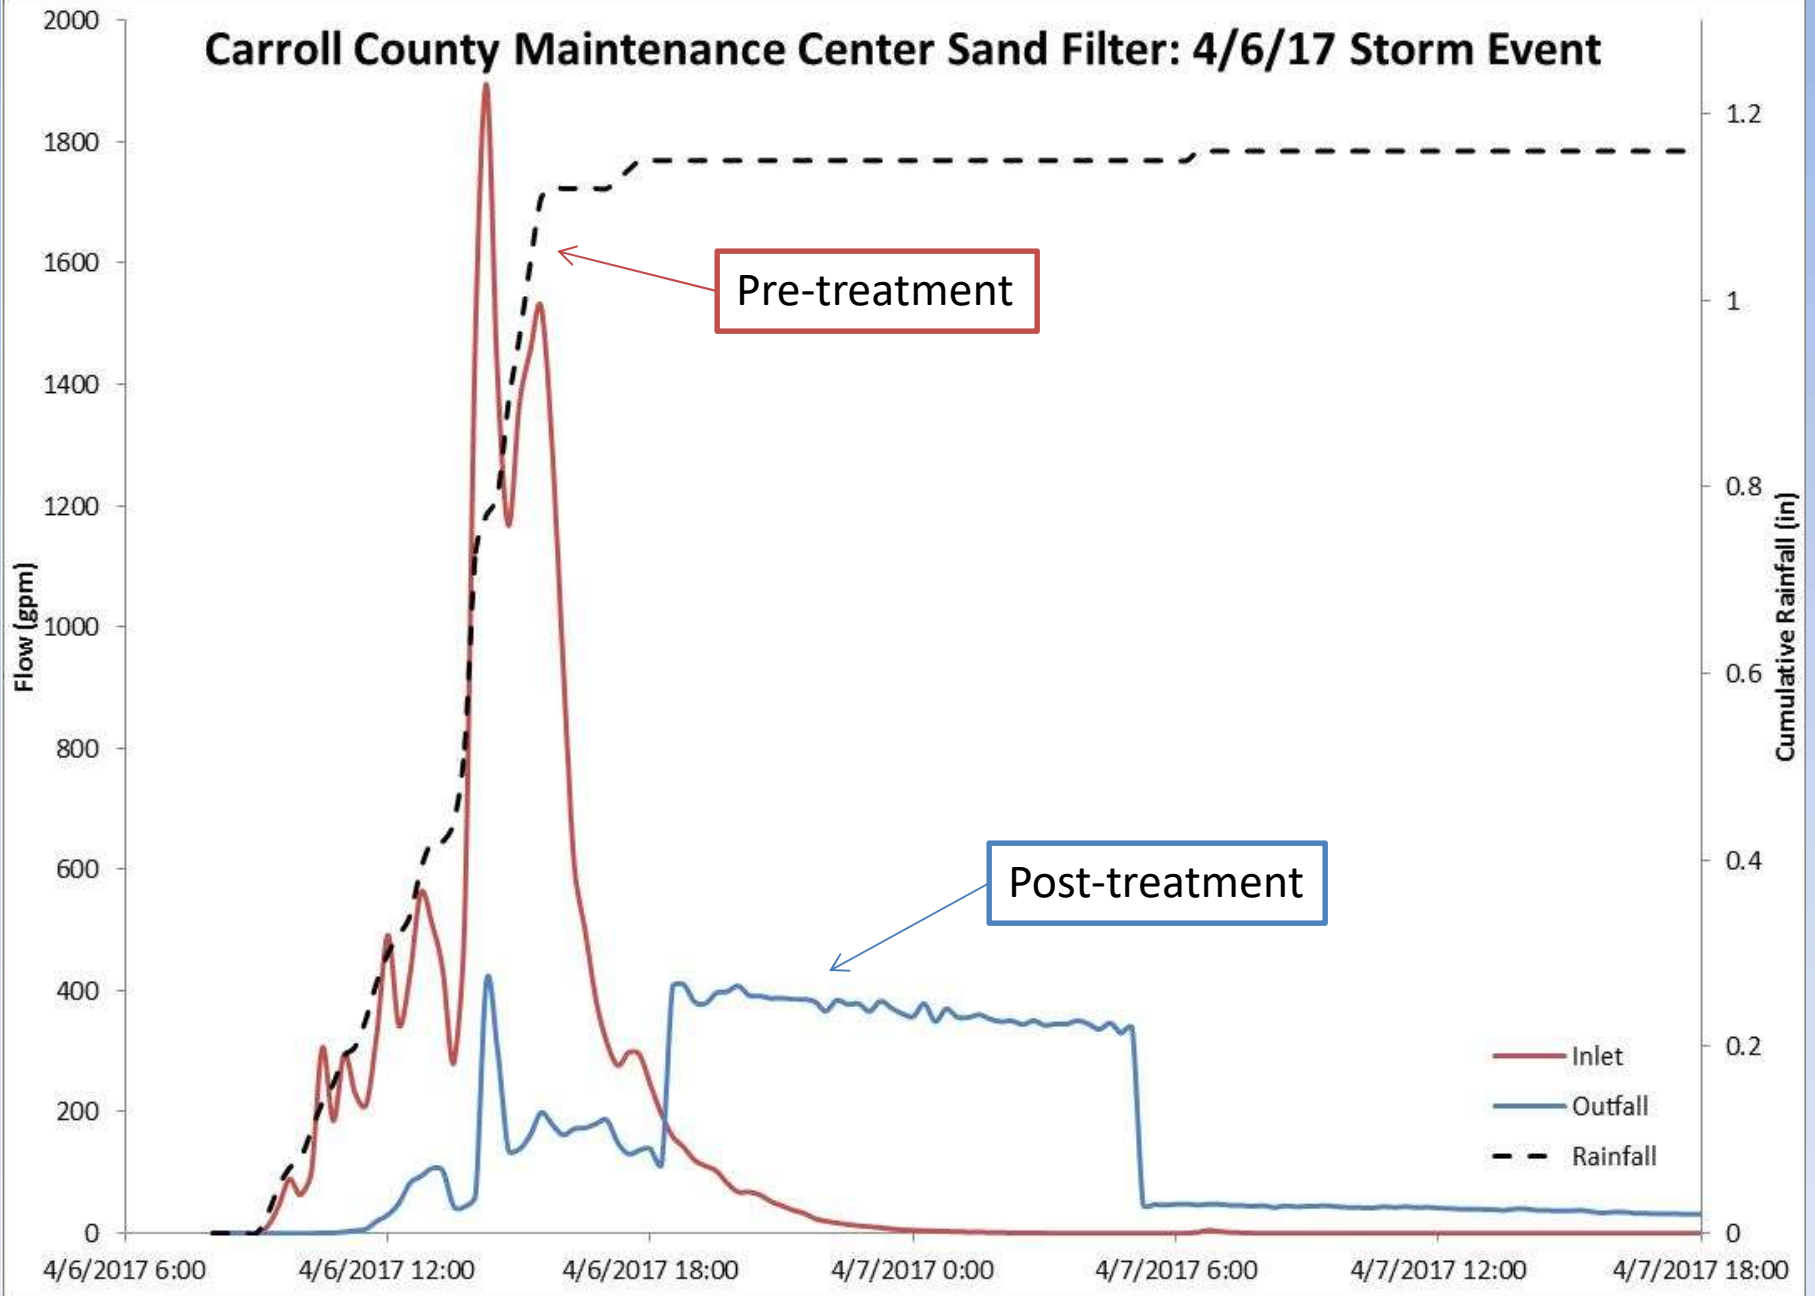
Carroll County Maintenance Center Sand Filter: 4/6/17 Storm Event

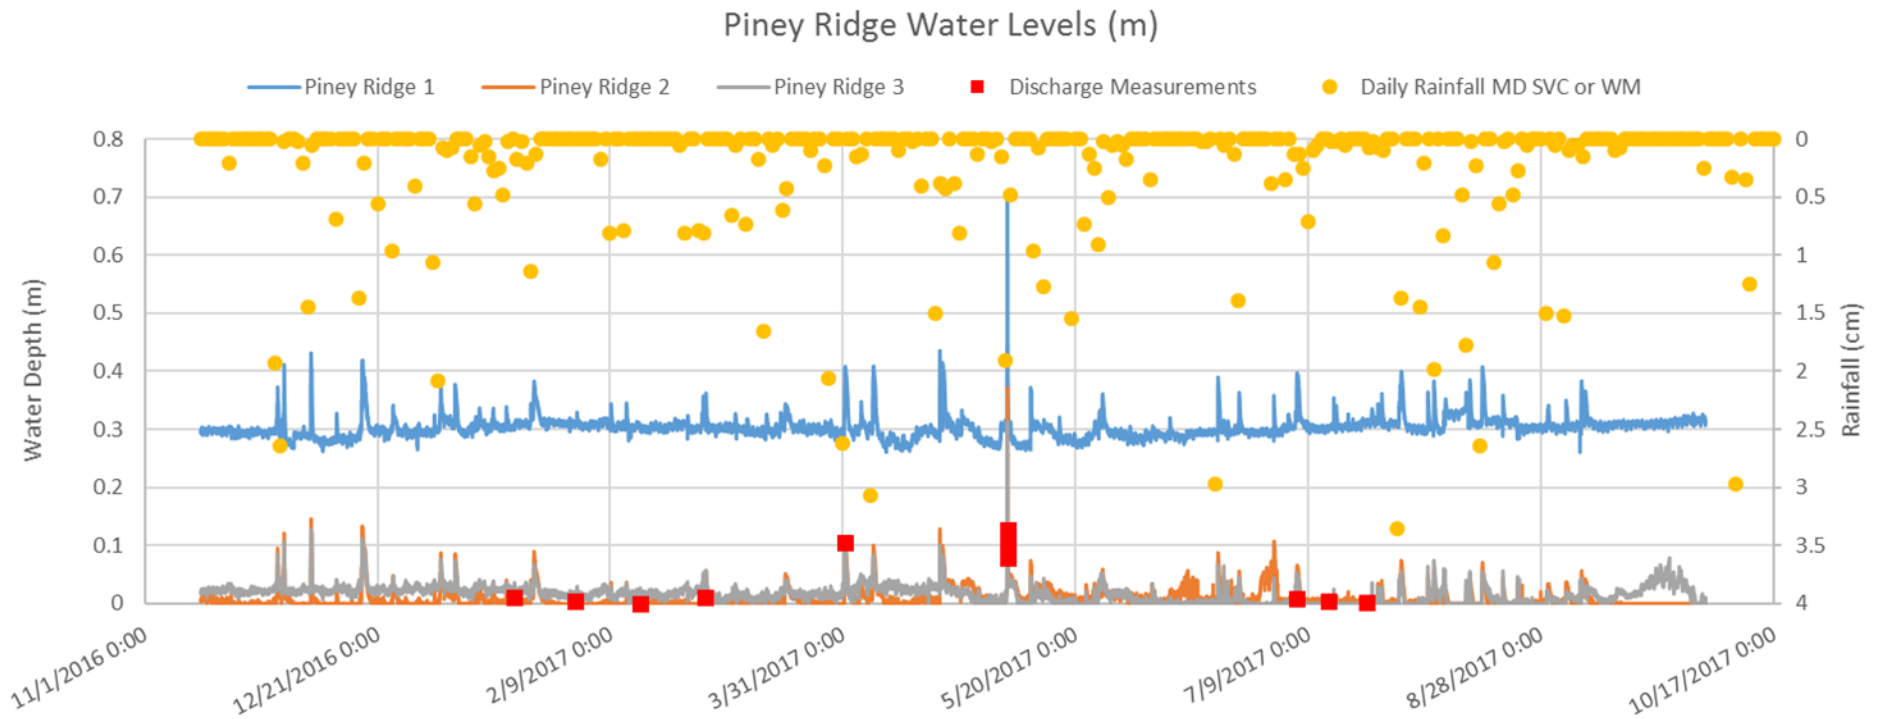
Time series of stage and rainfall (Nov '16 – Oct '17)

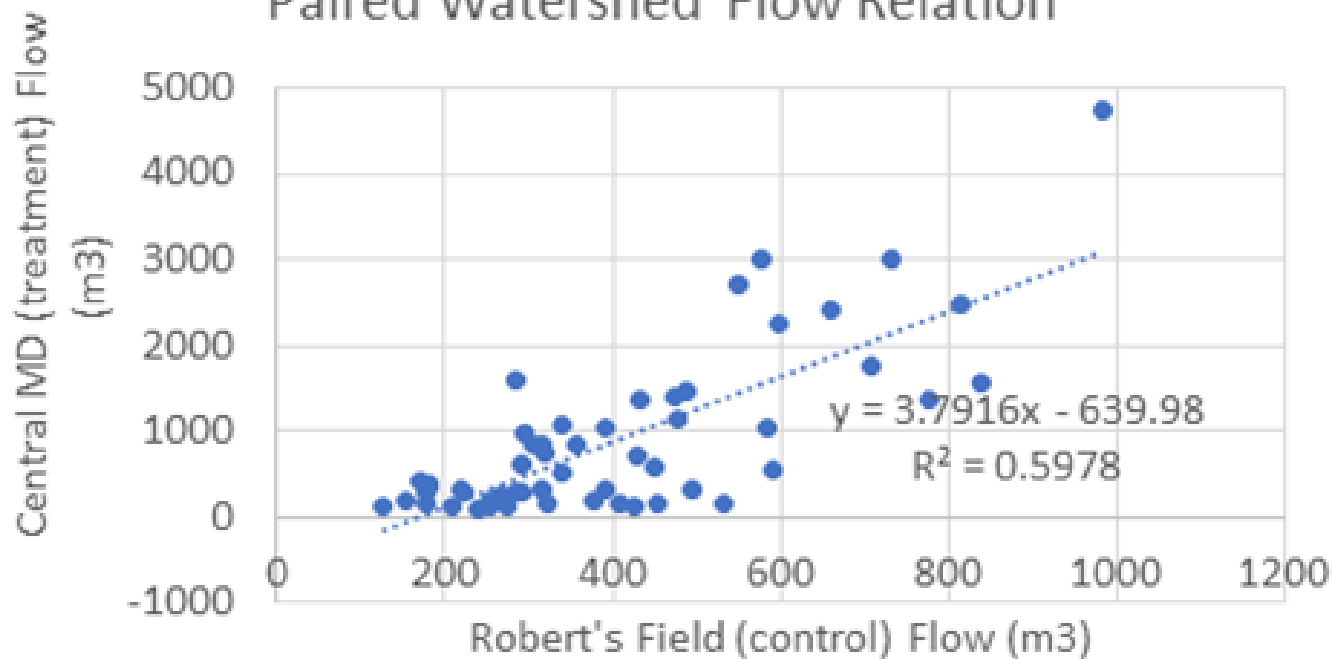
Paired Watershed Flow Relation

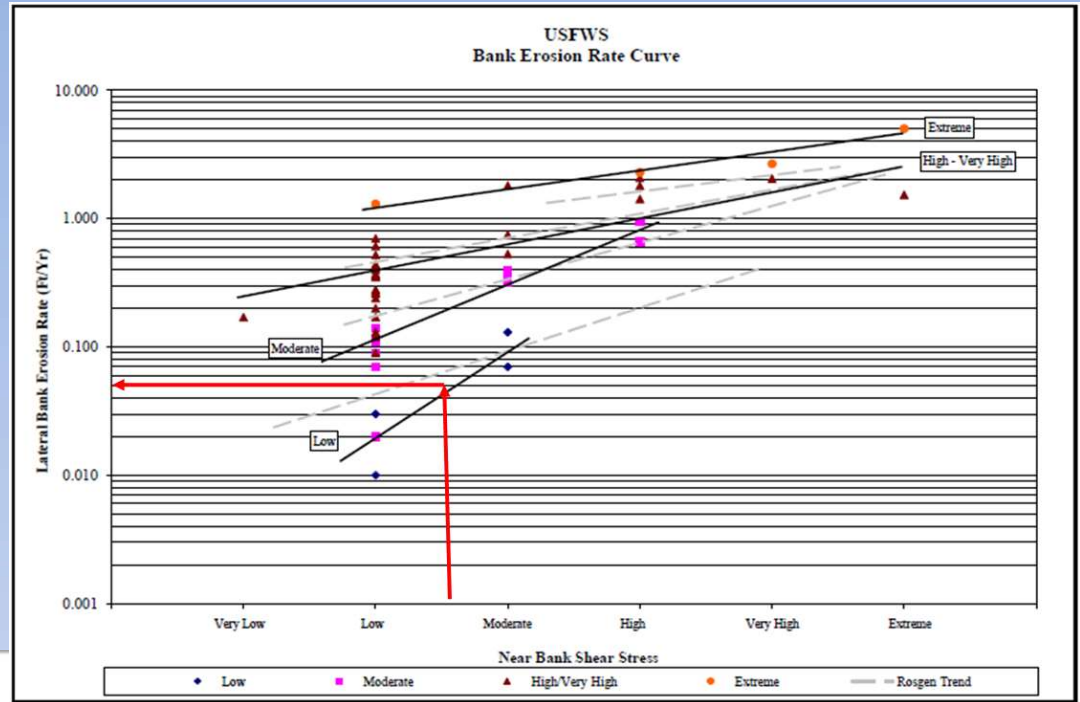
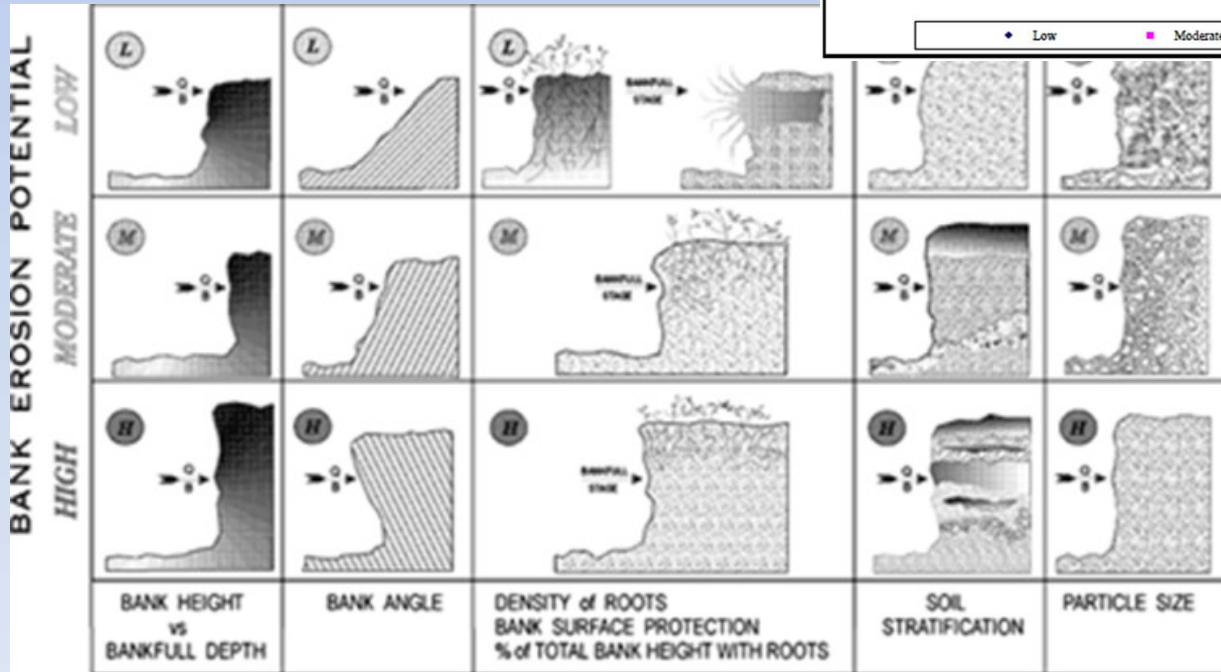
BANCS Assessment

- Bank Erosion Hazard Index (BEHI)
- Near Bank Stress (NBS)

Streambank Characteristics used to develop BEHI

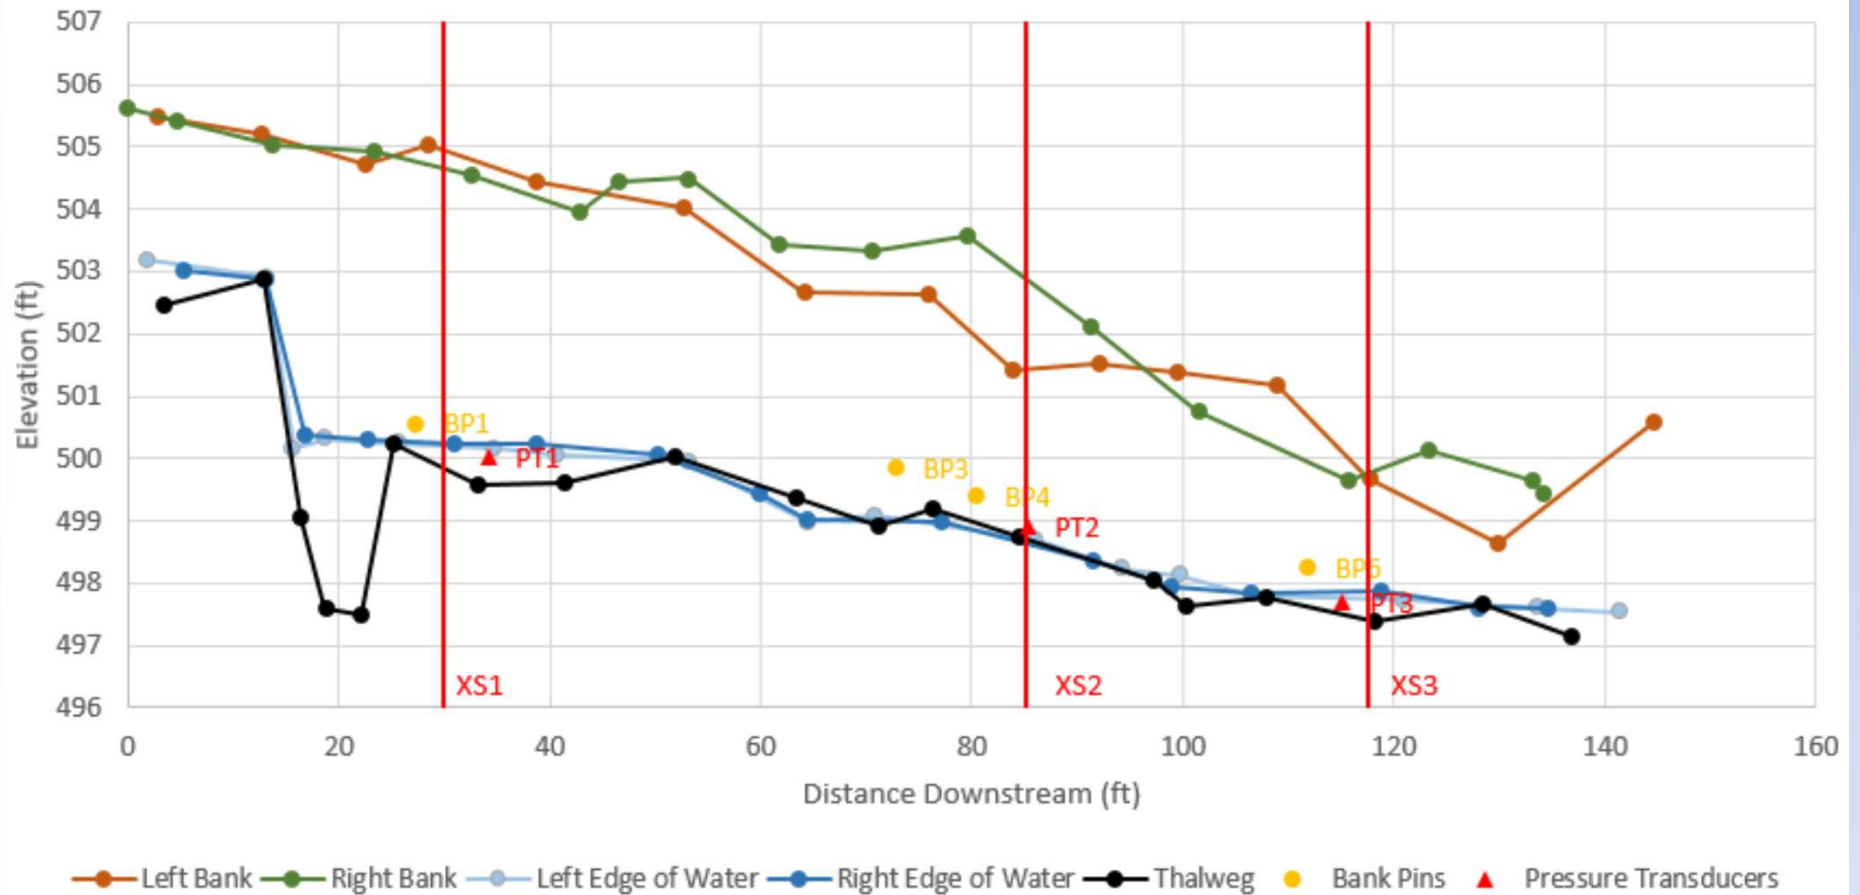
Blue Ridge Longitudinal Profile

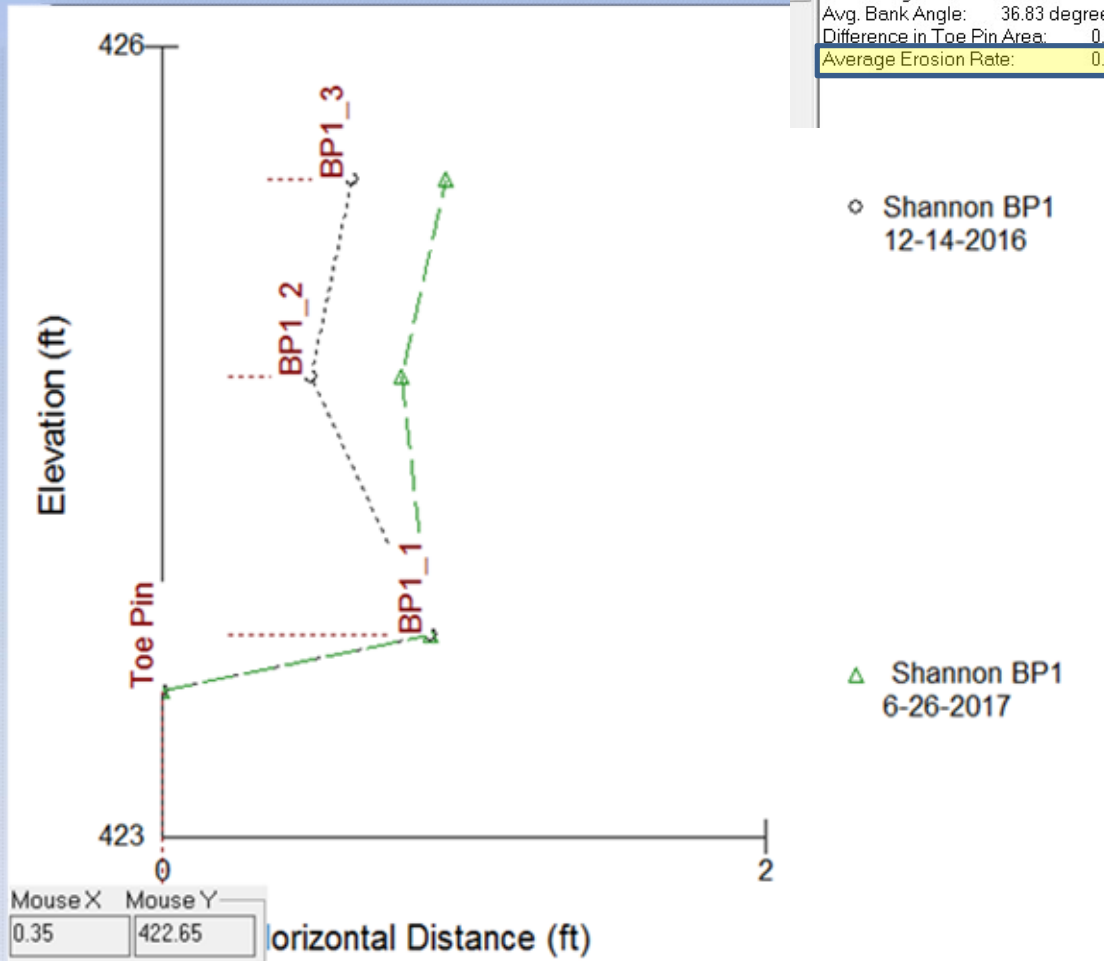
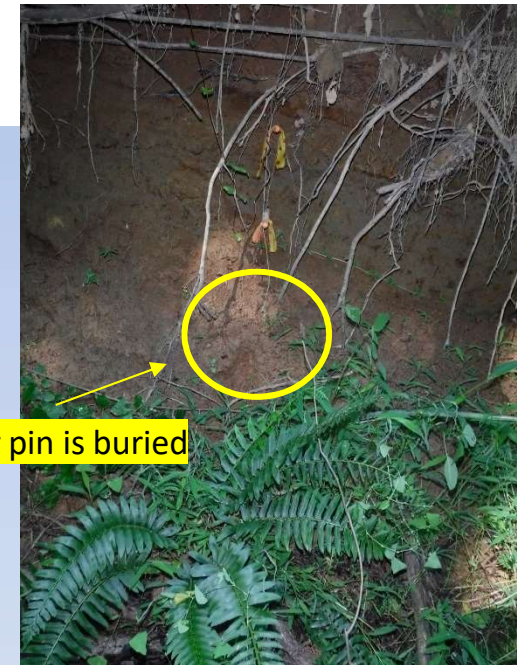
Bank Pins

Bank Angle (decimal degrees): 36.8296901304 Calculate Average Bank Angle

Toe Pin Area: 1.19 square feet (used for erosion monitoring)
 Bank Height: 1.94 feet
 Avg. Bank Angle: 36.83 degrees

Overlay #1
 Toe Pin Area: 1.57 square feet (used for erosion monitoring)
 Bank Height: 1.94 feet
 Avg. Bank Angle: 36.83 degrees
 Difference in Toe Pin Area: 0.38 square feet
 Average Erosion Rate: 0.1959 feet

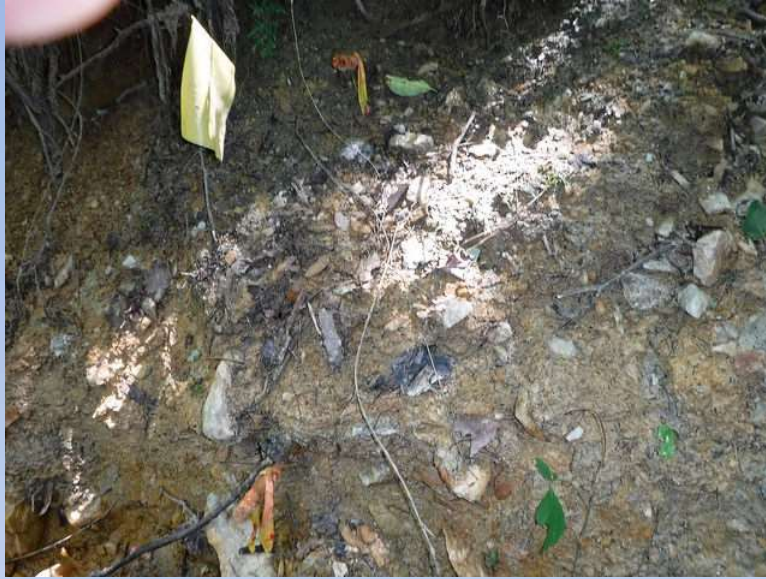
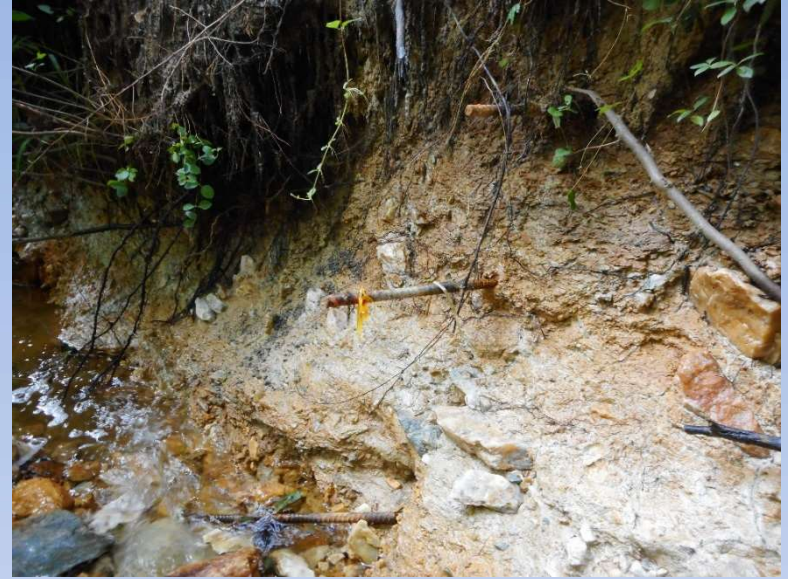
**Robert's Field
(Control)**

June 2017

July 2018

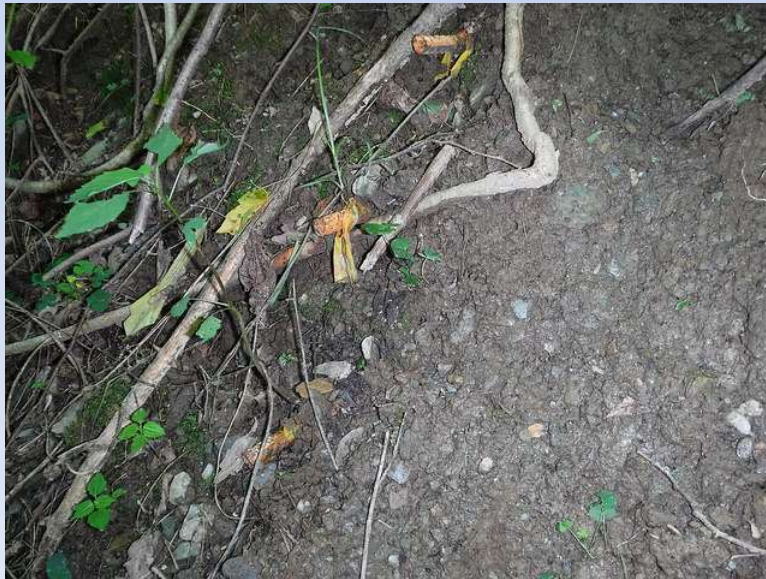
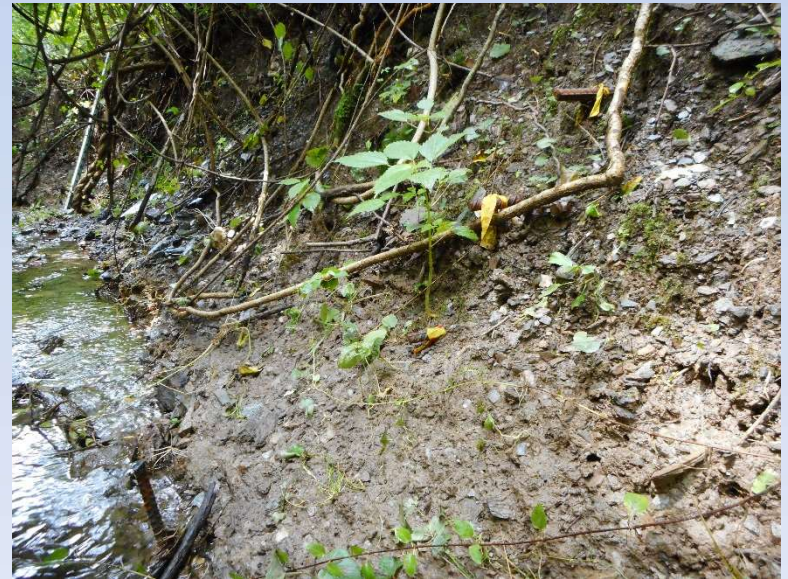
**Blue Ridge Manor
(Treatment)**
