**TWO BRIDGES**  
**TWO OUTCOMES**  
**LESSONS LEARNED**

**DILL CREEK, GA  
OLD CCC CAMP ROAD CROSSING, 2005**

**PEGAMORE CREEK  
LEE ROAD CROSSING**

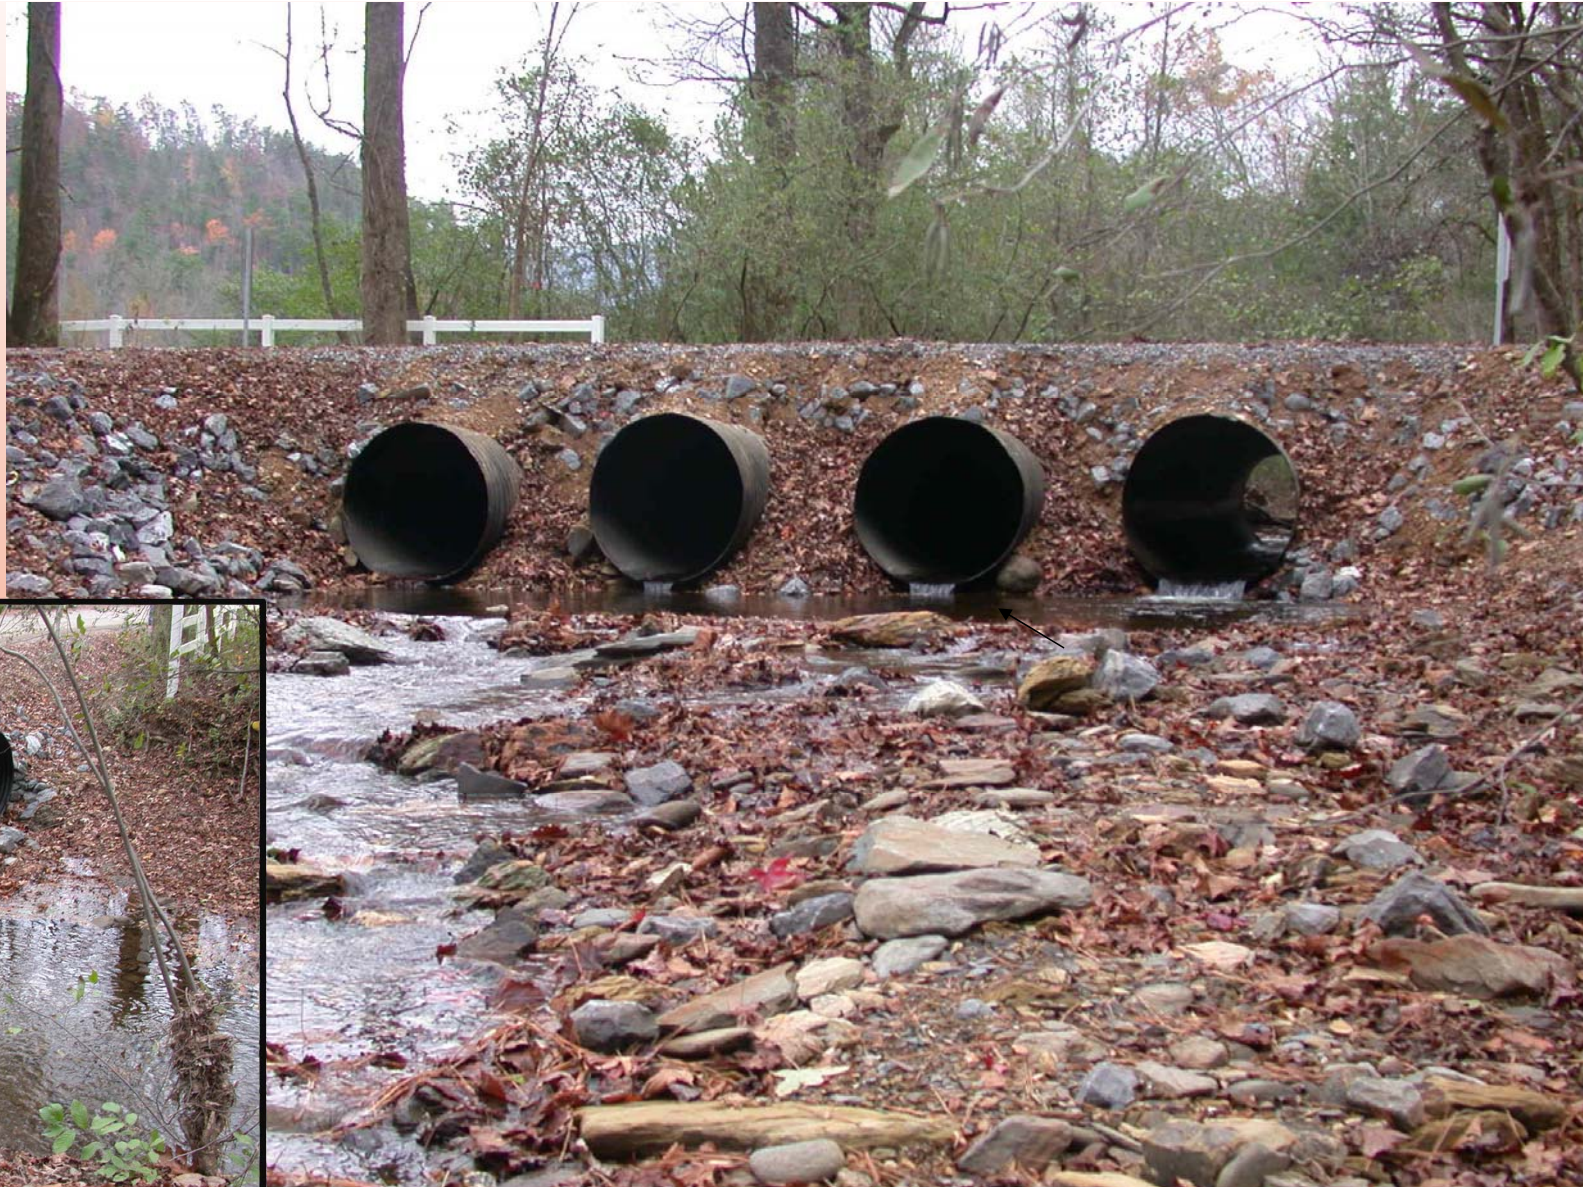
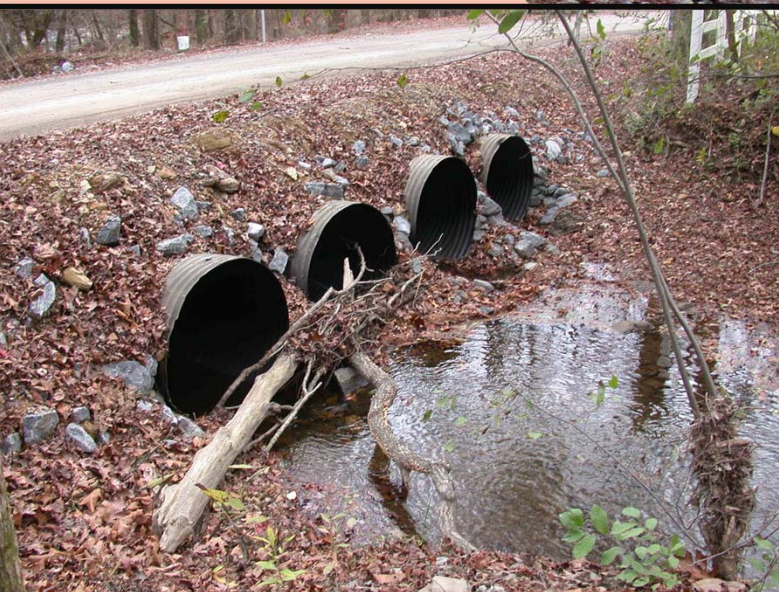
**CULVERTS UNDERSIZED**

**PERCHED OUTLET**

**INLET DROP**

**DEBRIS ACCUMULATION**

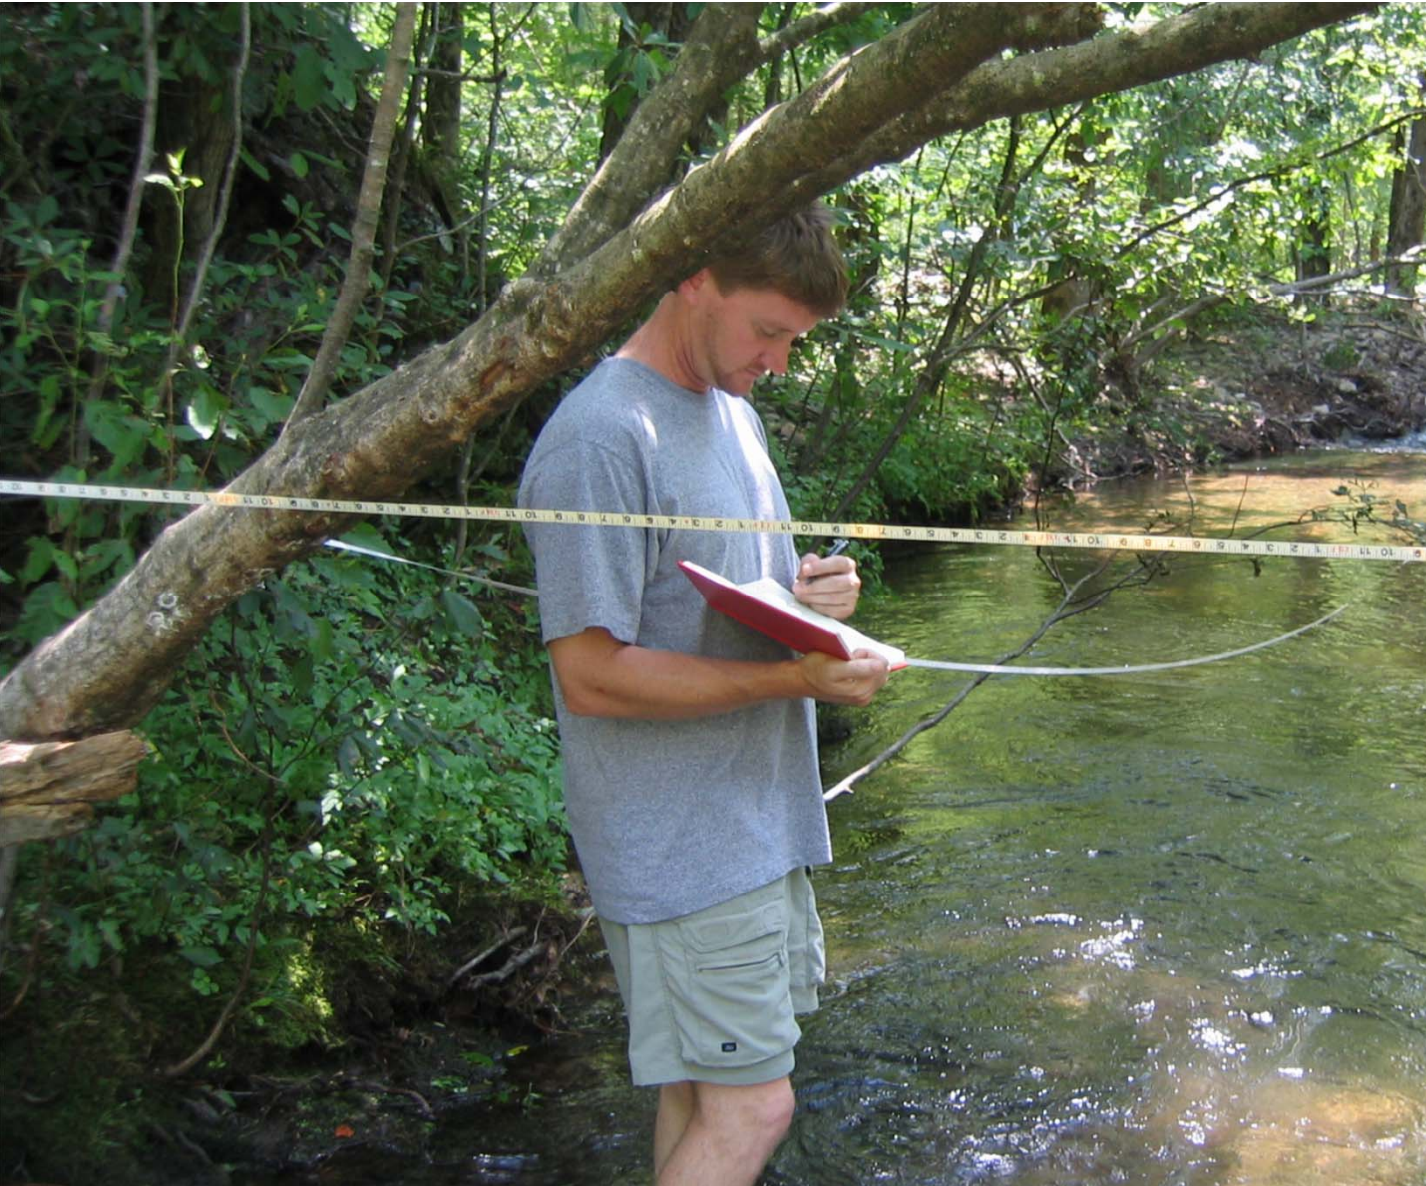
## **DILL CREEK AOP PLANNING**

Undersized crossing

Barrier to aquatic species including  
federally listed blue shiner (T)

Just above confluence with Holly  
Creek (5 T/E aquatic species)

Multiple road failures

Stream Bkf measured width: 21.6'

Stream Simulation Model  
Calculation: 27.92 minimum bridge  
span

Pre-fab bridge ordered

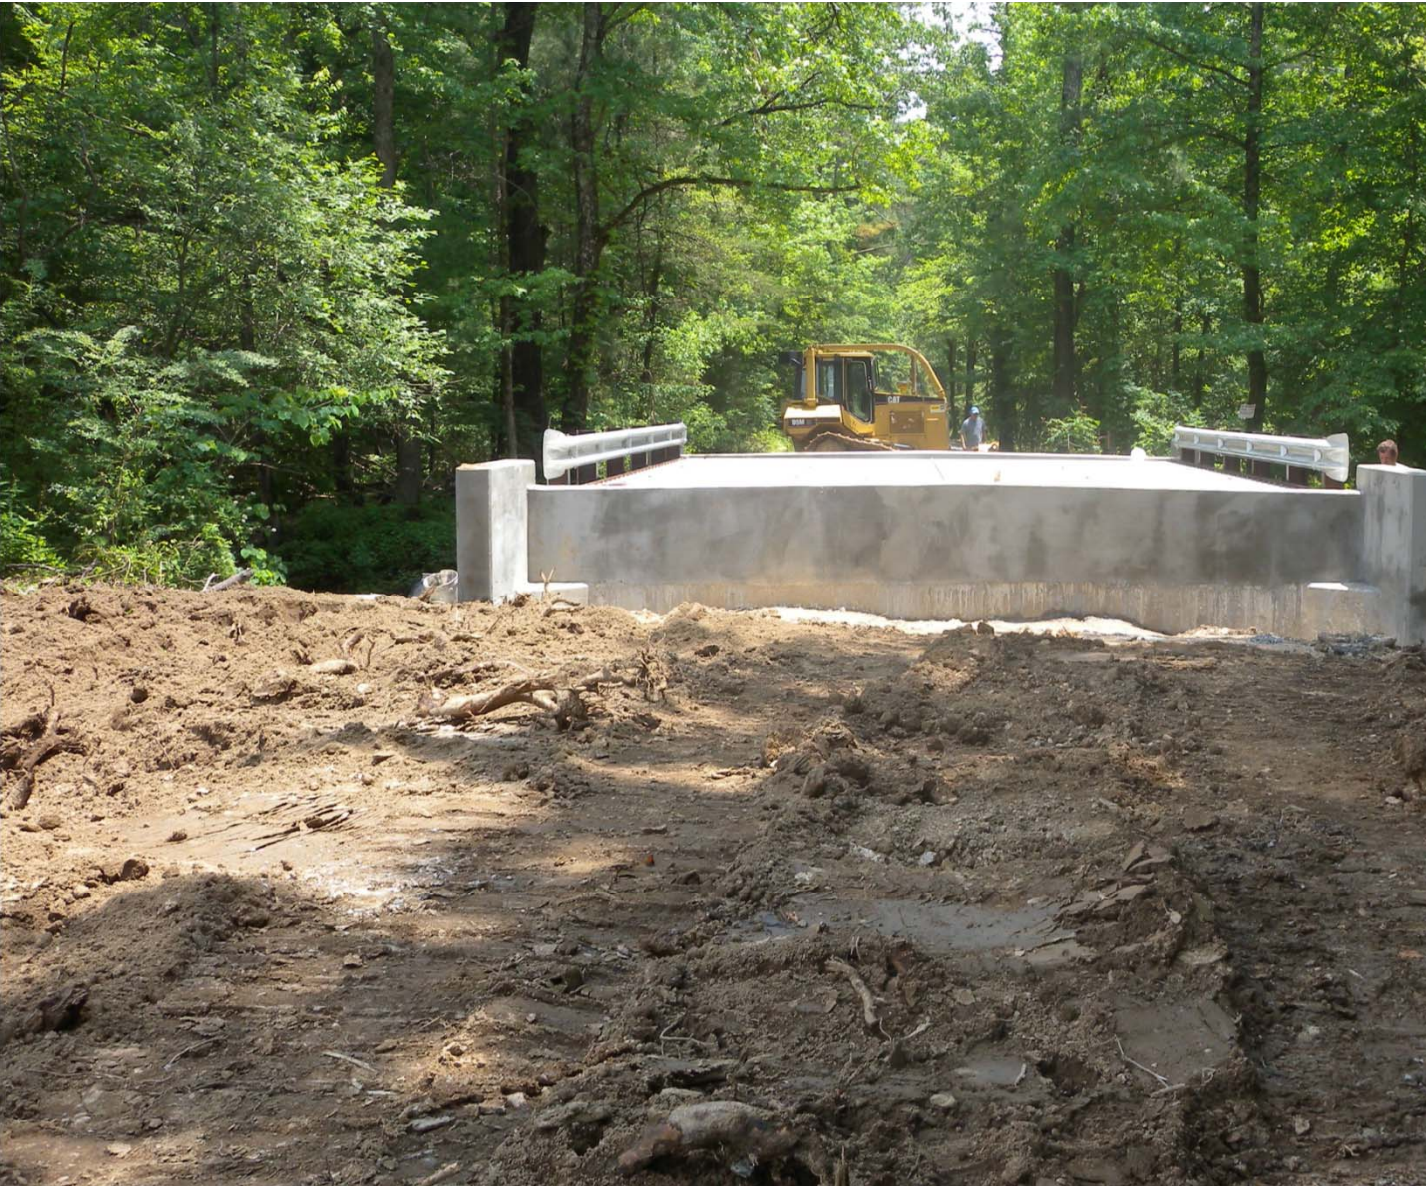
## ABUTMENT DESIGN

Originally designed by Big R  
Engineer (massive and too  
expensive)

Local landowner's firm redesigned  
pro bono

County public works department has  
oversight on crossing

Redesign was not shared with nor  
approved by the Service prior to  
construction

- Multiple stakeholders, no established liaison nor open communication between stakeholders and engineer/contractors
- Abutment design not shared with all team members
- No preconstruction meeting to discuss project goals, design, review permits, answer questions
- Design engineer not available during construction
- Contractor refused to make changes/implement adaptive management (not supportive of project goals/just getting job done according to plans)

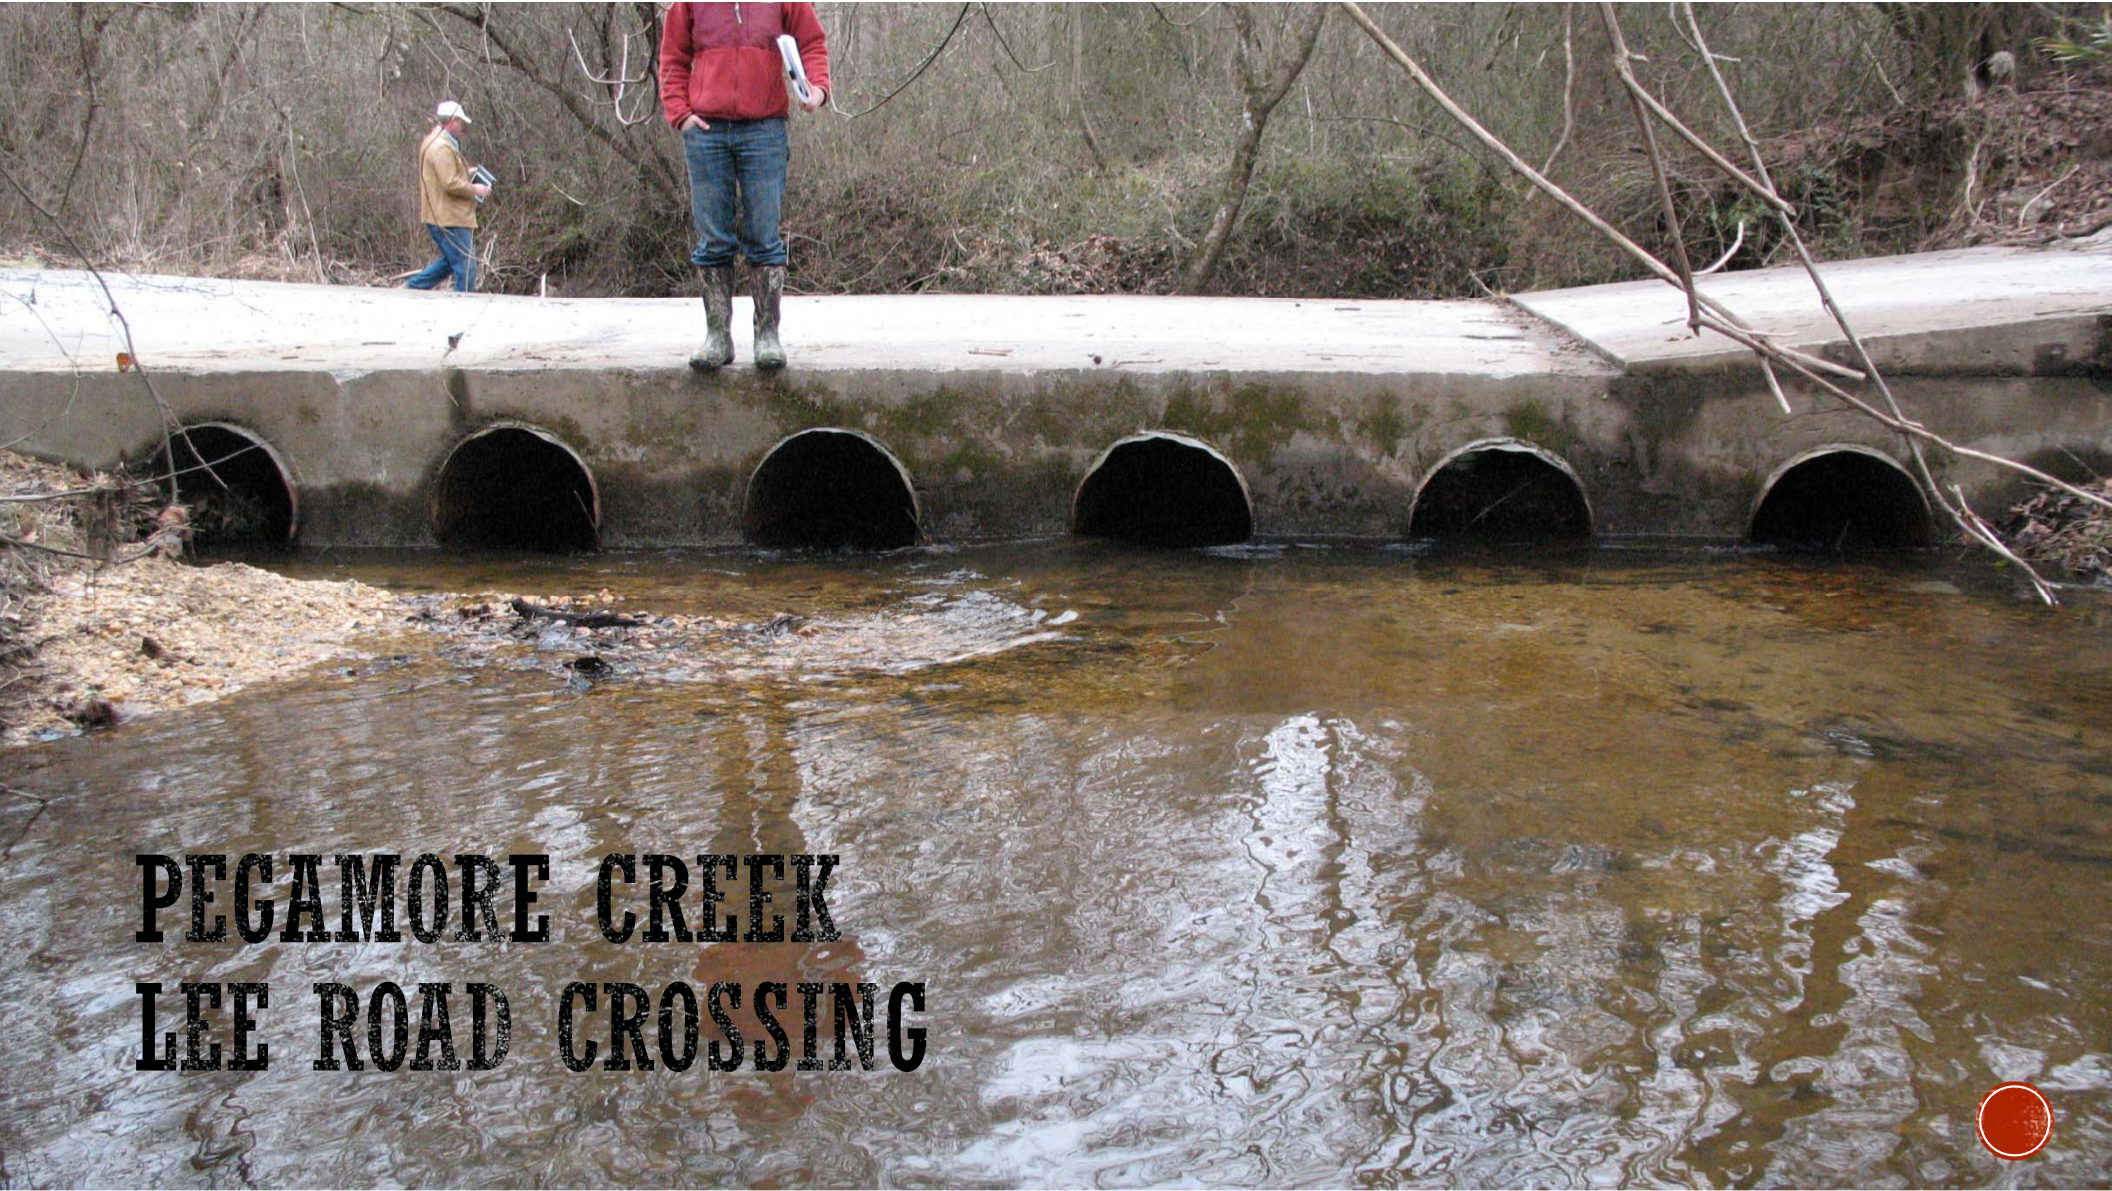
Undersized, six barrel low water crossing

Barrier to aquatic species including federally listed Etowah (E) and Cherokee (T) darters

Flooding isolates local residents

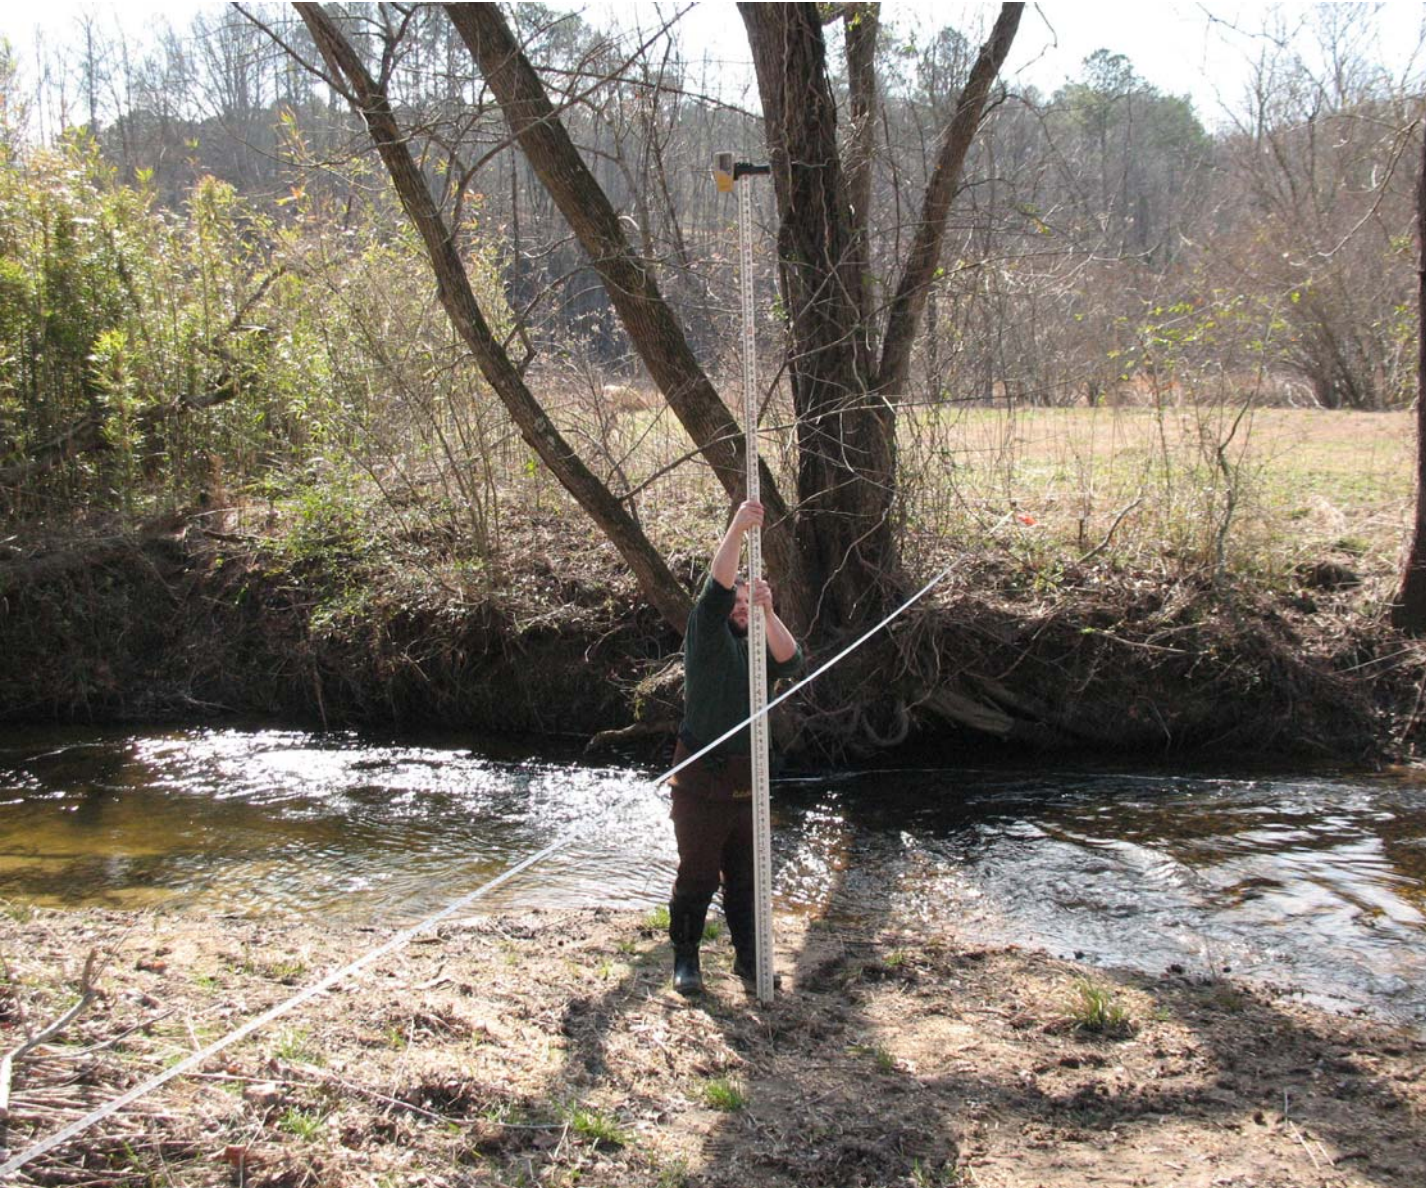
# PEGAMORE CREEK AOP PLANNING

Tributary to Raccoon Creek

Stream Bkf width: 23.9'

Stream Simulation Model  
Calculation: 30.68 minimum bridge span

Pre-fab bridge

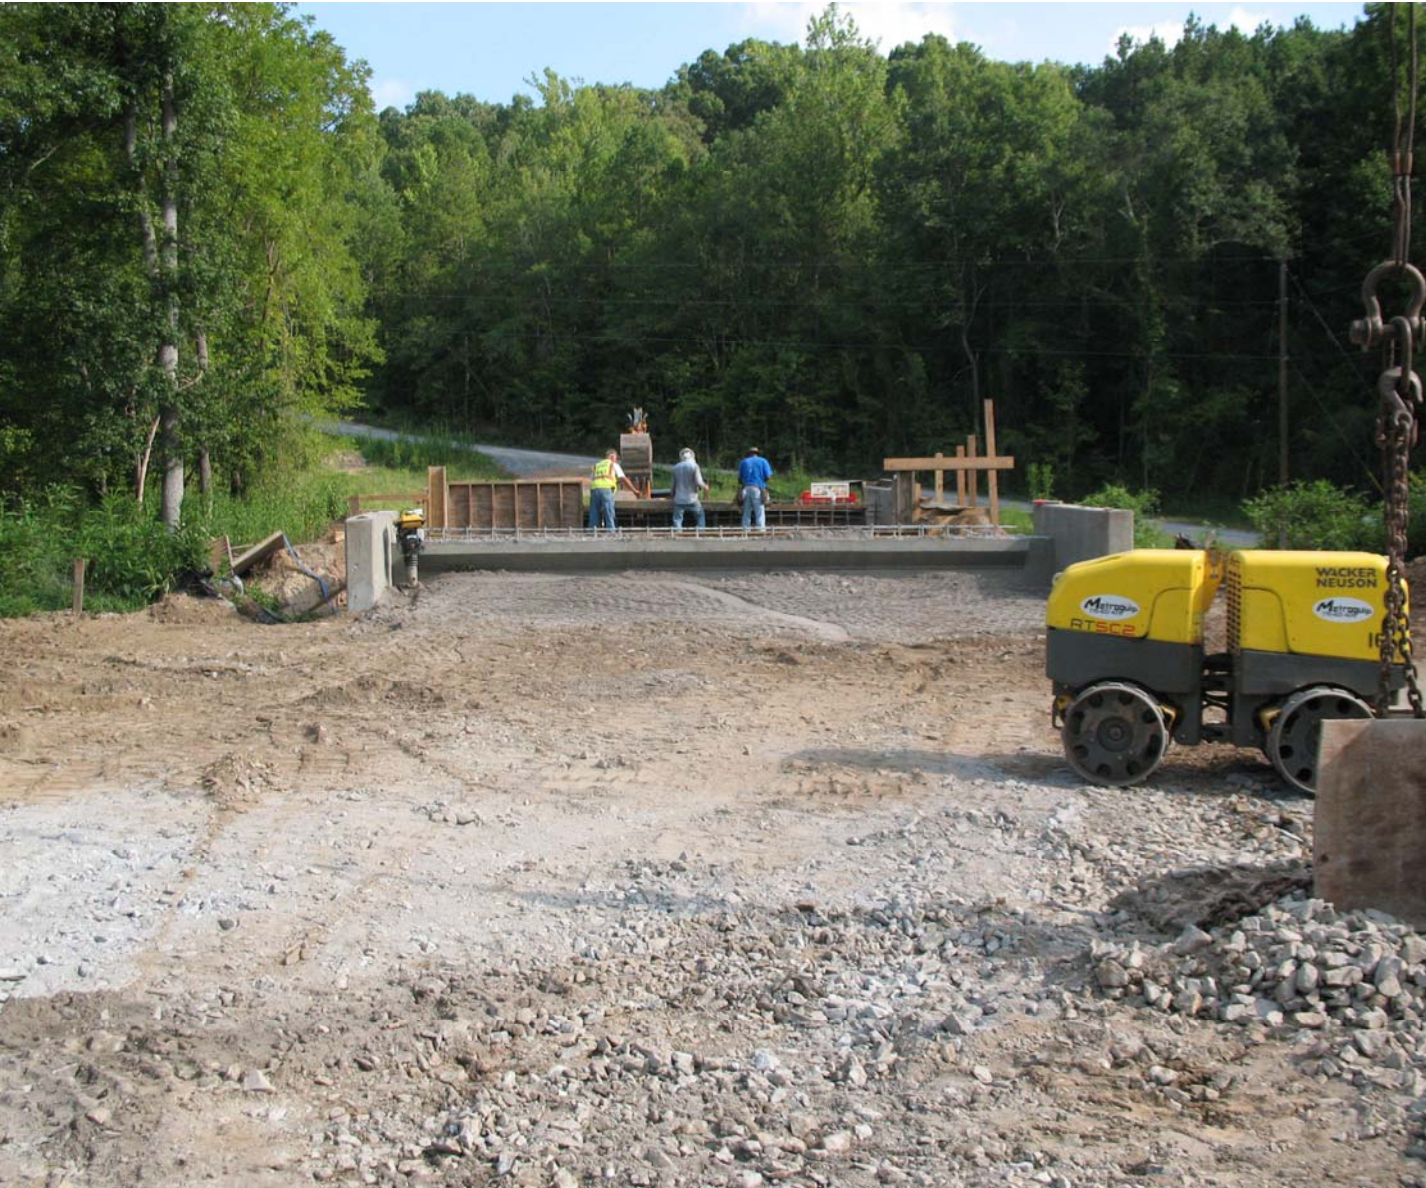
## ABUTMENT DESIGN

County road, public works oversight

Project team met with design engineer and contractor during planning phase

The importance of maintaining bridge span over channel explained ad nauseam

Design shared with and approved by technical team

Project implementation monitoring shared among stakeholders

- Multiple stakeholders with established liaison and clear communication
- Abutment draft design reviewed and approved by technical team
- Preconstruction meeting to discuss project goals, permit requirements, conservation measures, etc.
- Technical team on site almost daily during construction
- Contractor understood and was supportive of project goals and willing to adaptively manage project
