Using Stream Enhancement in Urban Settings to Protect Valuable Infrastructure and Prevent Potential Water Quality Impacts From Infrastructure Failure

Daren Pait, PE, CFM

Jason Diaz, PE, CFM

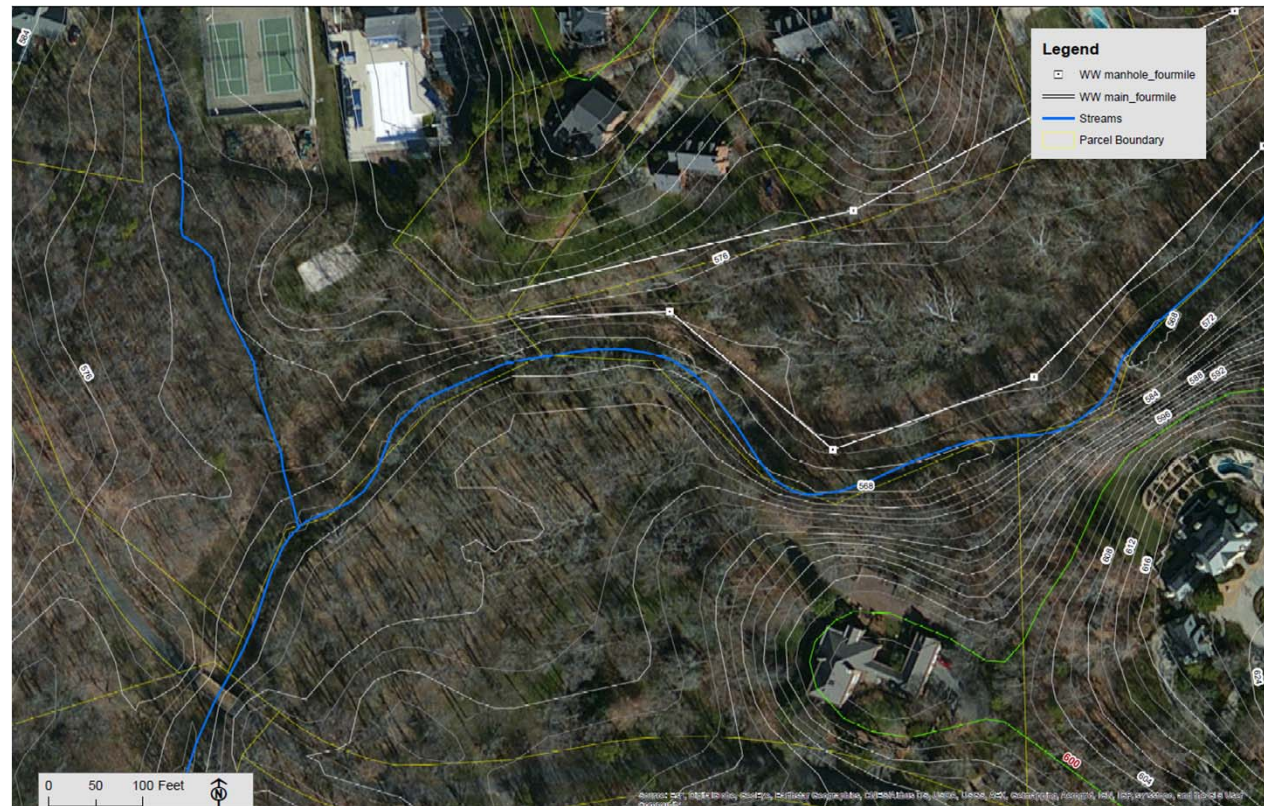
Fourmile Creek

- Identified as one of 16 locations by maintenance staff
- Accelerated erosion of about 12" lateral movement per year
- 10-year storm event contained within banks (very incised)

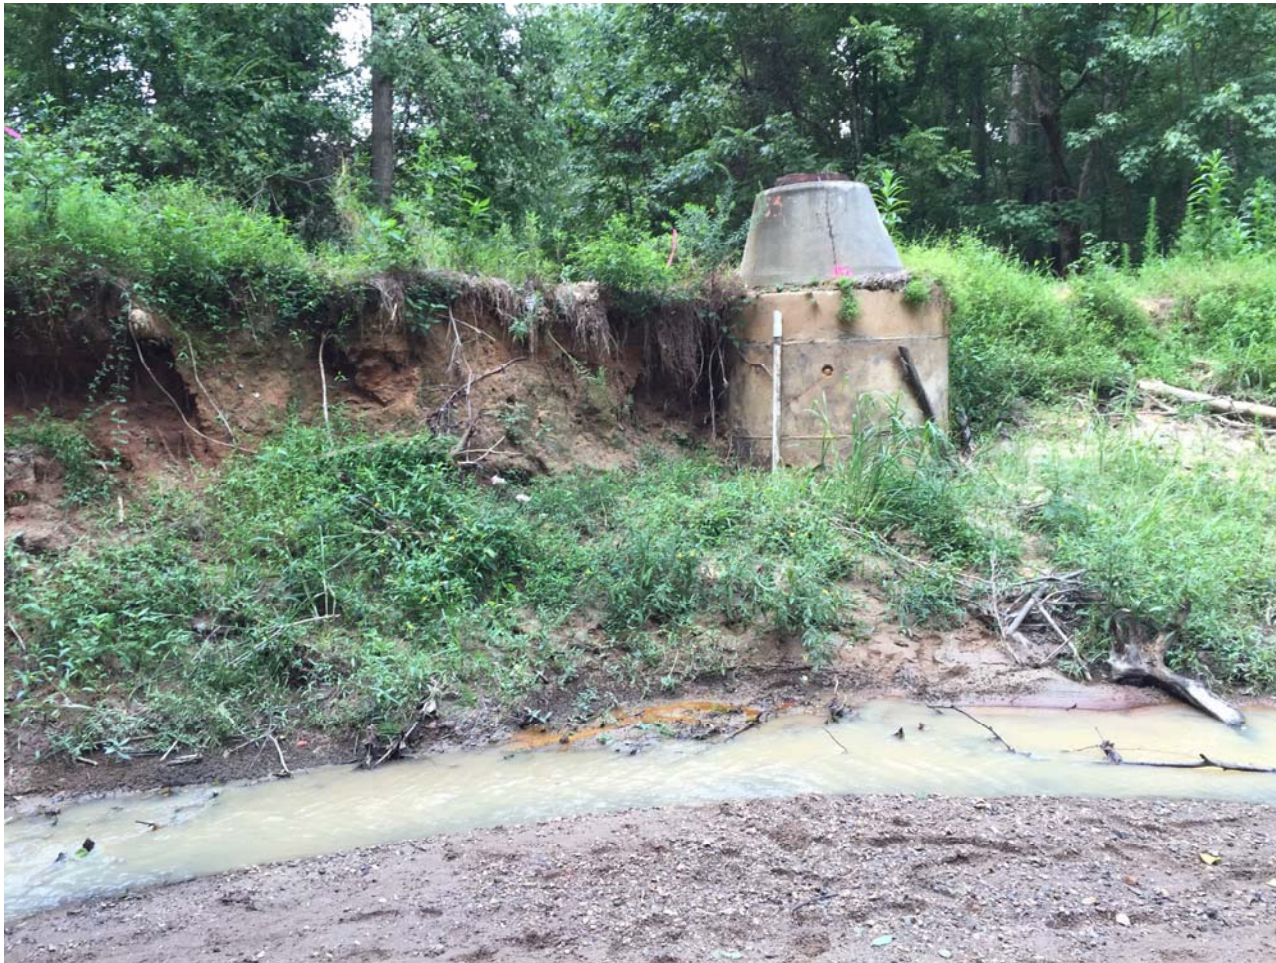
Fourmile Creek - Construction Costs

- First designed as boulder toe protection with rock vane, and associated stone armoring for structure.
- Construction entrance/haul road was along sanitary sewer easement
- Only access was through private asphalt road
- Stream contractor was responsible for repairs
- First bids averaged \$230,000
- Re-designed as toe-wood protection and vegetated soil lifts
- Re-bid price came in at \$78,000

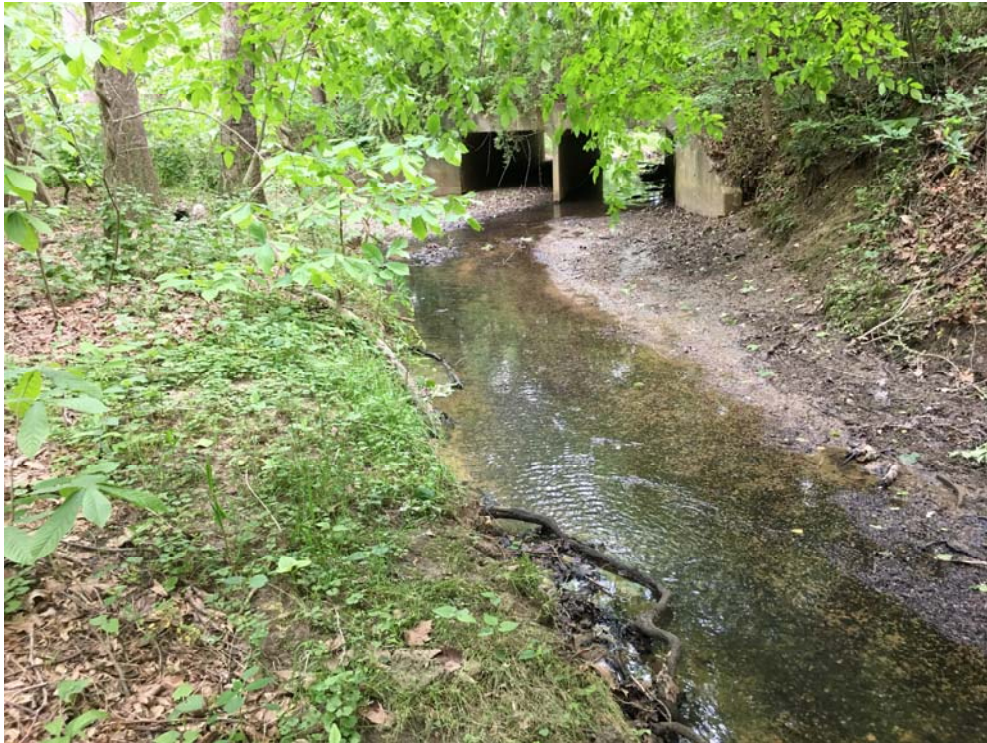
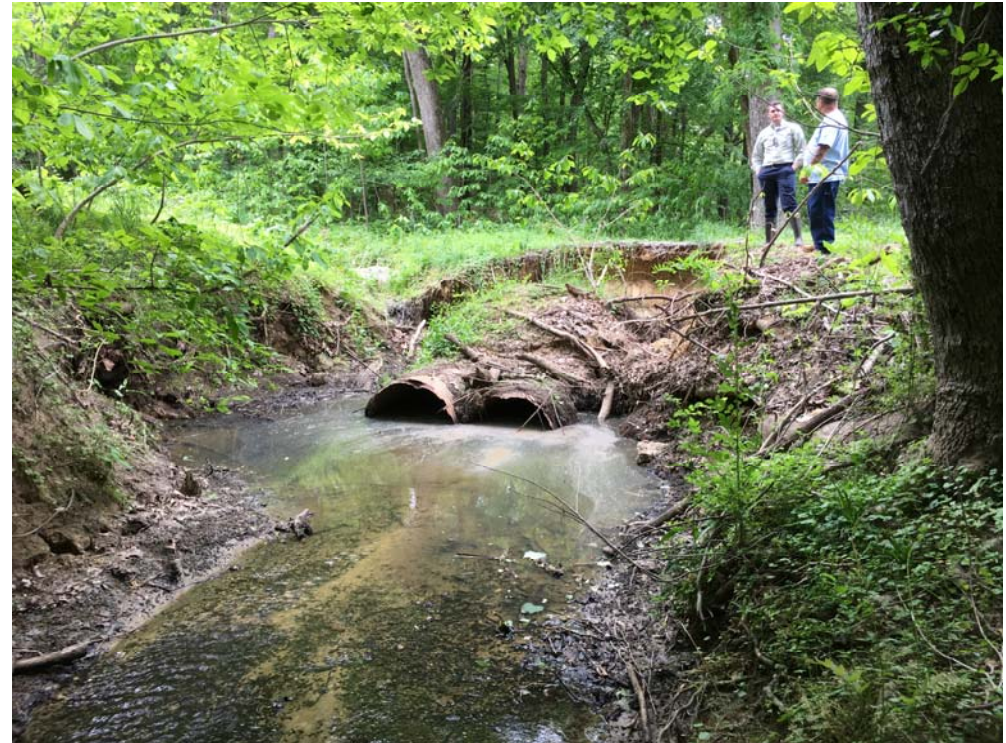
Force Main Conflict

- 24" Force Main, 80 PSI
- 1.2 square mile drainage area for stream

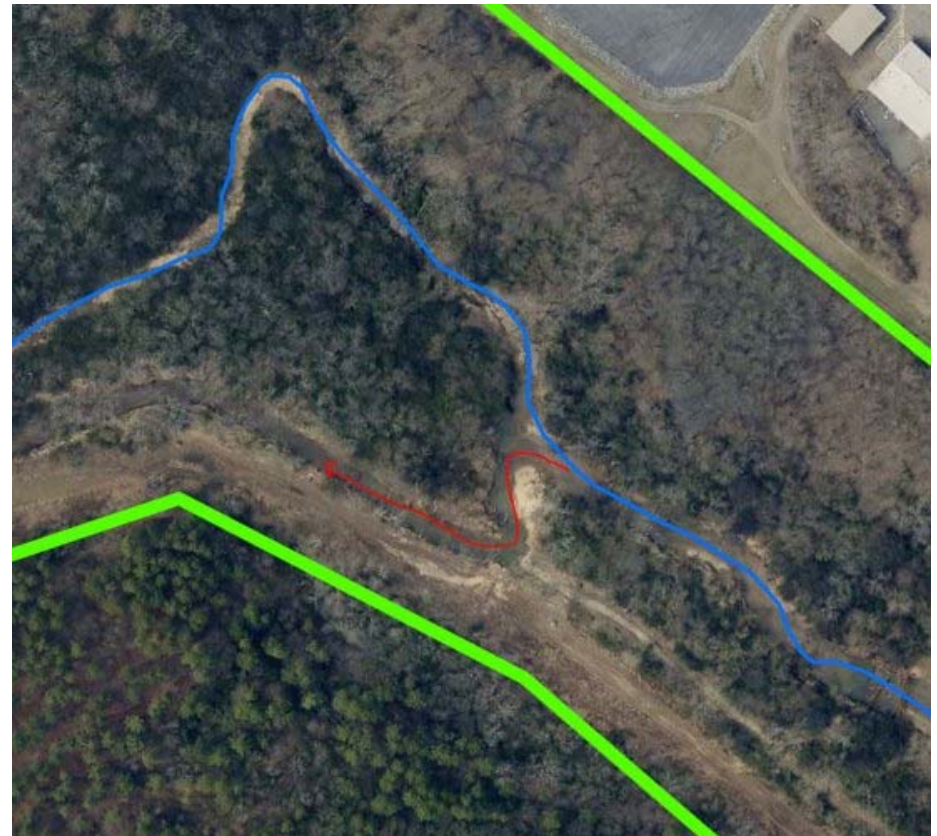
Long Creek - Before

- What Happened
- Includes 3,100 linear feet of channel re-location
- Qualified for Clean Water Management Trust Fund Grant
