When Manholes Go Missing:

Stream Solutions for Municipal Sanitary Systems

EcoStream 2018 – Stream Ecology & Restoration Conference

Tim Schueler, Hazen and Sawyer

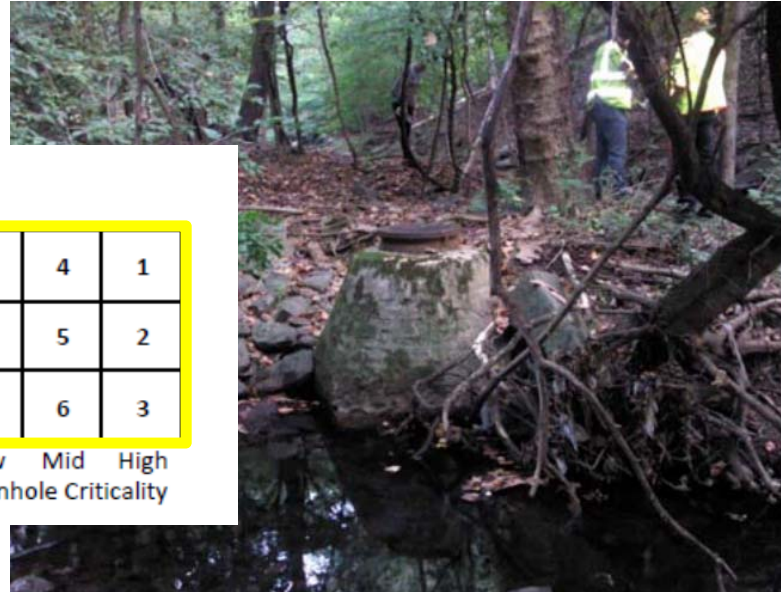
Manual inspection: agency-based

CONDITION / CRITICALITY ASSESSMENT

Manhole	High	34.7
Stream	Mid	25.5
Priority	2

Stream Criticality	High	7	4	1
	Mid	8	5	2
	Low	9	6	3
		Low	Mid	High
		Manhole Criticality

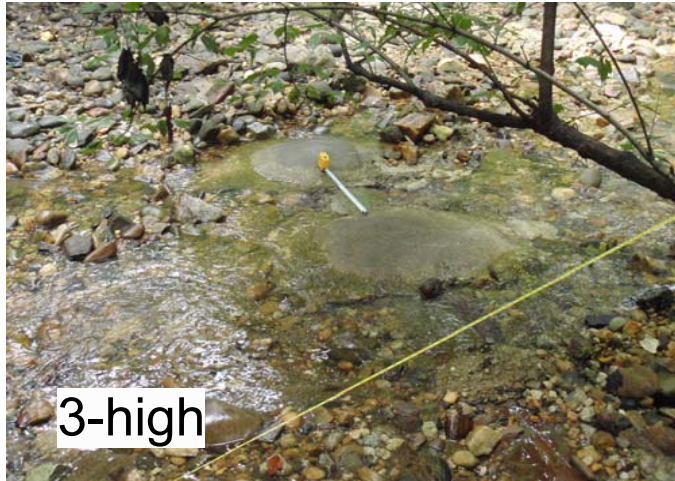
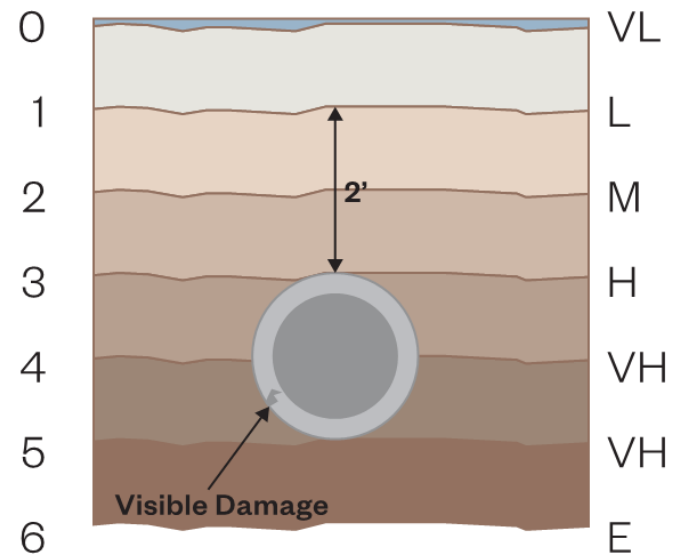
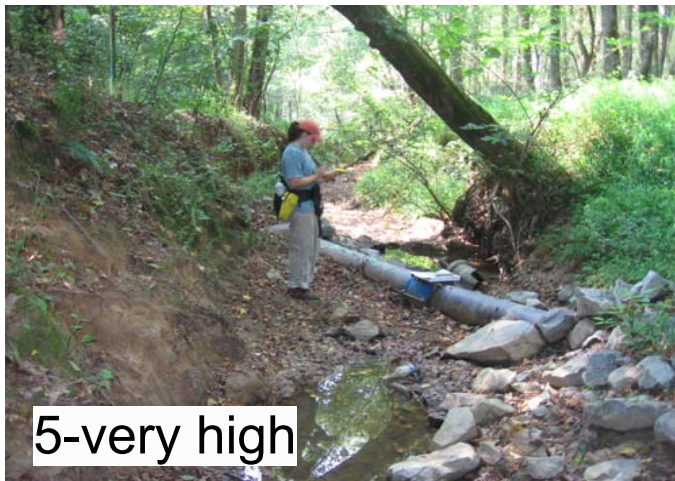
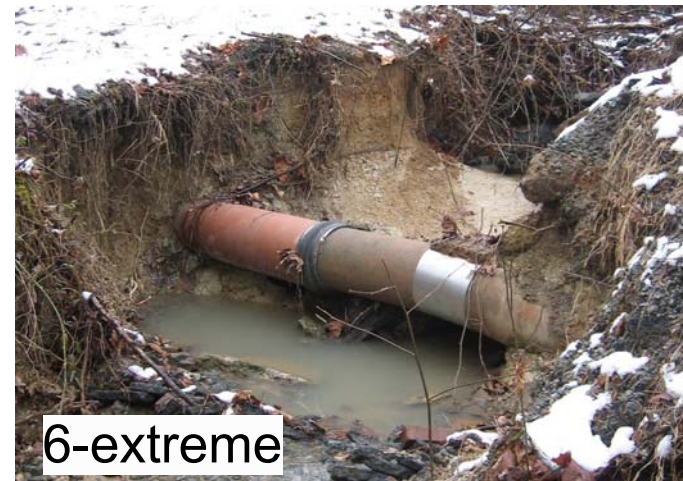
Score	Description	Risk
0	More than 2 feet of cover over the top of the pipe	Very Low
1	Less than 2 feet of cover, pipe/encasement is not exposed	Low
2	Less than 2 feet of cover, pipe /encasement is exposed	Medium
3	Less than one foot of cover, pipe/ encasement is exposed	High
4	Pipe/encasement is exposed to spring line of pipe	Very High
5	Pipe/encasement exposed to bottom of pipe/encasement	Very High
6	Observable deformation in exposed pipe/encasement	Extreme

Manual inspection – linear assets

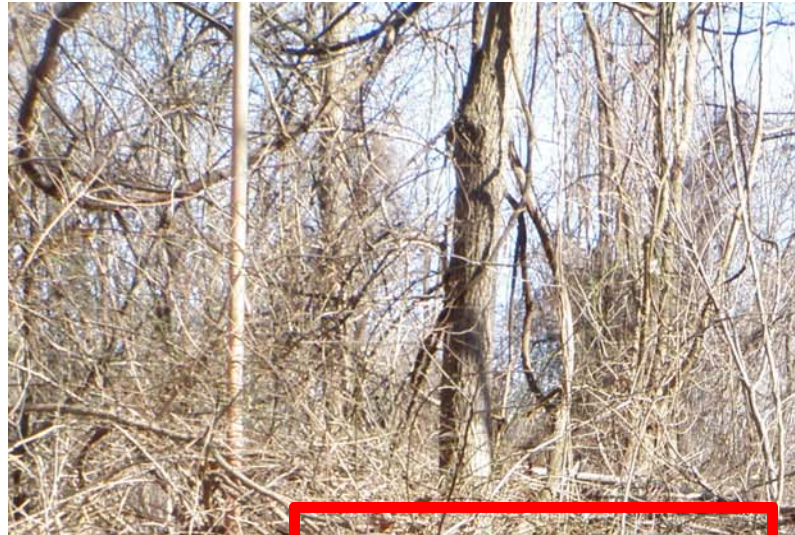
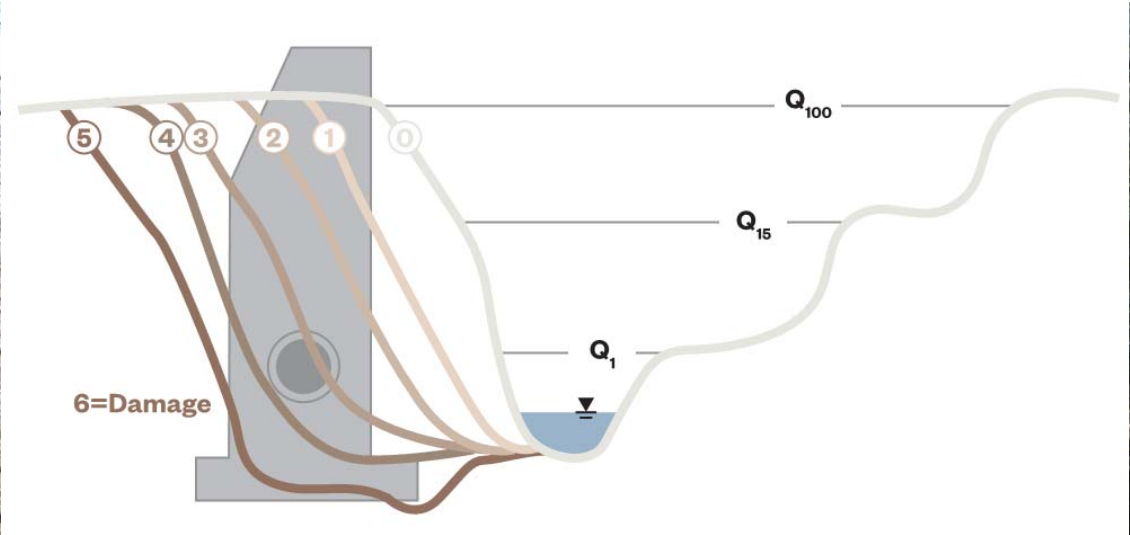
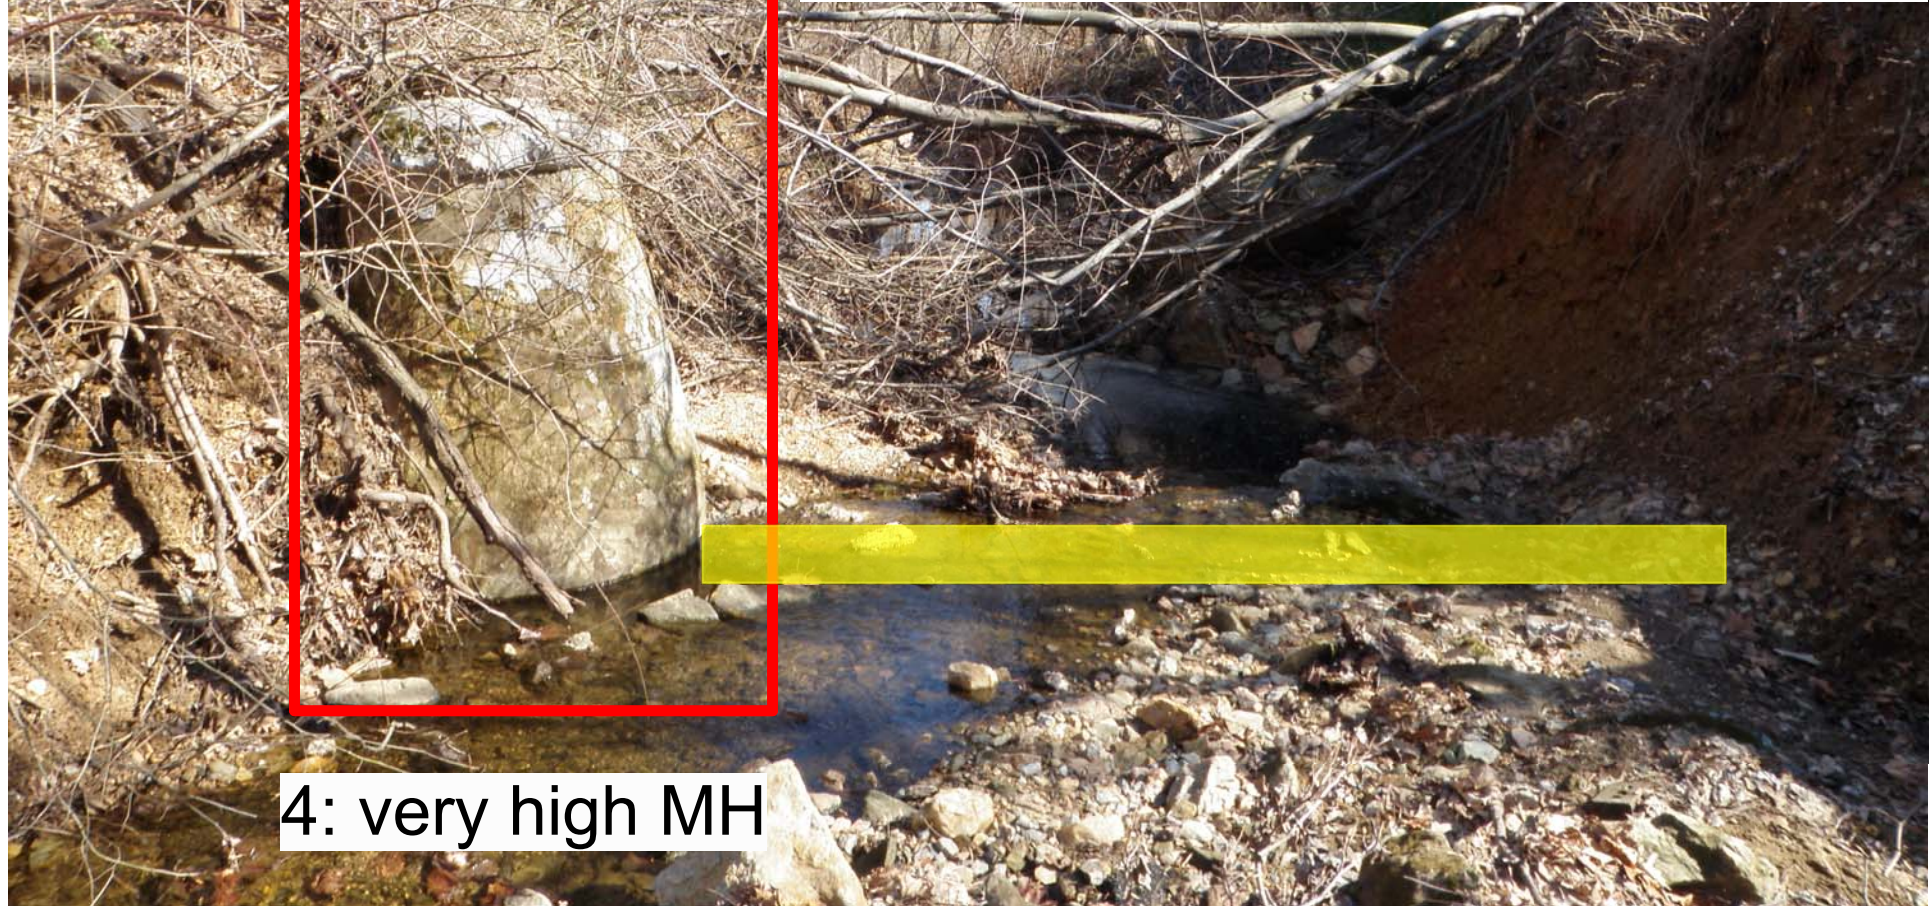
Manual inspection – manholes

Score	Description	Risk
0	MH not at risk of exposure from runoff up to the Q100	Very Low
1	MH not at risk of exposure from runoff up to the Q15	Low
2	MH not at risk of exposure from runoff up to the Q1	Medium
3	MH is current exposed	High
4	Pipe(s) into or out of MH are exposed	Very High
5	Bottom of MH is visible	Very High
6	MH is markedly, visibly damaged or deformed	Extreme

4: very high MH

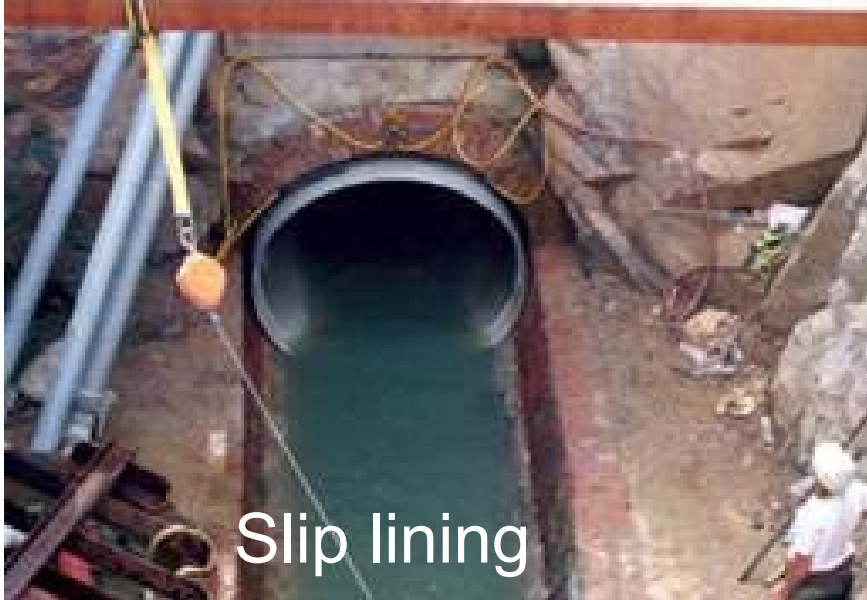
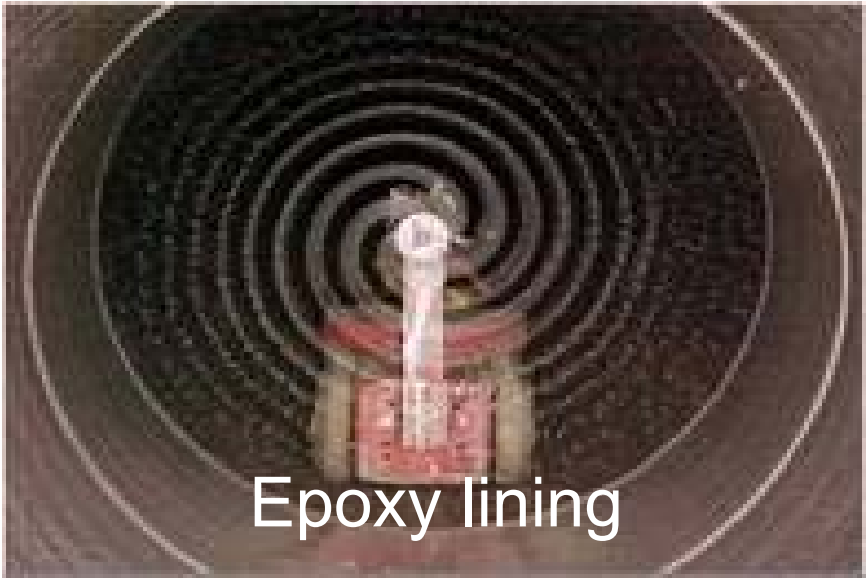
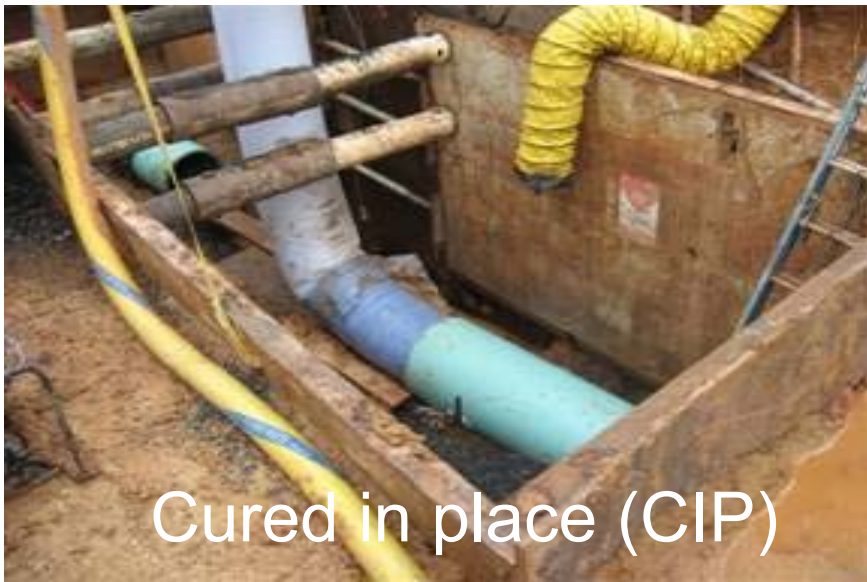
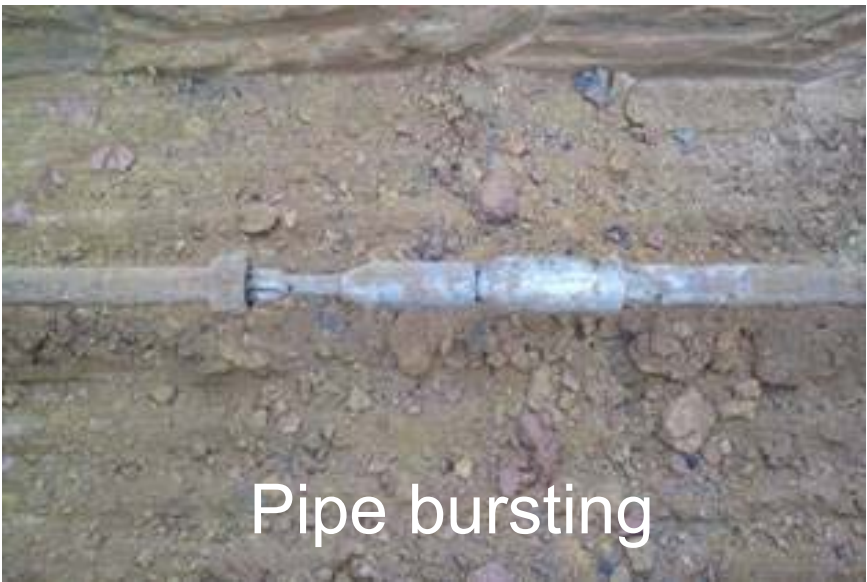
Mitigation measures: internal repair

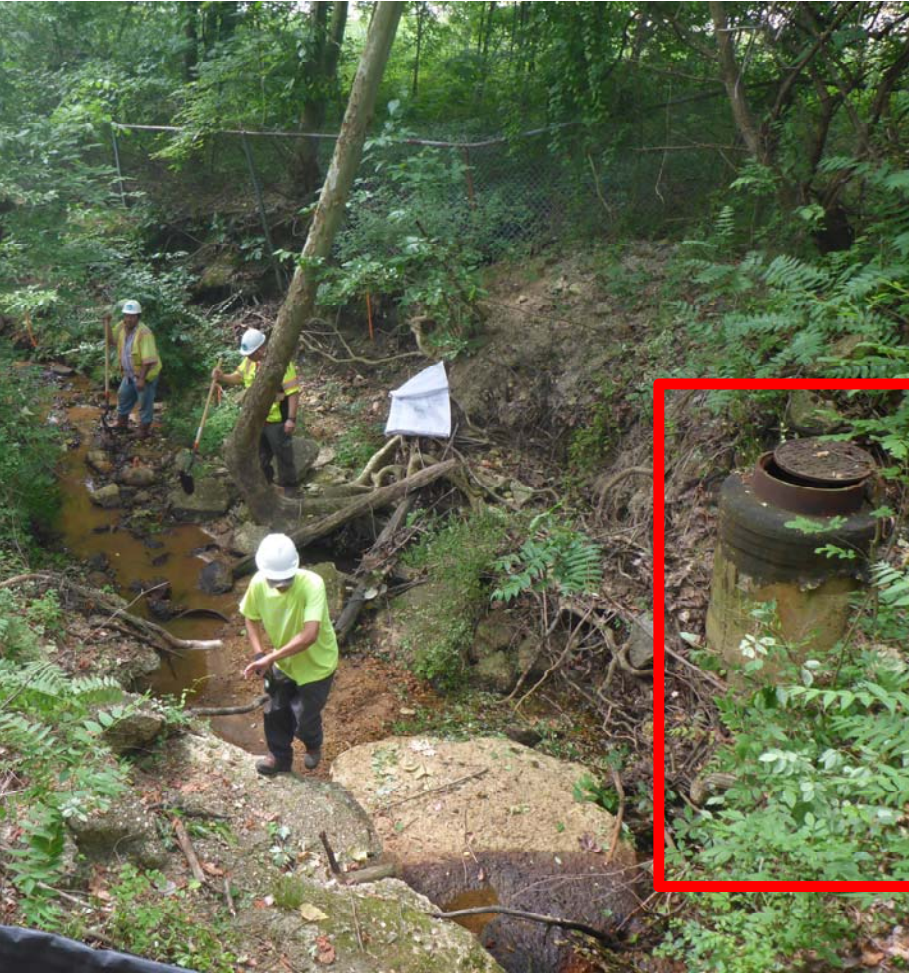
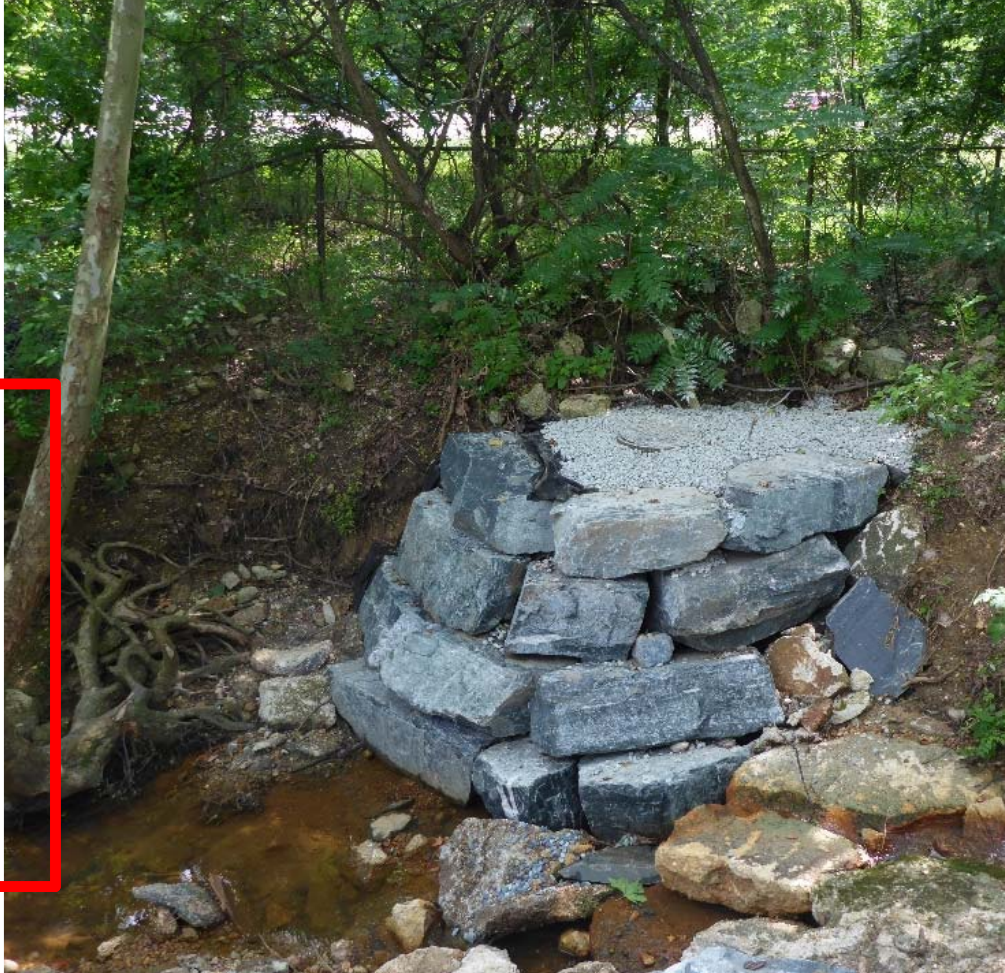
Mitigation measures: external repair

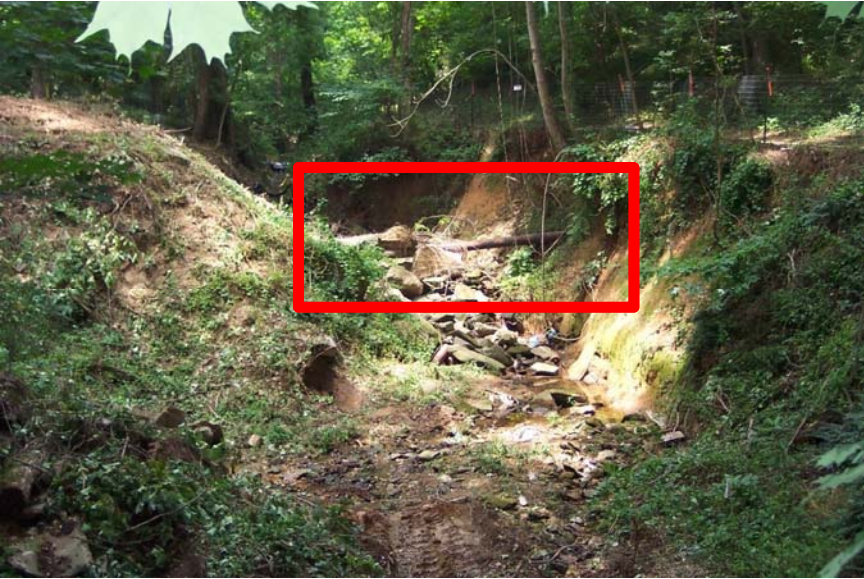
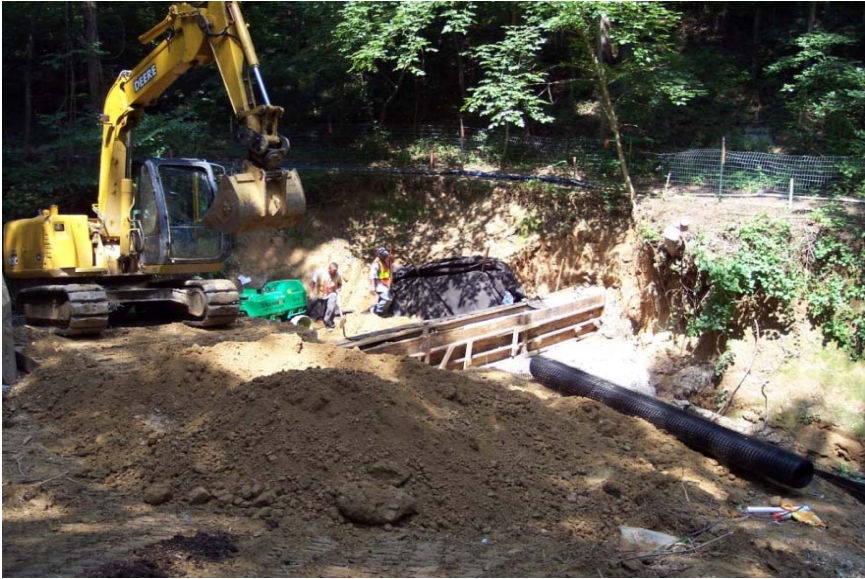
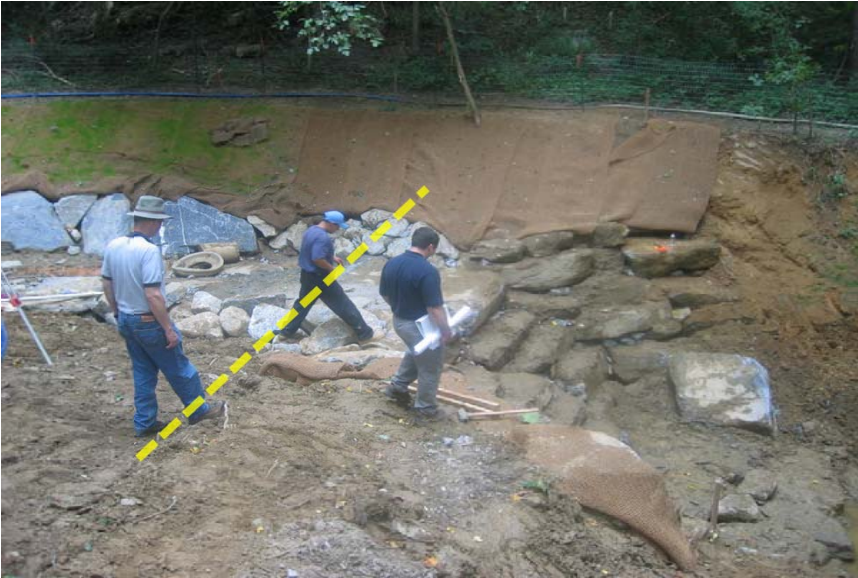
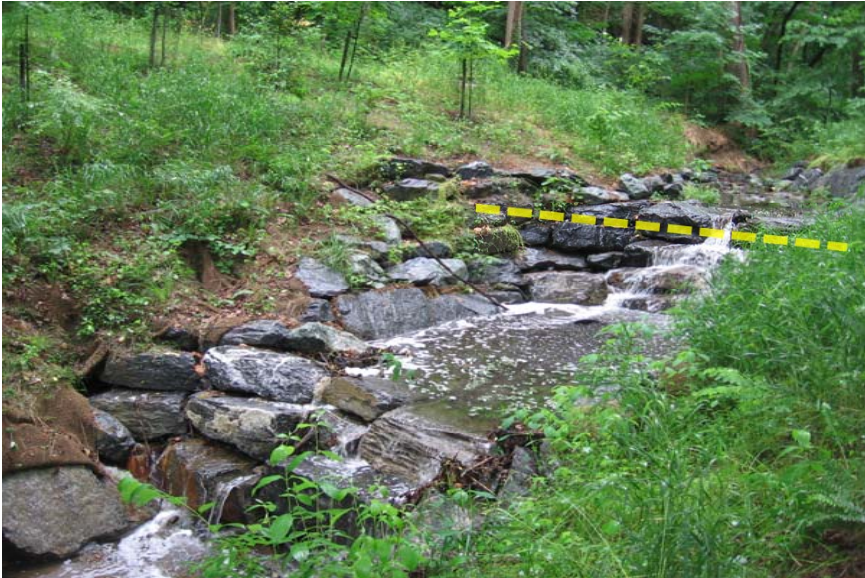
Mitigation measures: external repair

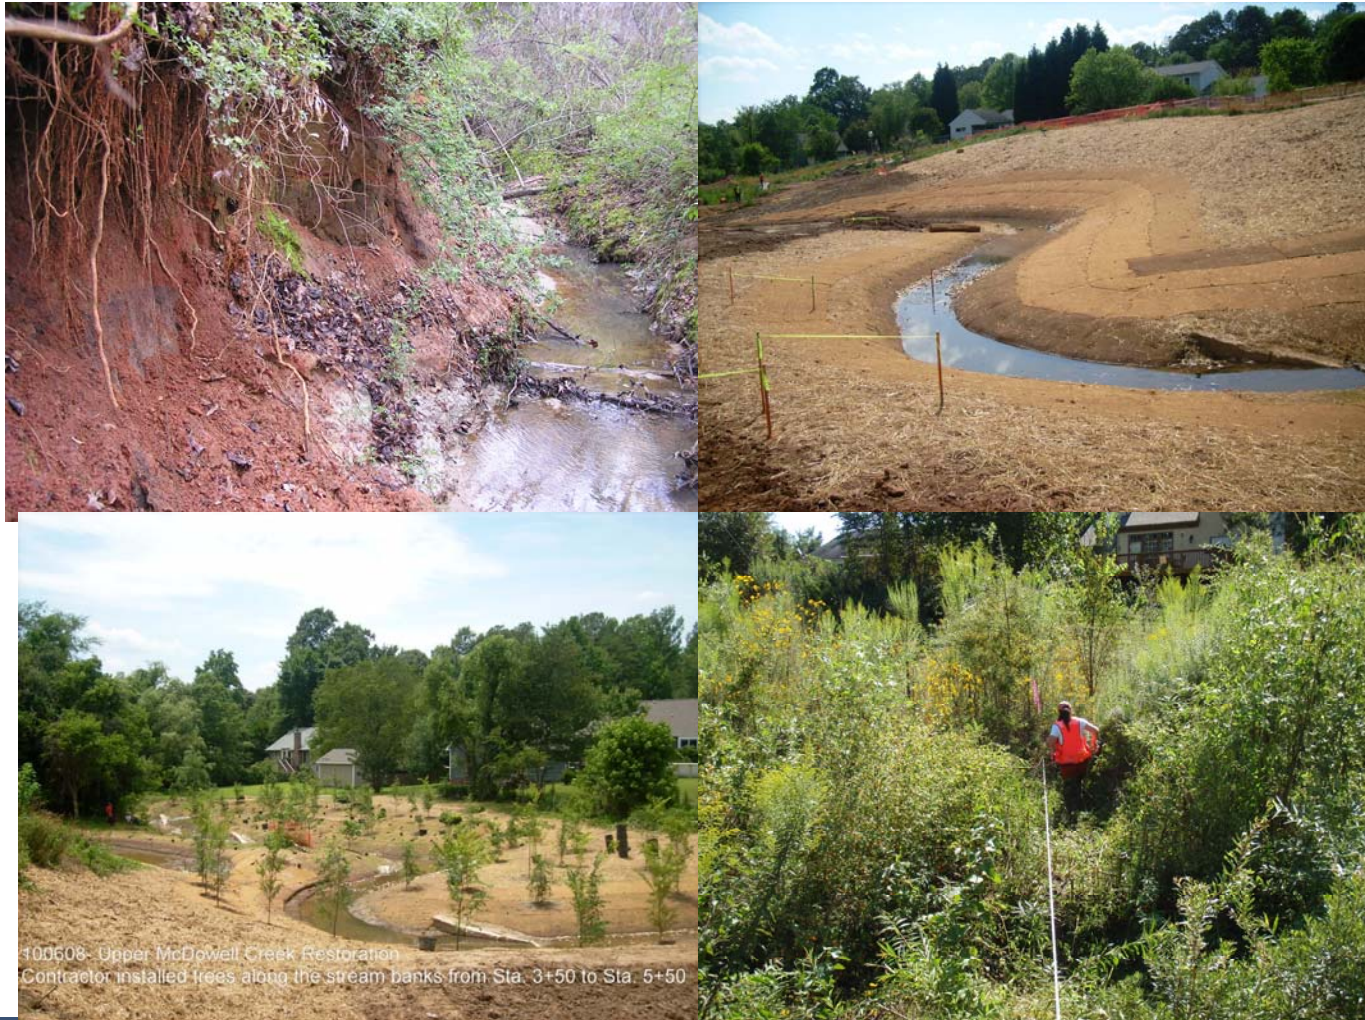
Mitigation measures: stream restoration

Stream restoration defined as modifying plan, dimension and profile

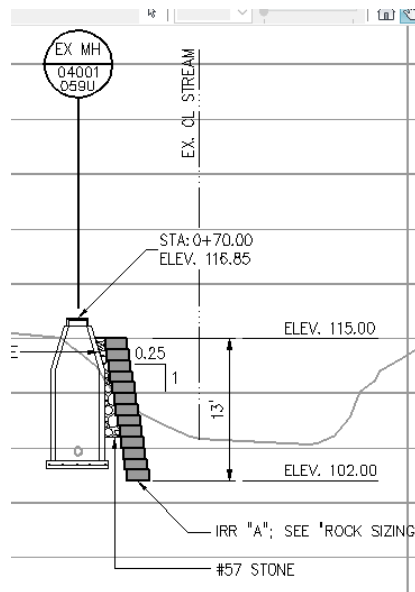
Pursue stream restoration (plan, dimension, profile) design if:

1. Two meander wavelengths
2. Acceptable stream valley width
3. Appropriate vertical tie-ins (particularly downstream)

Stream Facets

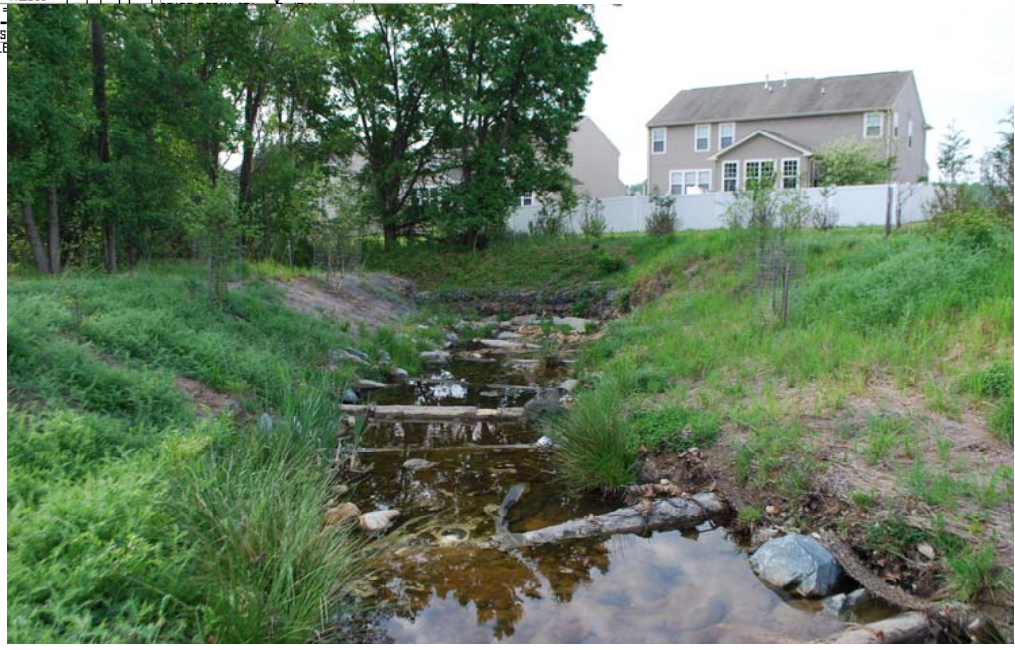
Piscataway Creek, Maryland

Breakdown of internal, external, relocation and restoration; 77 assets
