EcoStream Conference,
Asheville, NC
August 14-16, 2018

Stream Restoration
and Fish Habitat
Banking in Canada

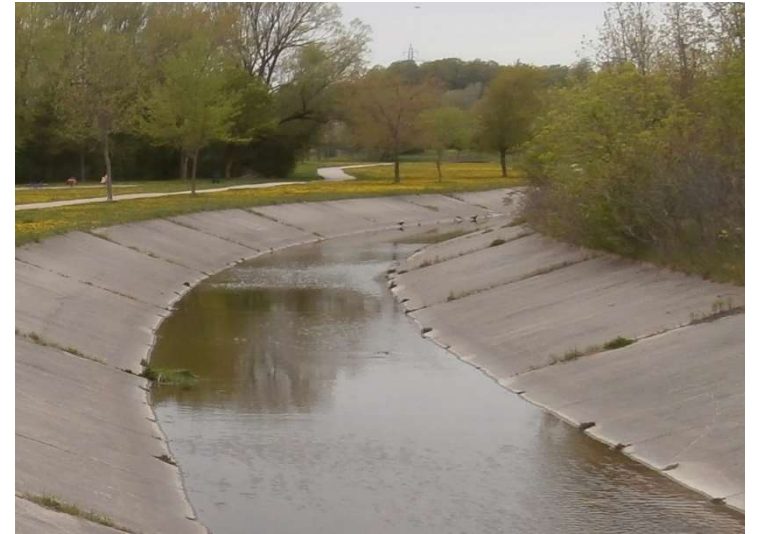
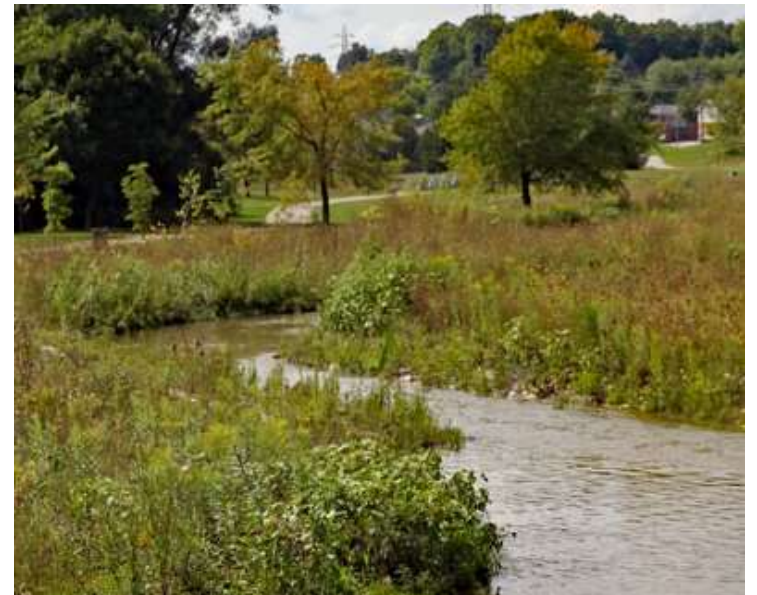
Filsinger

- Naturalization of 2.0 km of concrete lined channel
- 0 m² of existing fish habitat
- 12,600 m² of warmwater fish habitat
- Used to develop the first fish habitat bank

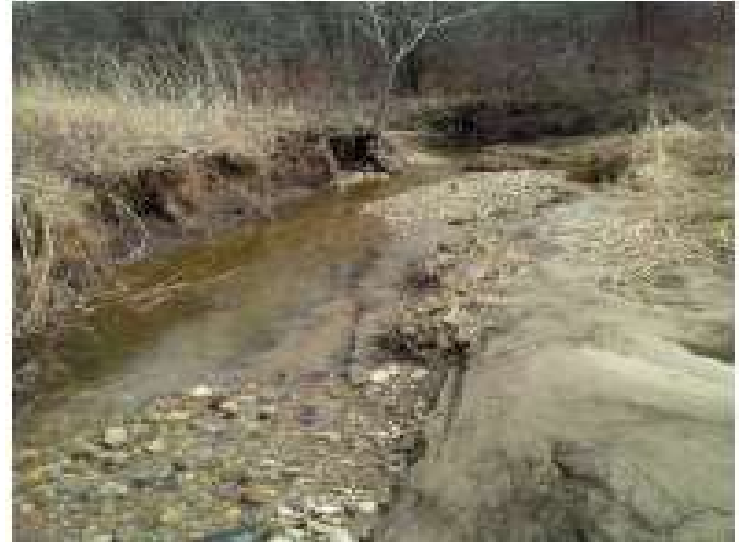
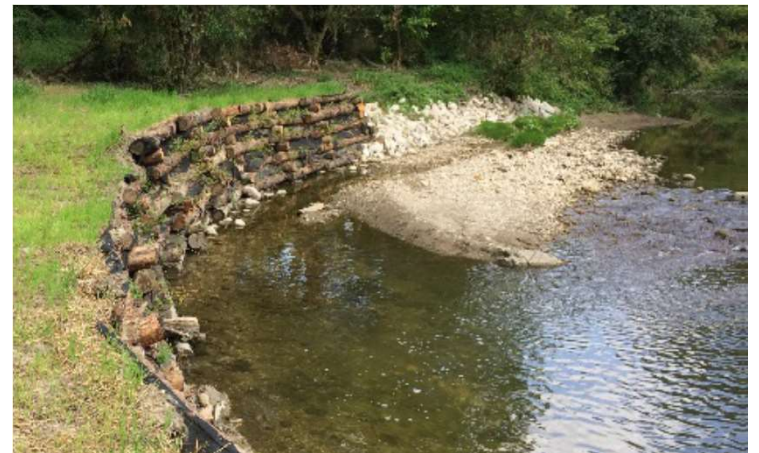
Balzer

- Restoration of 800 m of degraded urban channel
- Badly overwidened – used Regional curve to determine bankfull width
- 1,438 m² of warmwater fish habitat credits

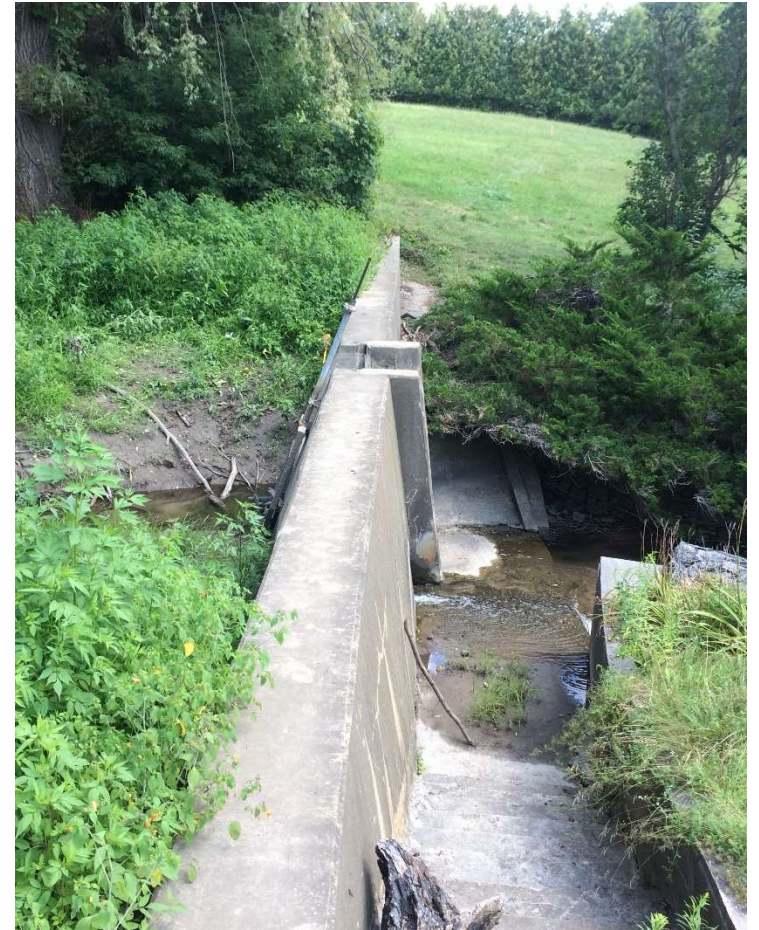
Idlewood Creek

- Removal of two dams and gabion channel
- Restoring upstream fish passage
- $\frac{1}{4}$ bankfull area upstream of dam
- 4,600 m² of coolwater fish habitat credits

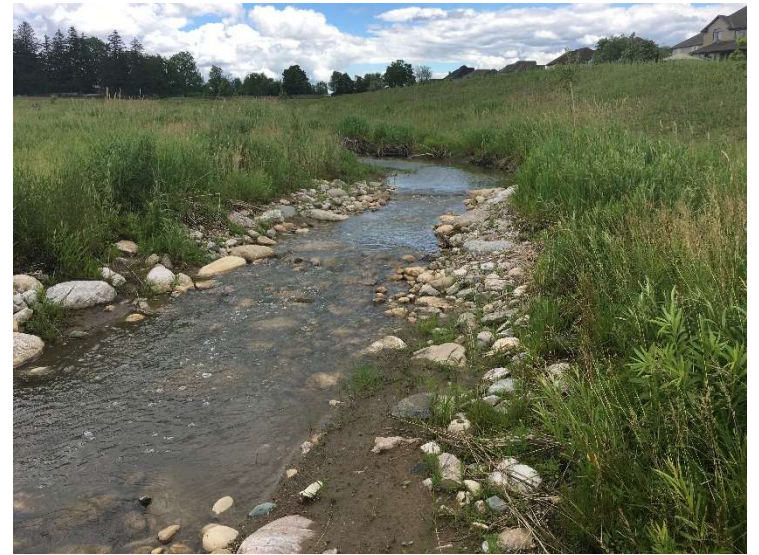
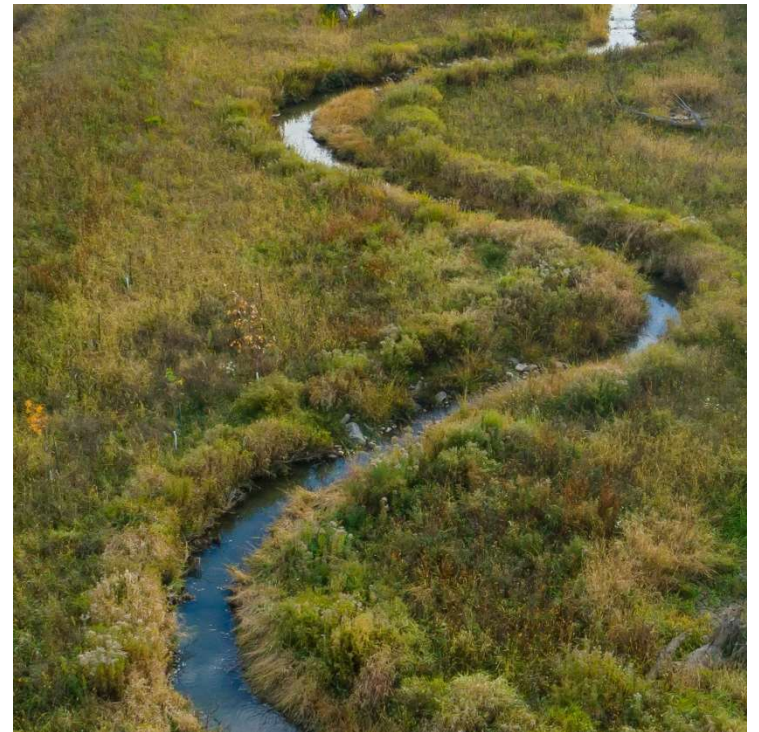
Mathers

- Daylighting 800 m of stream channel
- 0 m² existing fish habitat
- 1,900 m² of warmwater habitat credits

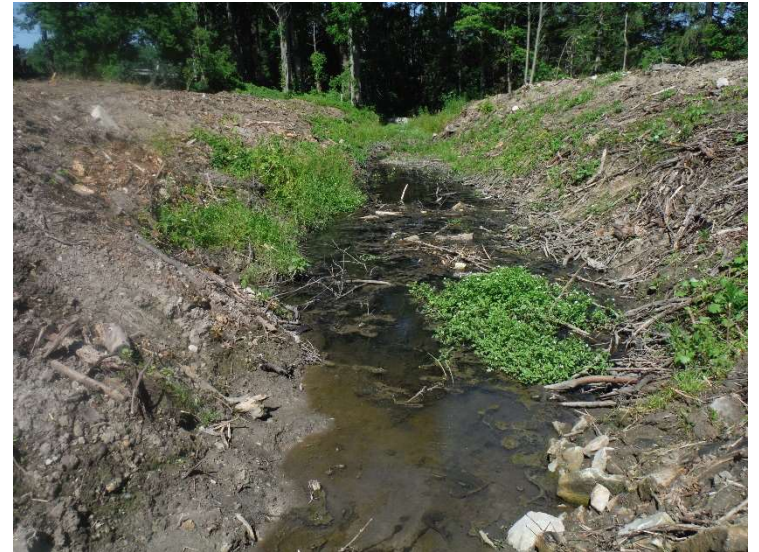
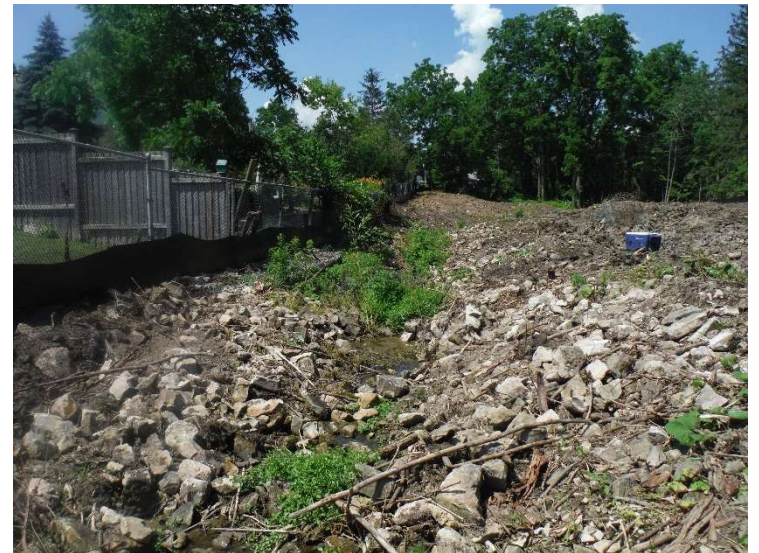
Tributary C

- Restoration of 330 m of degraded channel and removal of fish passage barrier
- Some existing fish habitat
- Potential for 490 m² of warmwater fish habitat
