# *Hurricane Harvey - What Have We Learned?*

*Developing Resiliency In  
Harris County Streams  
and Flood Control  
Channels*

# Houston Texas & the Harris County Flood Control District

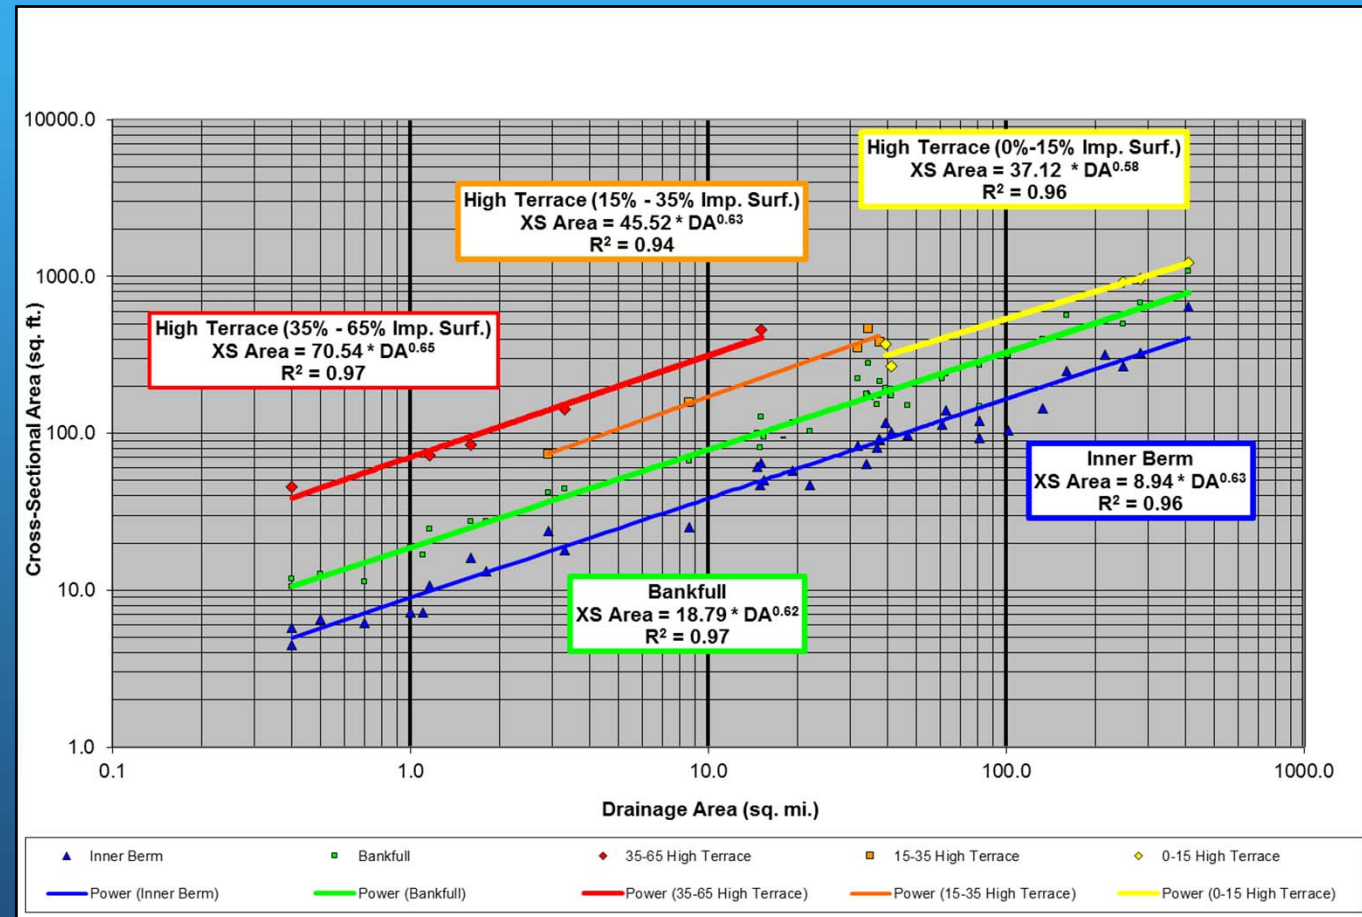
# HCFCD Countywide Fluvial Geomorphic Study (2008)

- 45 streams surveyed

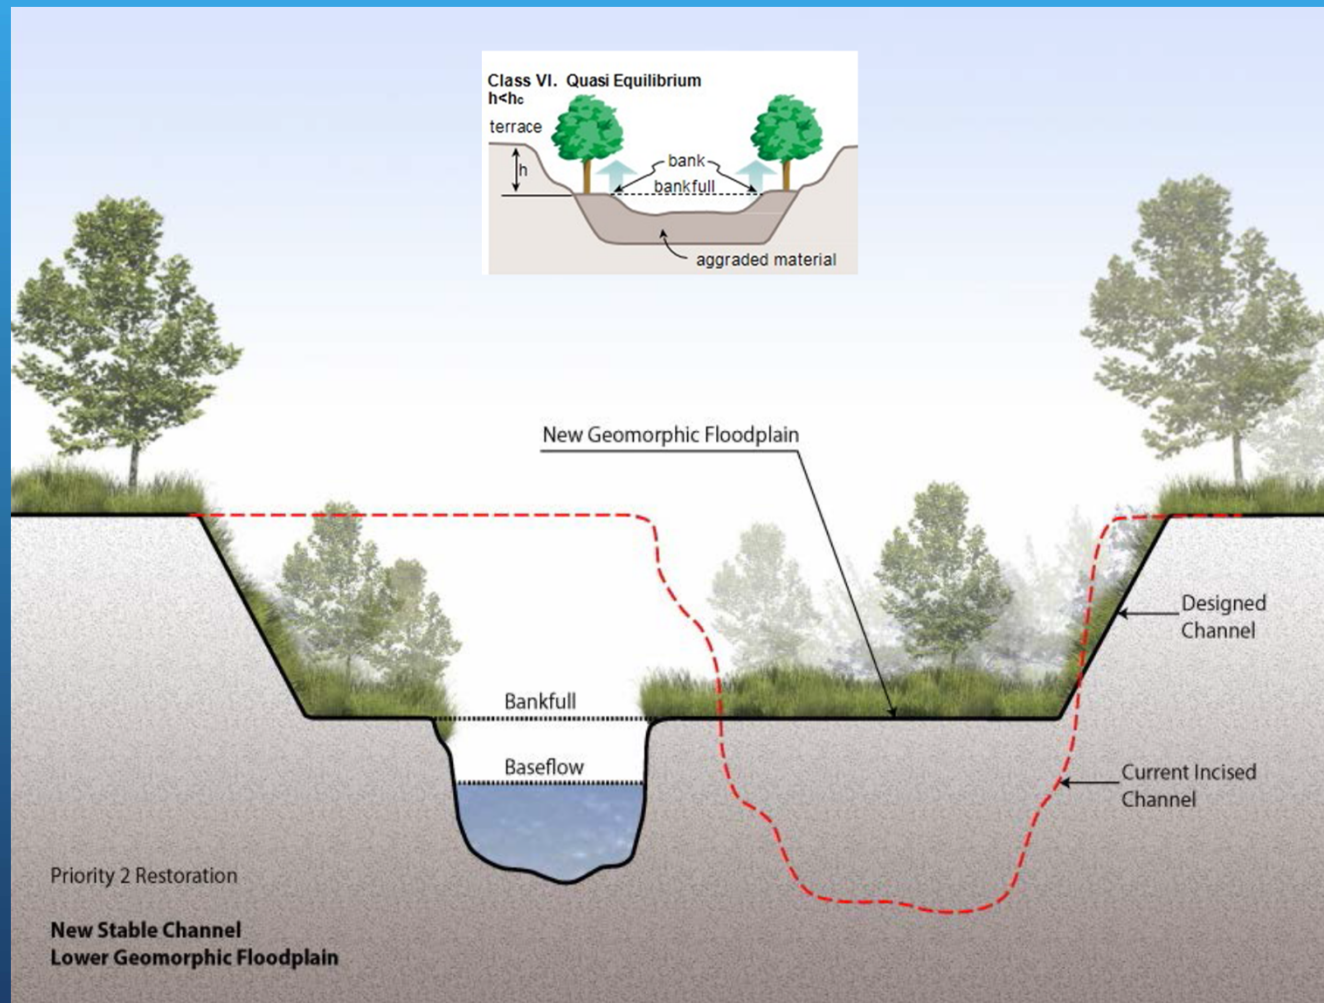
# HCFCF Priority 2 Restoration Components

- Establish equilibrium at lower elevation

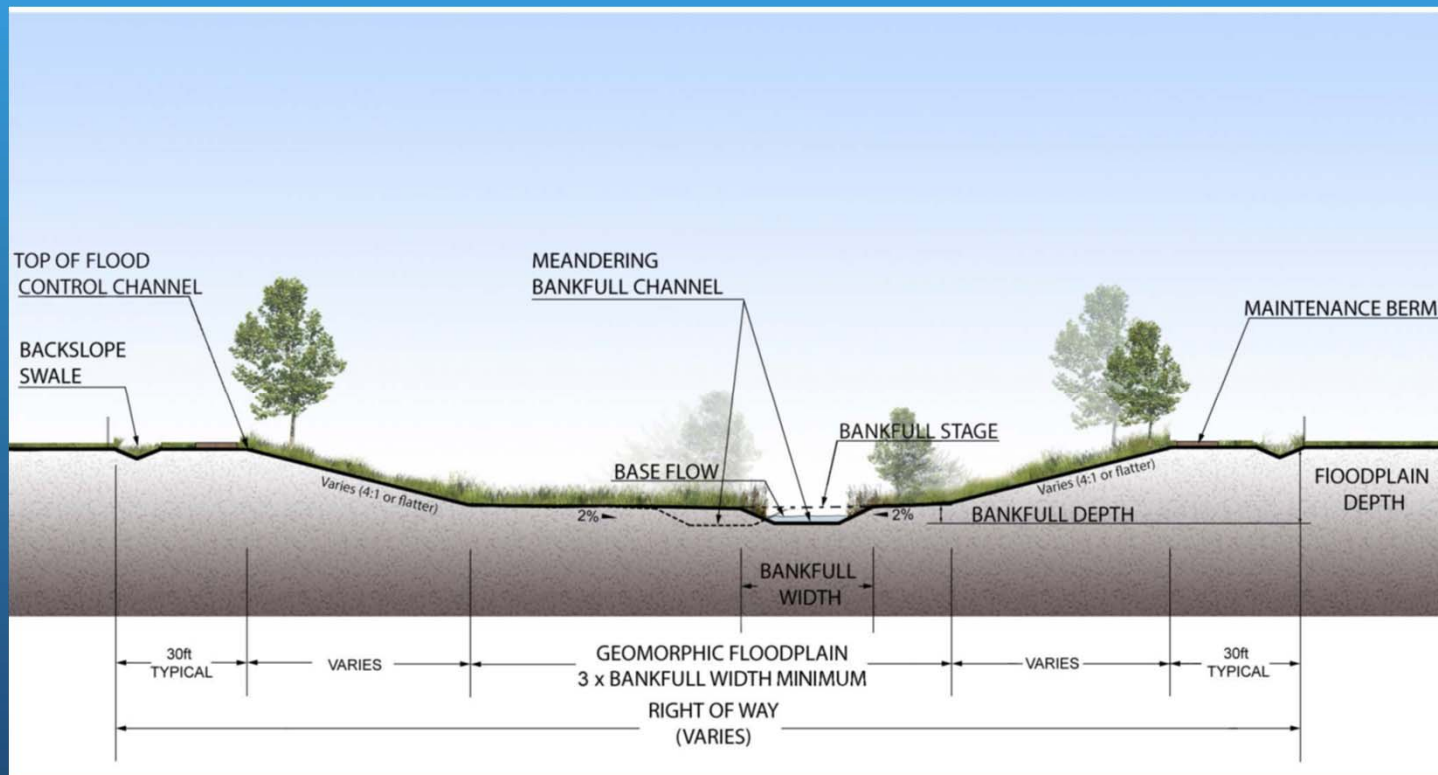
# HCFCD Priority 2 Restoration Components

- Rosgen C channels (with possible transition to E channel)
- Nominal bankfull floodplain bench (Min:  $3 \times W_{BKF}$ )

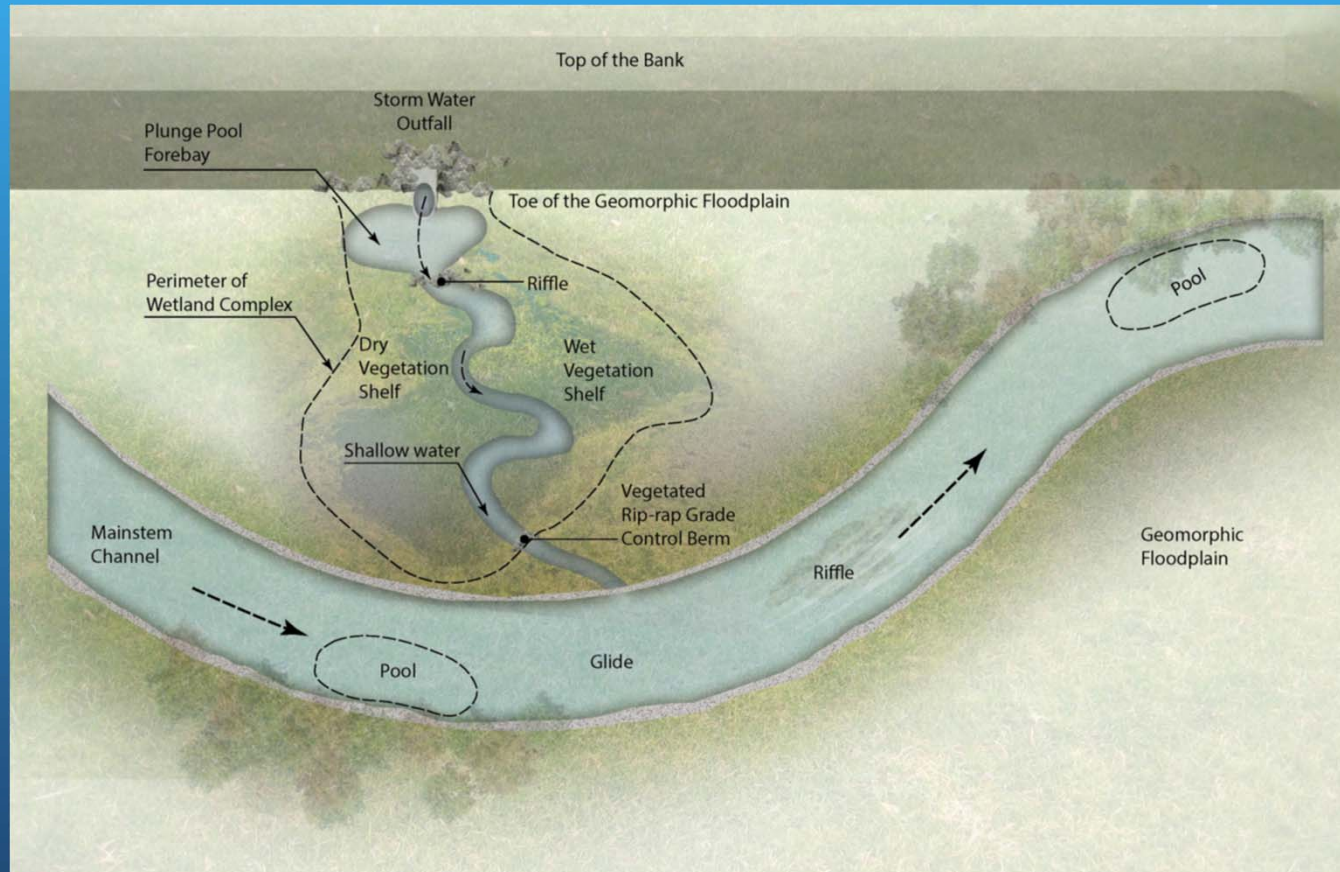
# HCFCD Priority 2 Restoration Components

- Stormwater quality wetlands on bankfull bench

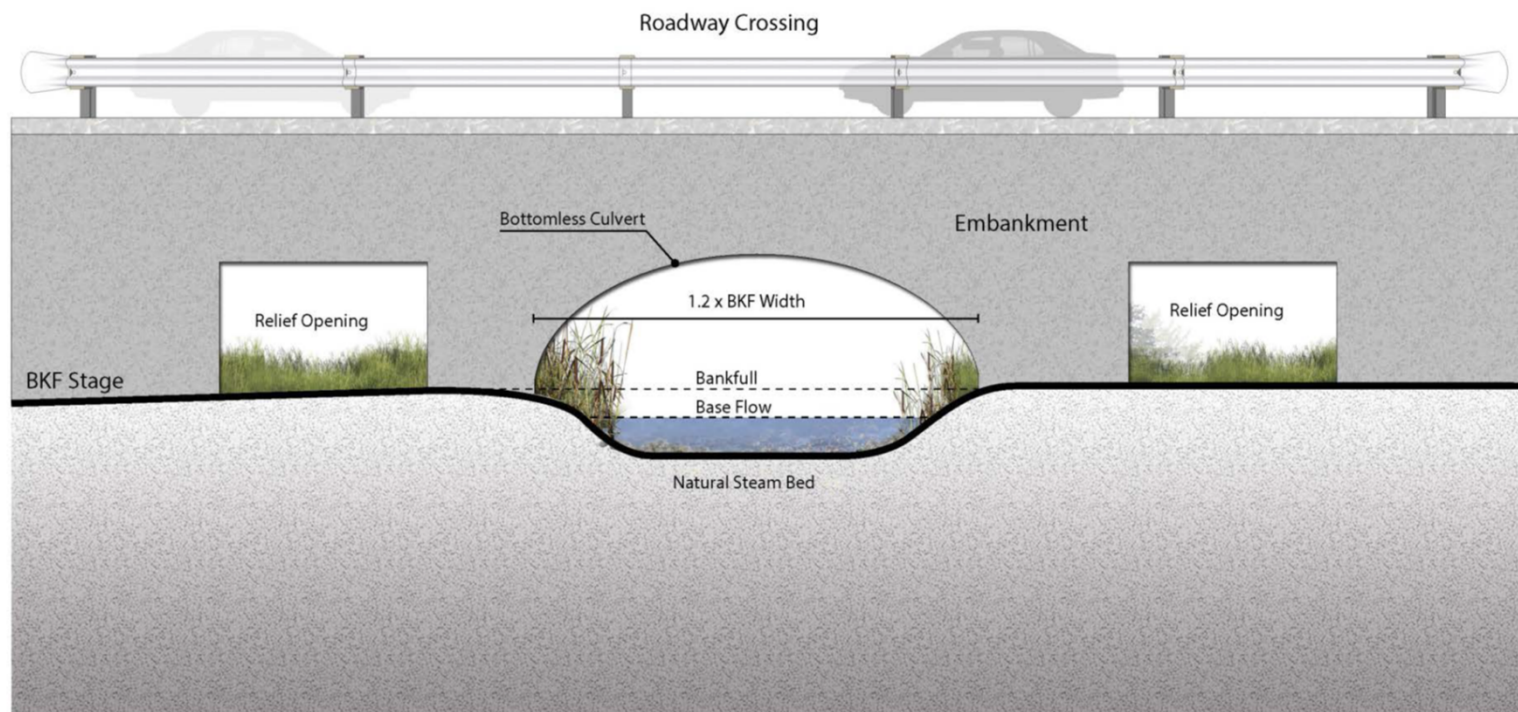
# HCFC Priority 2 Restoration Components

- Bankfull channel-spanning crossings & floodplain culverts

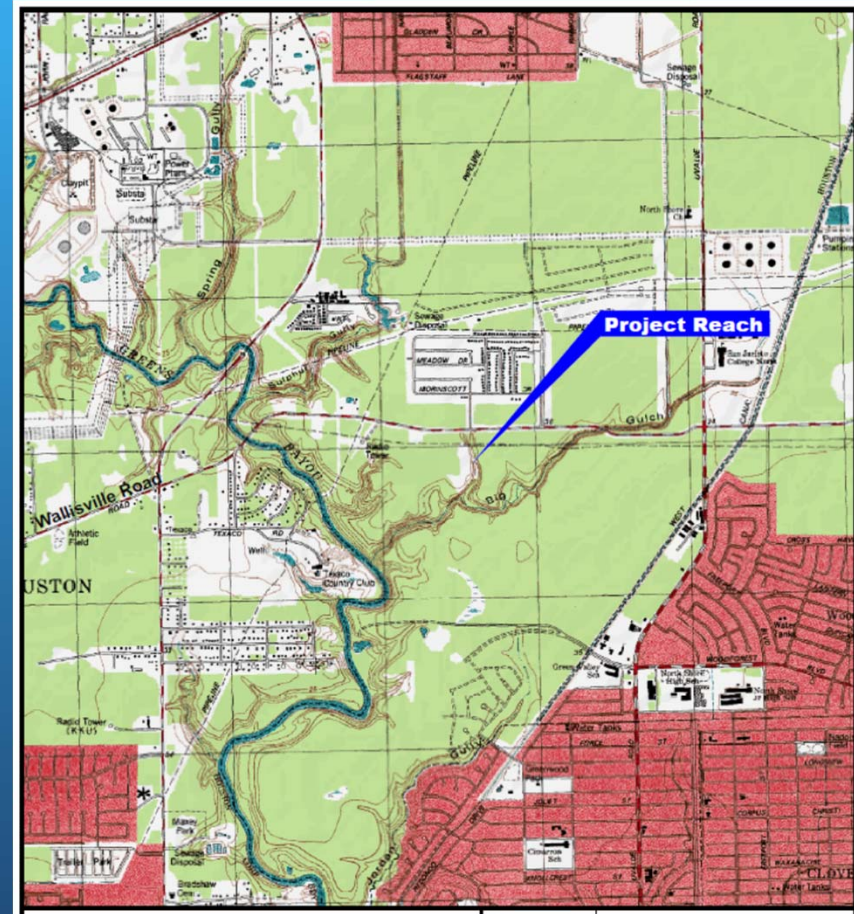
# Tributary to Big Gulch @ North Shore Family Park, Houston

- 115 acres (.18 mi<sup>2</sup>) drainage area
- Watershed is completely piped subdivision (no sediment load) with no stormwater detention (flashy)
- “Sugar” sand banks and relic refuse burn pits (melted glass and metal) uncovered by downcutting stream
- Steep system for Houston (2%)
- “Hungry” (no sediment load) and flashy flows
- Downcutting (over 10 feet) and over-widening in channel evolution
- Overwidening threatens park on one side, schools on the other side, and stormsewer outfalls

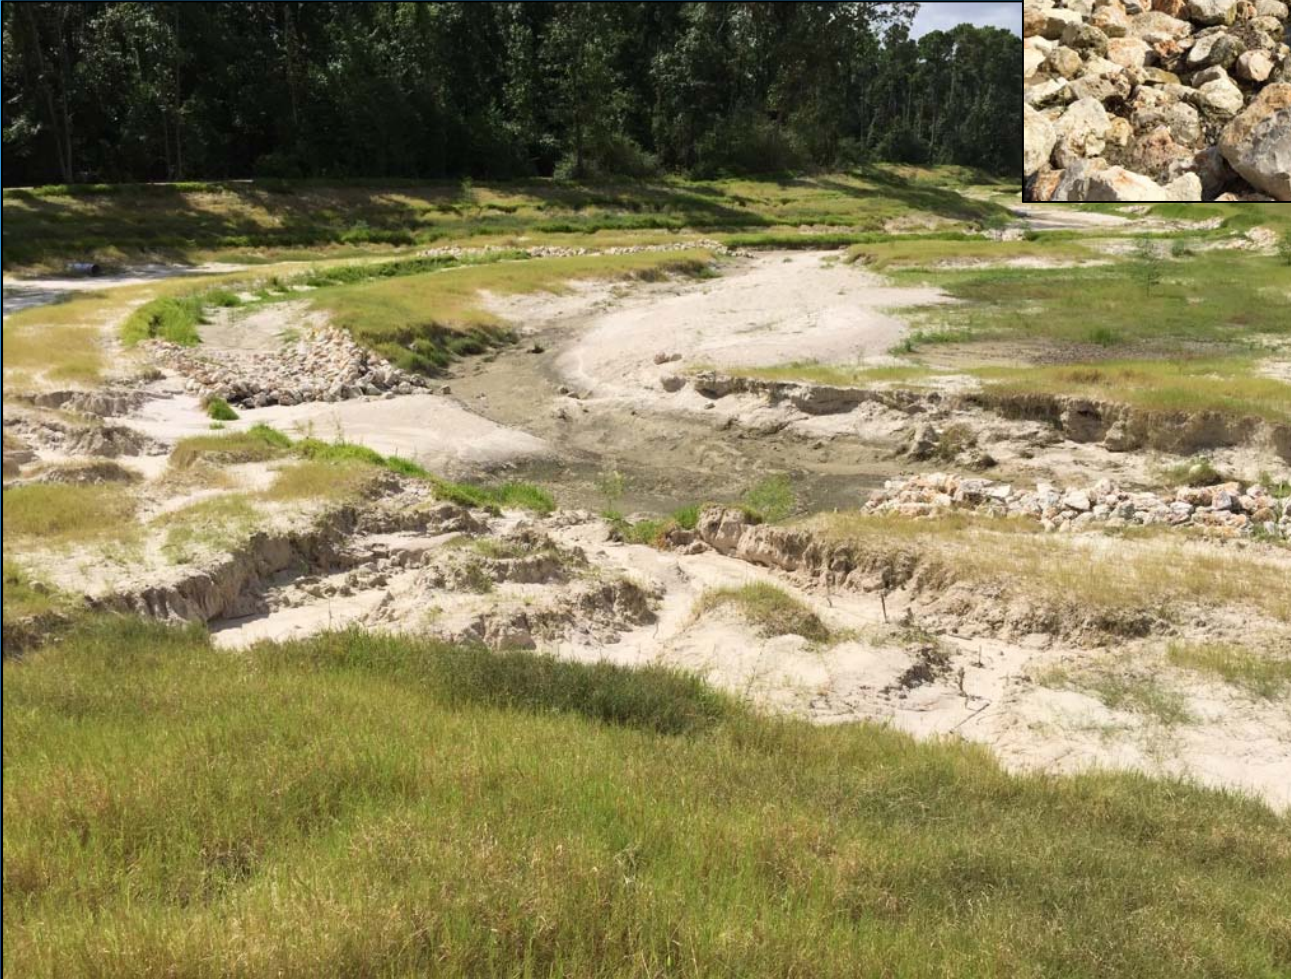
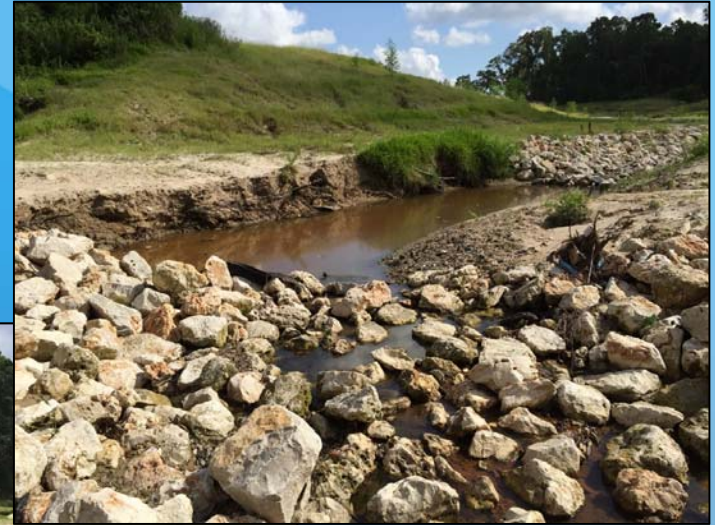
## After (July 2015)

- Project Completed: April 2015
- Memorial Day Flood: May 2015

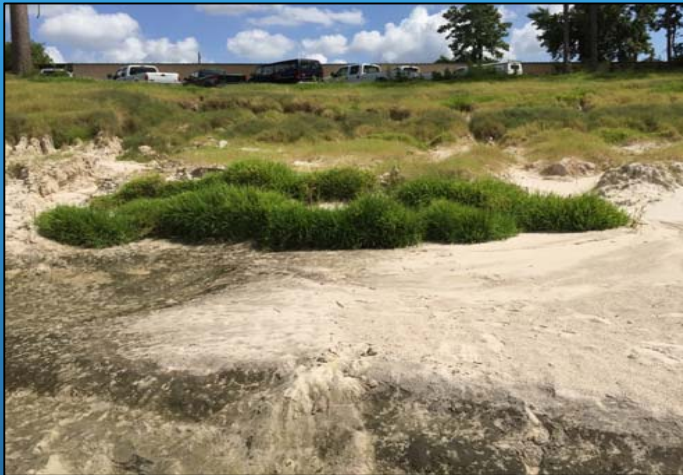
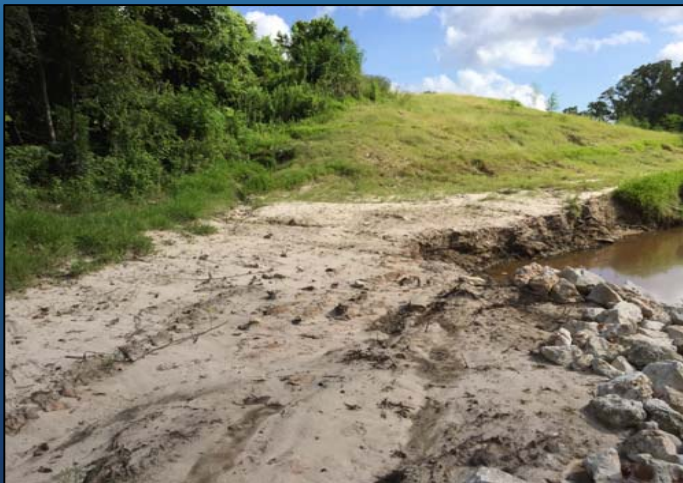
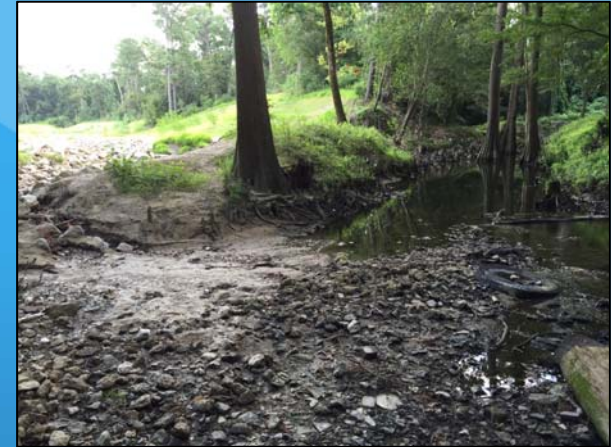
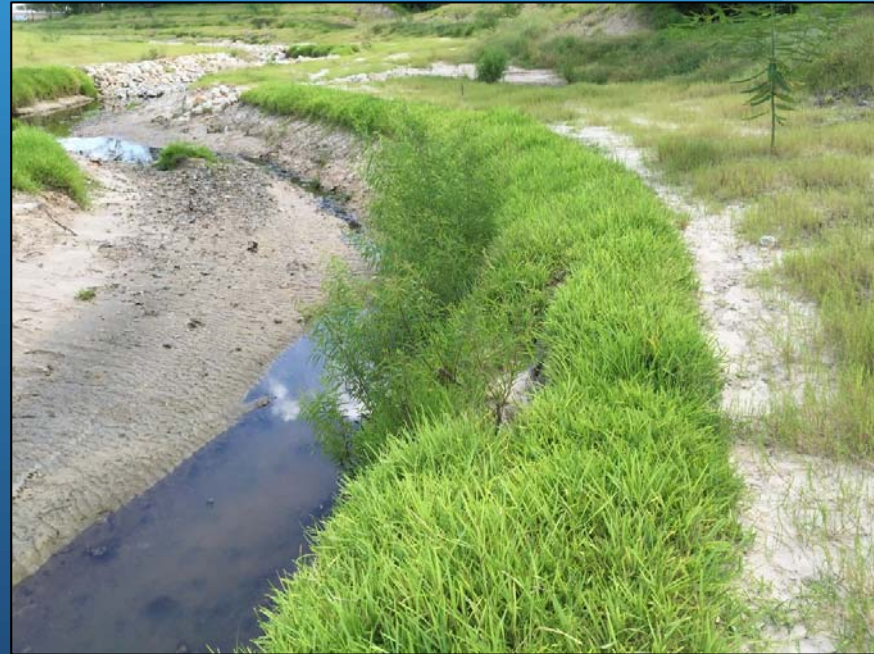
# After (July 2015)

- Project Completed: April 2015
- Memorial Day Flood: May 2015

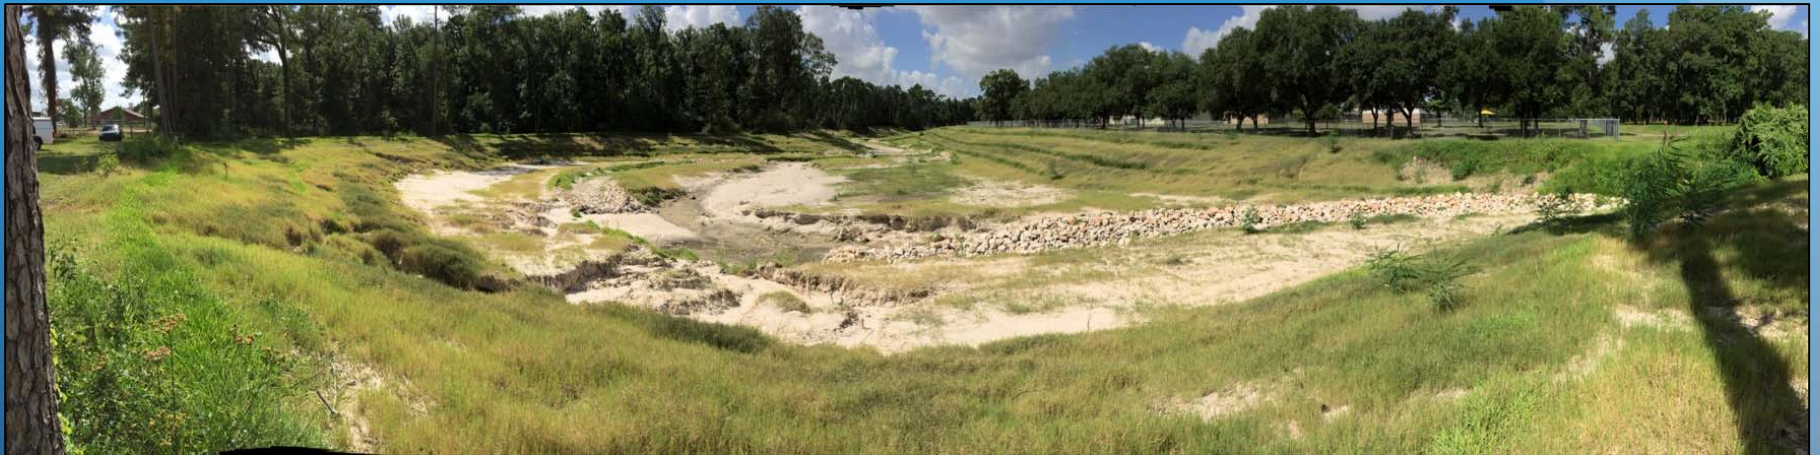
## After (July 2015)

- Project Completed: April 2015
- Memorial Day Flood: May 2015

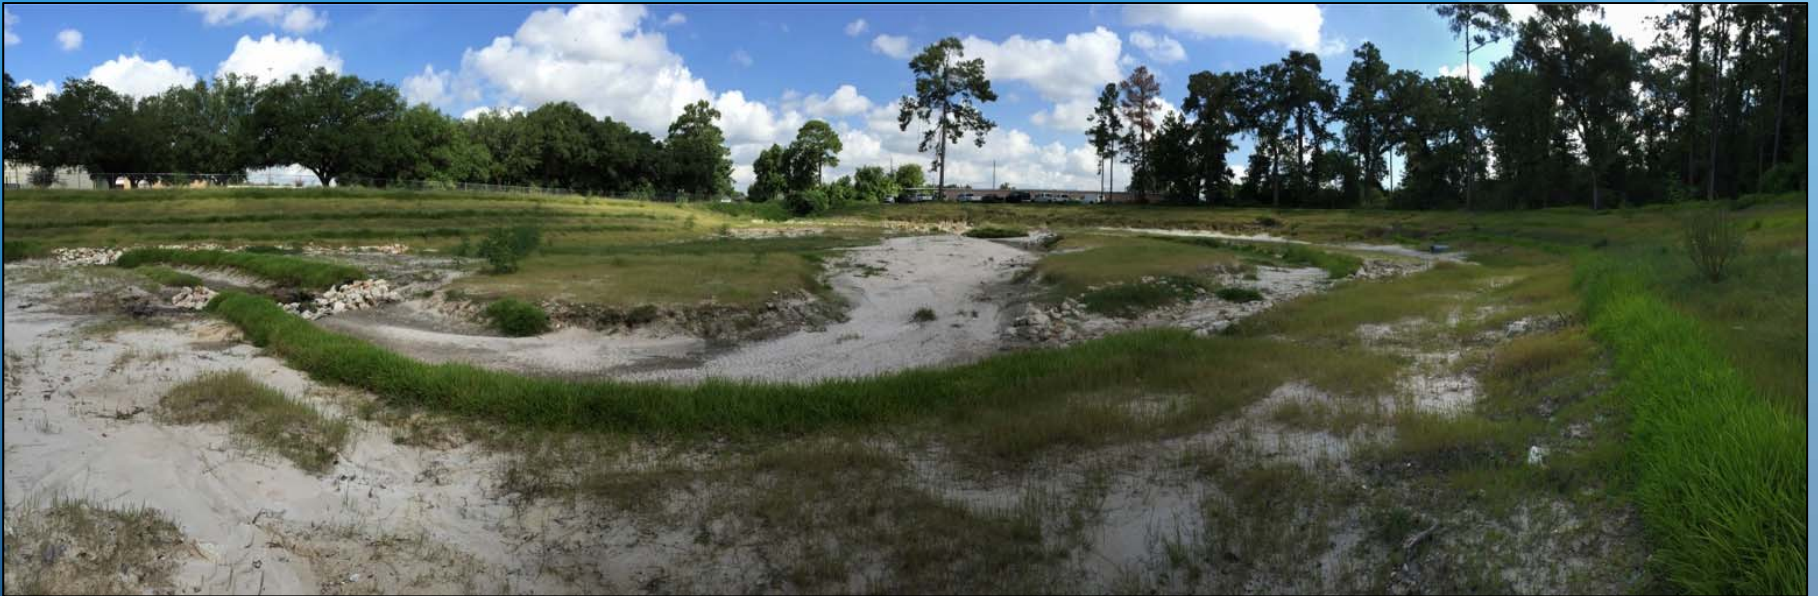
## After (July 2015)

- Project Completed: April 2015
- Memorial Day Flood: May 2015

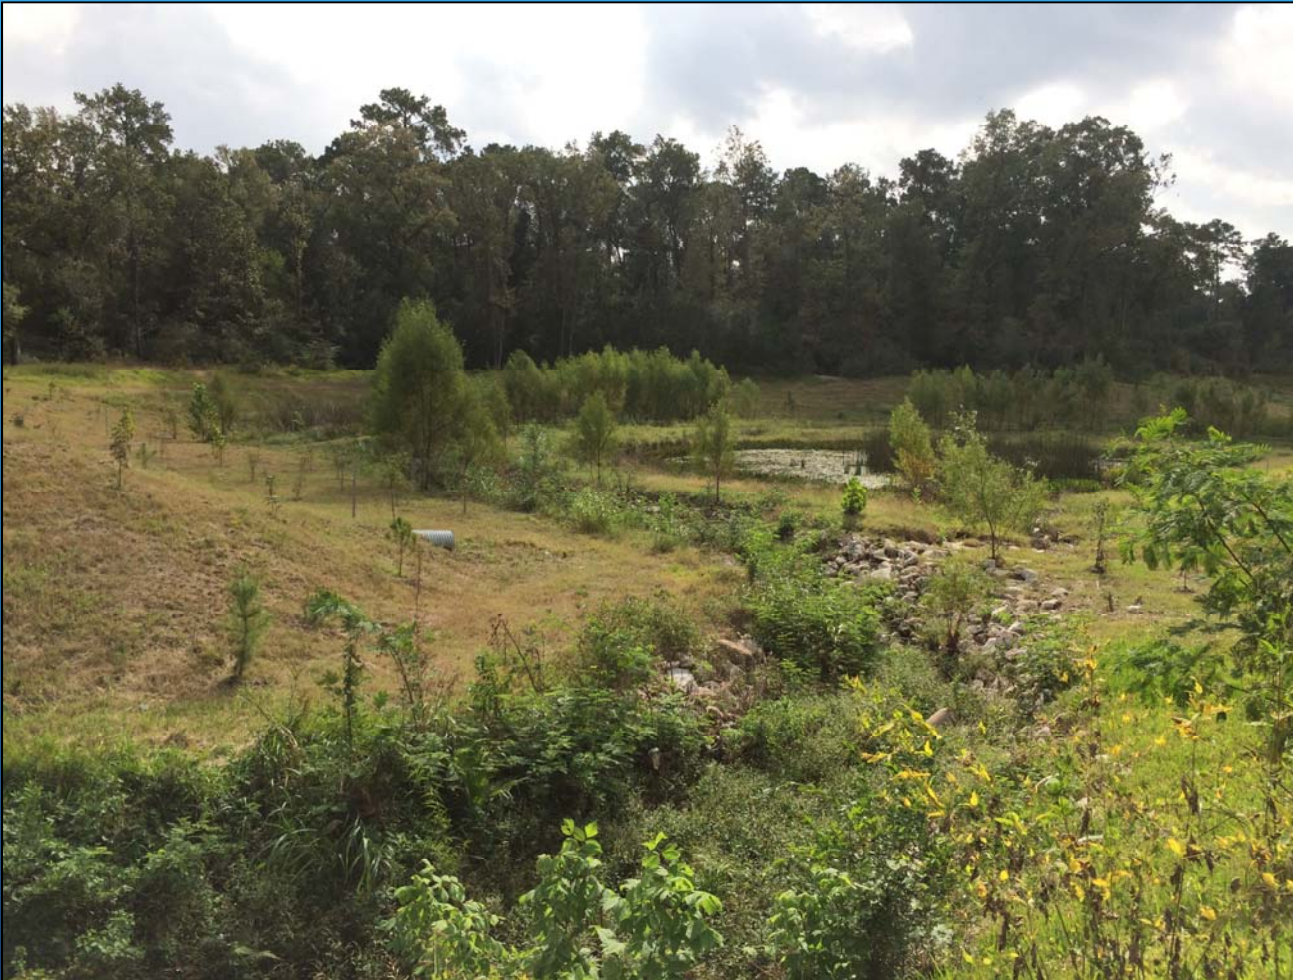
# After (July 2017)

- HCFCFCD Repaired in late 2015
- Stable and self-improving after Tax Day Flood (2016), and Hurricane Harvey (2017)

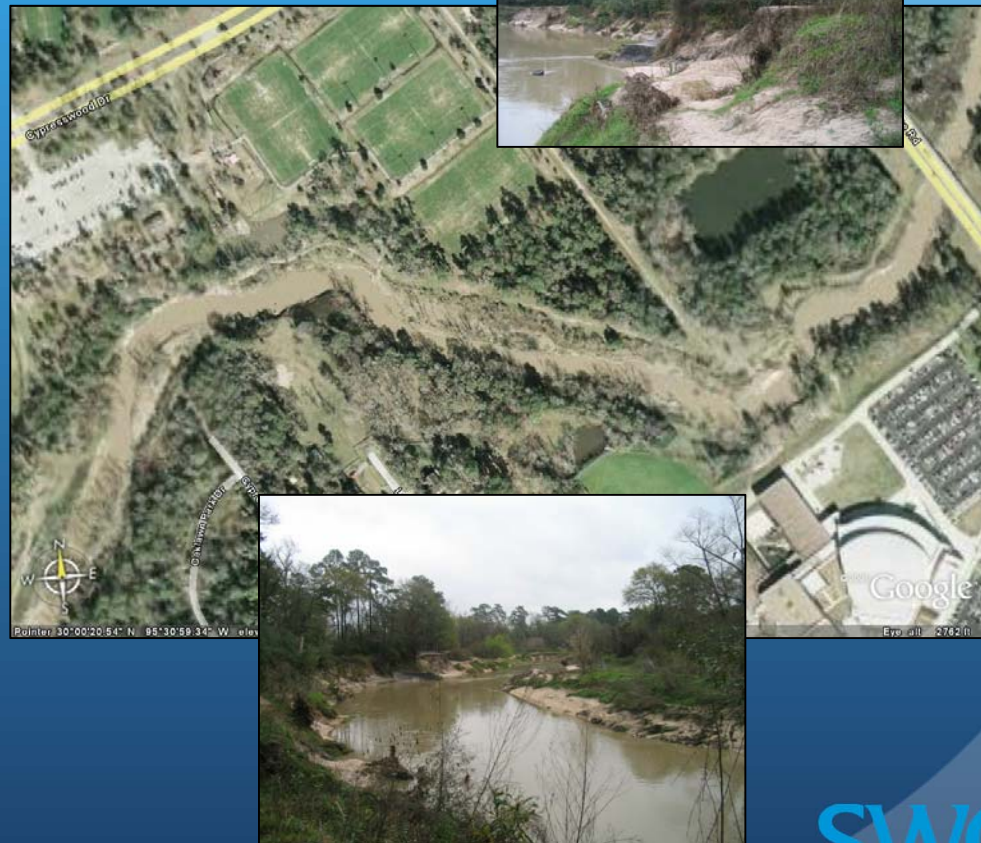
# Cypress Creek @ Mayer Park, Houston

- 189 mi<sup>2</sup> drainage area
- Sand bed & banks with stiff marine clay outcroppings acting as natural, slowly melting grade control
- Natural, but majority of reaches in area had been dredged in the past
- Unstable reaches upstream sending large sediment loads through project reach
- Overwidening threatens park infrastructure and stormsewer outfalls

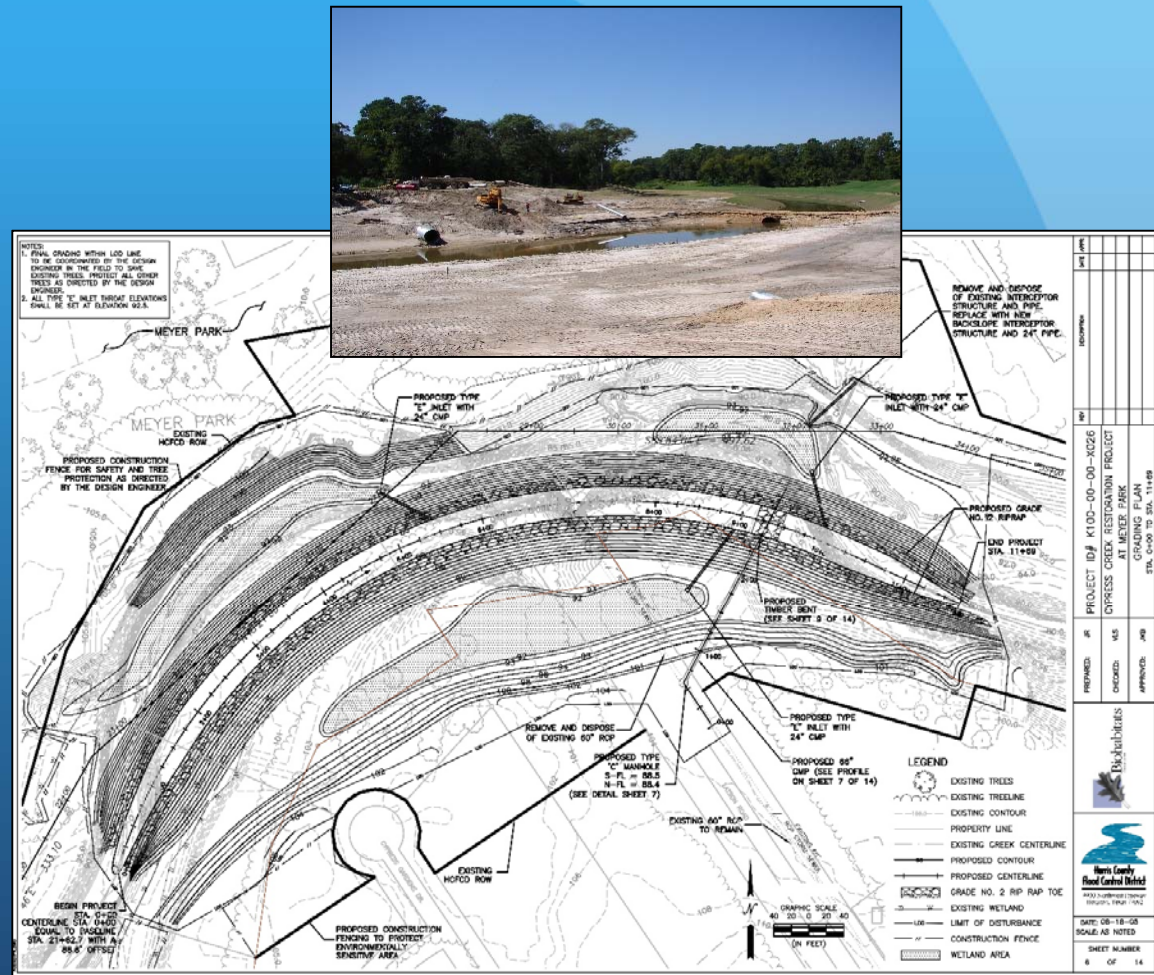
# Reach I - Improvements

- Relocated Priority 2 NCD Meander Bend
- Riprap Armored Channel Toe (Both Banks)
- Constructed Floodplain Bench
- Stabilized Banks & Slopes
- Floodplain SWQ Wetlands
- Grass & Tree Plantings
- Backslope Interceptors
- Armored Stormsewer Outfalls

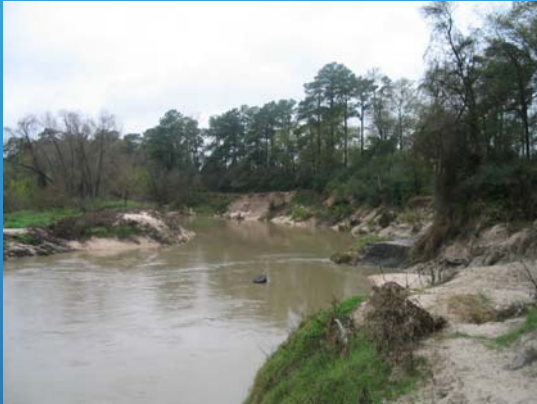
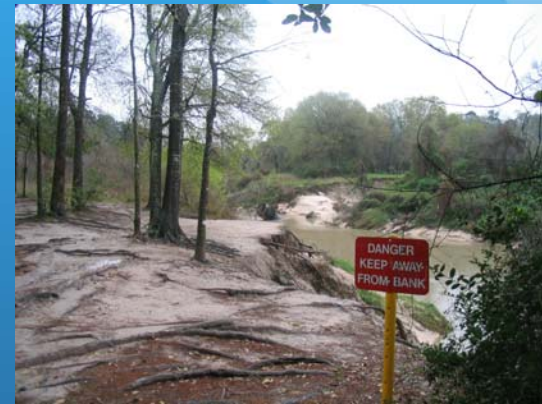
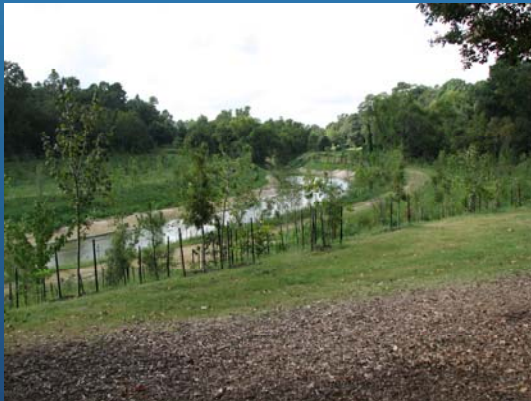
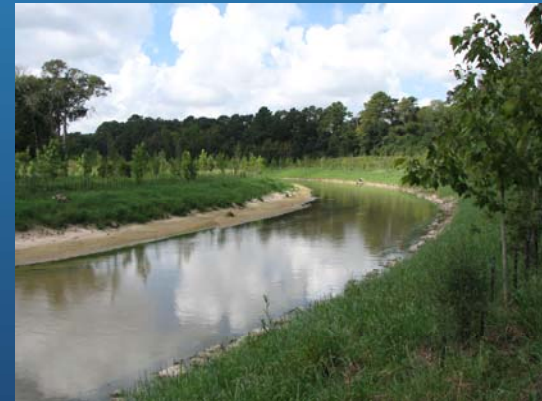
# Reach 1 Before & After (2009)

- Stable and self-improving after 8 bankfull events

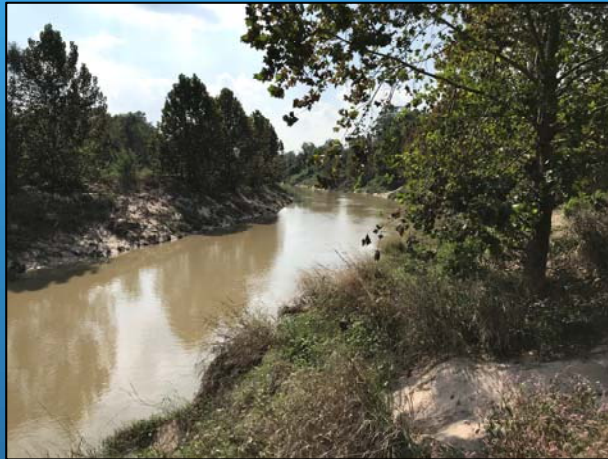
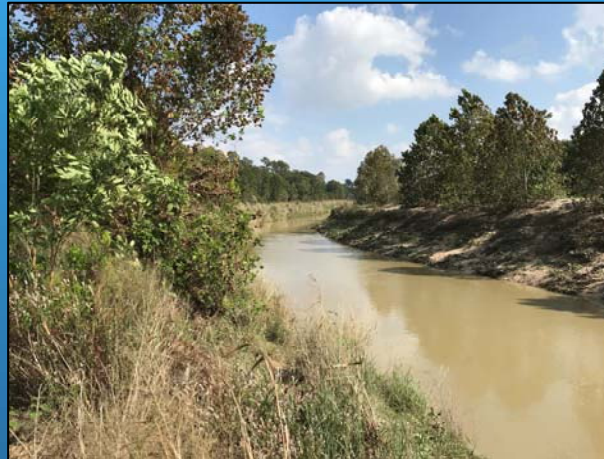
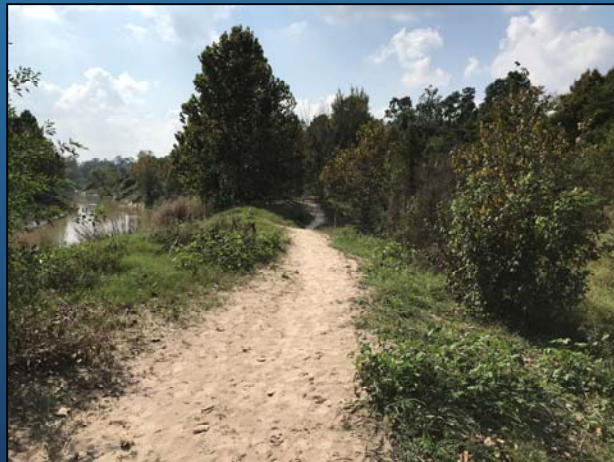
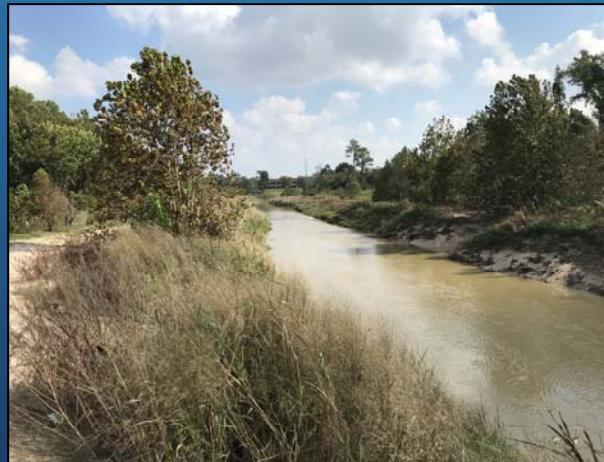
# Reaches 1 & 2 After (2017)

- Stable and self-improving after Memorial Day Flood (2015), Tax Day Flood (2016), and Hurricane Harvey (2017)

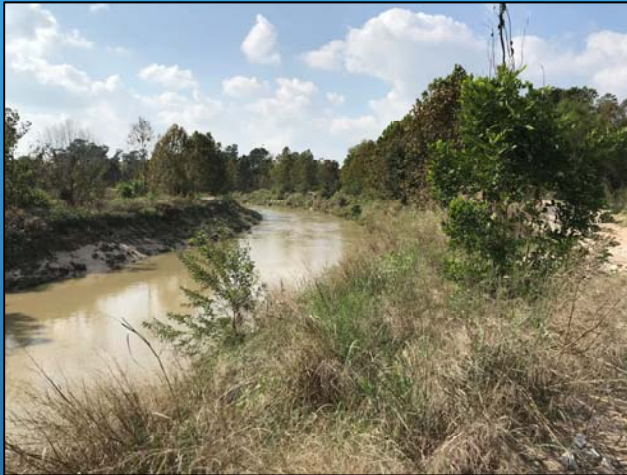
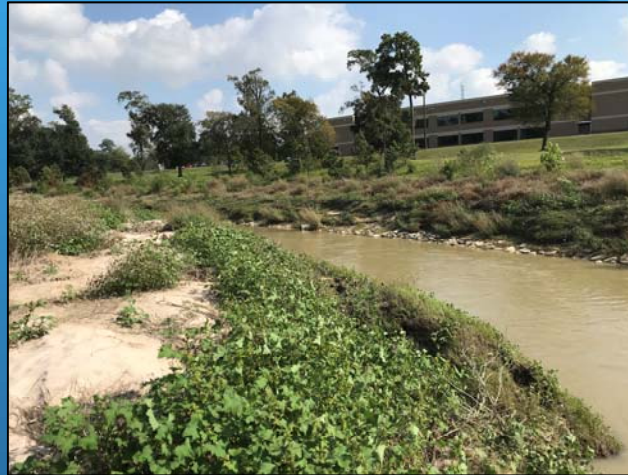
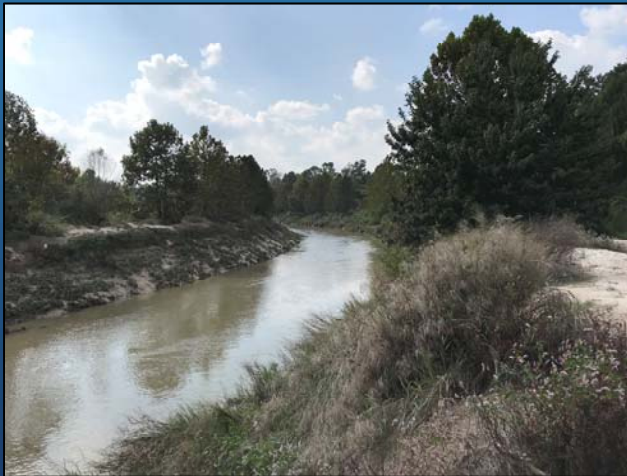
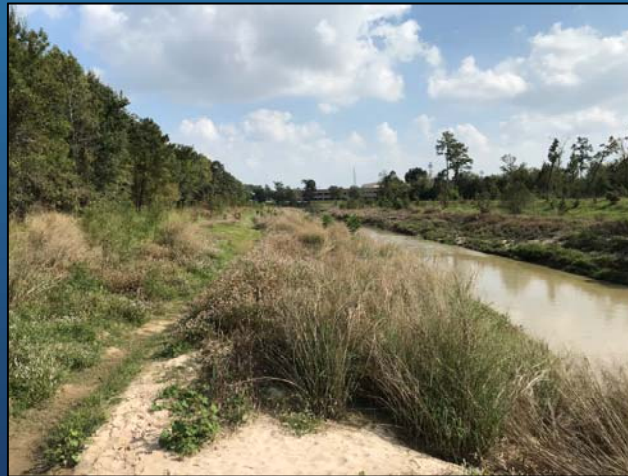
# Reaches 1 & 2 After (2017)

- Stable and self-improving after Memorial Day Flood (2015), Tax Day Flood (2016), and Hurricane Harvey (2017)

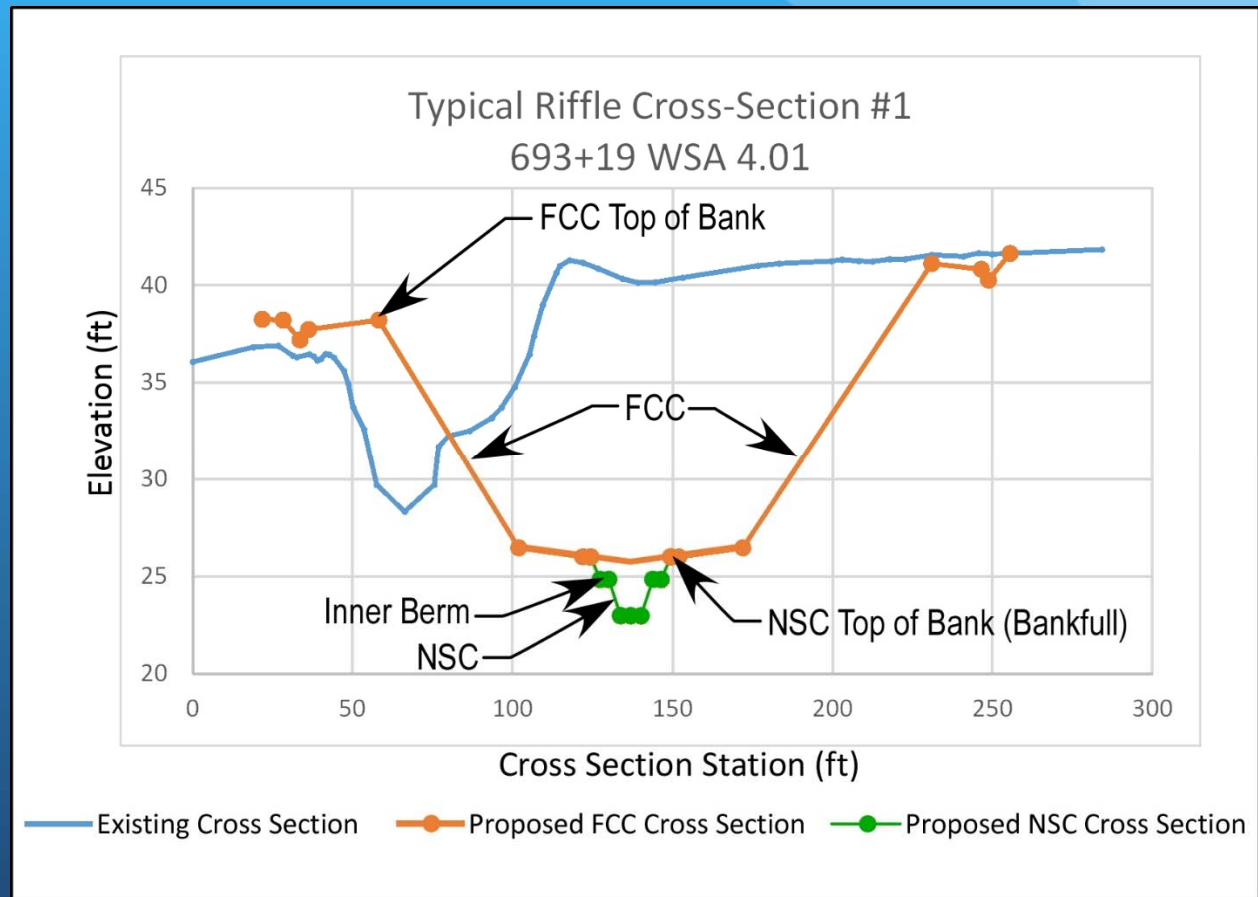
# Upper Hunting Bayou Joint USACE Flood Damage Reduction Project

- Rosgen C Channel (upstream end)

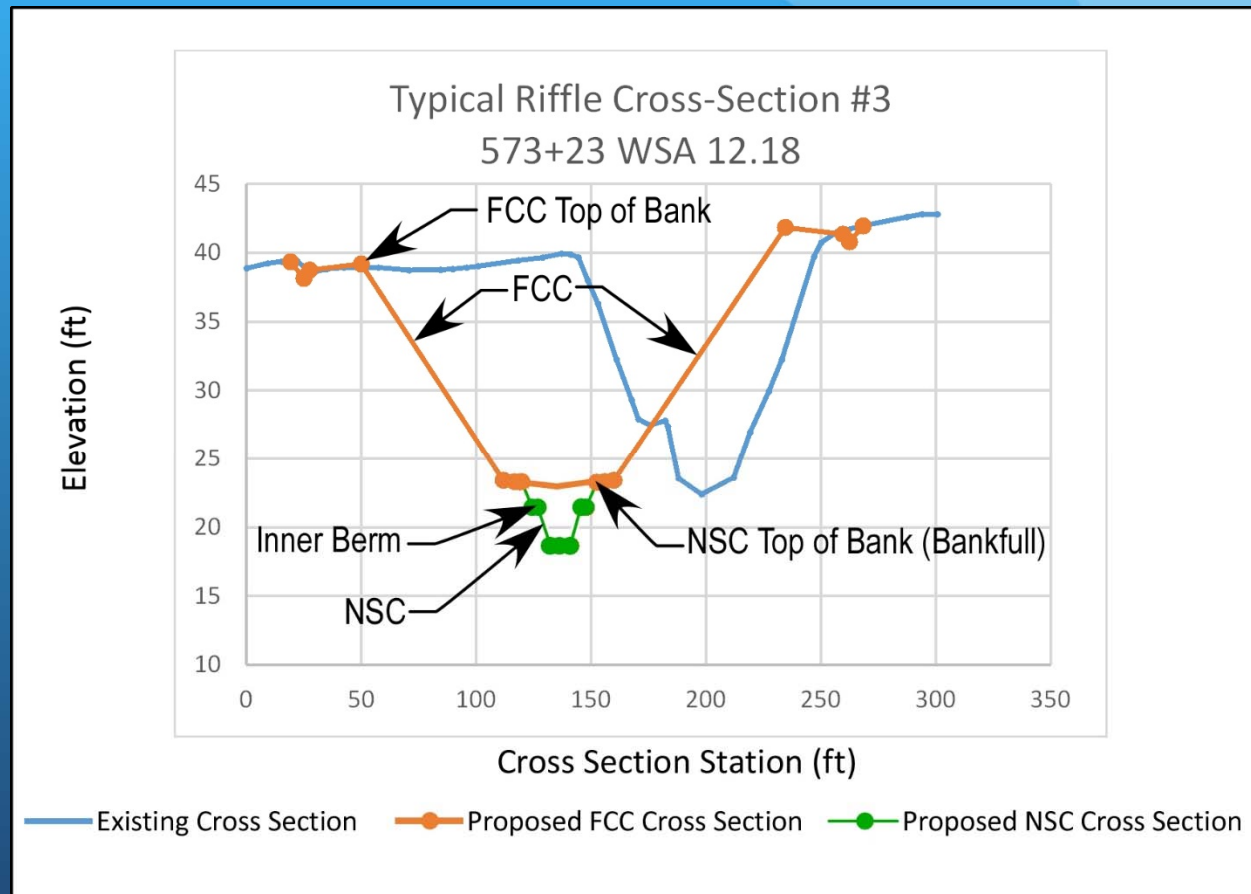
# Upper Hunting Bayou Joint USACE Flood Damage Reduction Project

- Rosgen B Channel  
(downstream end)

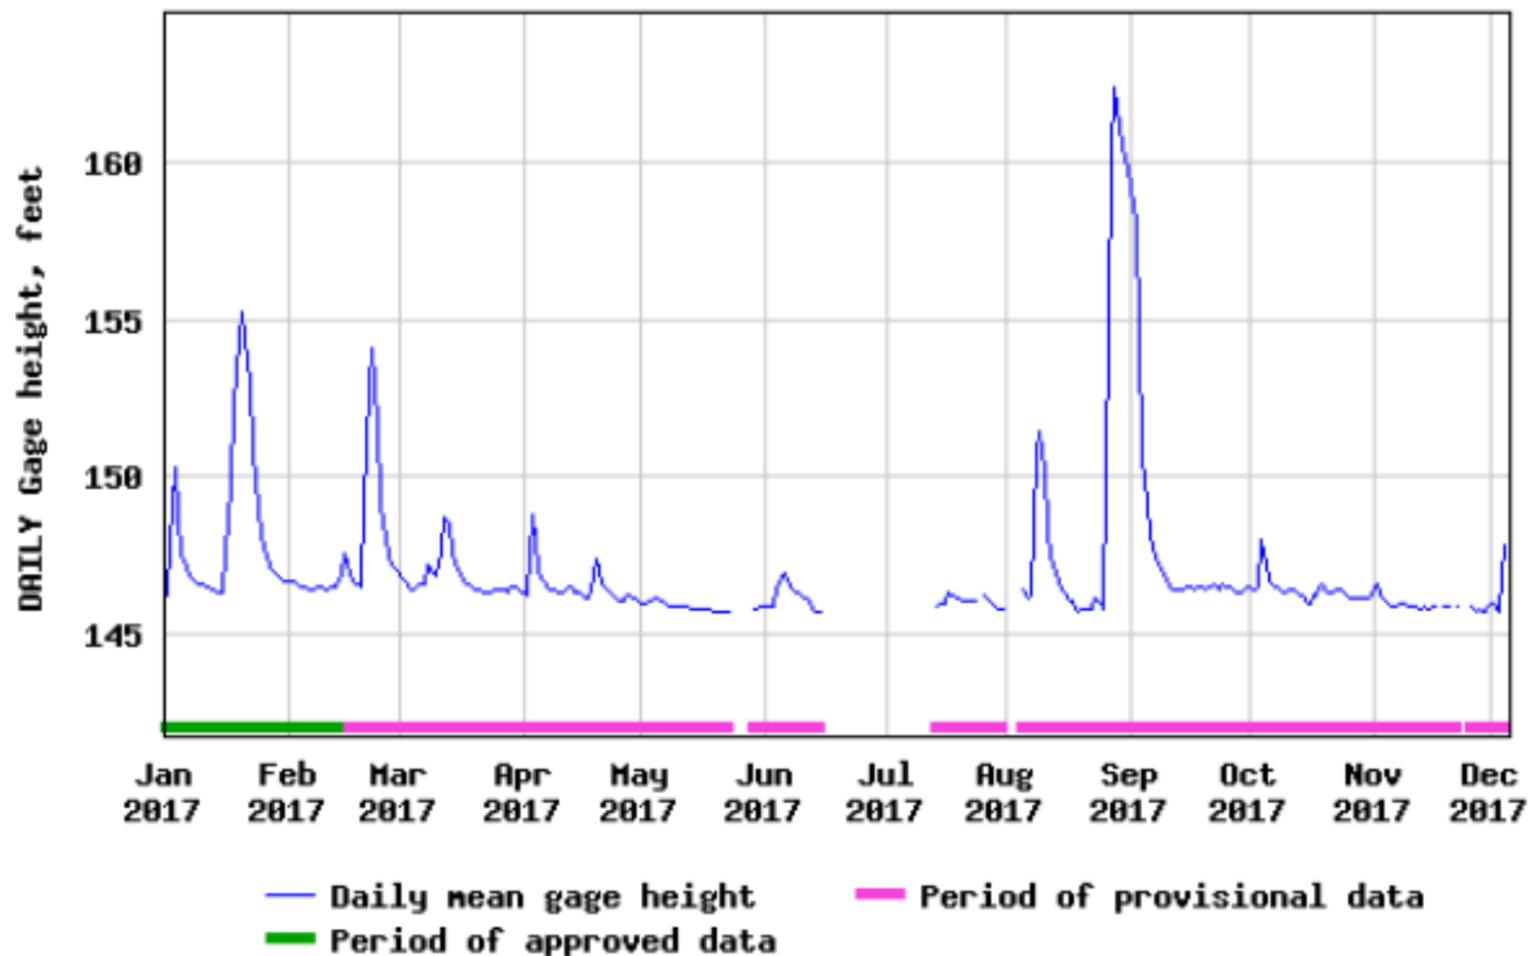
# Daily Gage Height Jan. – Dec. 2017

USGS 08068720 Cypress Ck at Katy-Hockley Rd nr Hockley, TX
