# *Hurricane Harvey - What Have We Learned?*

*Developing Resiliency In  
Harris County Streams  
and Flood Control  
Channels*

# Houston Texas & the Harris County Flood Control District

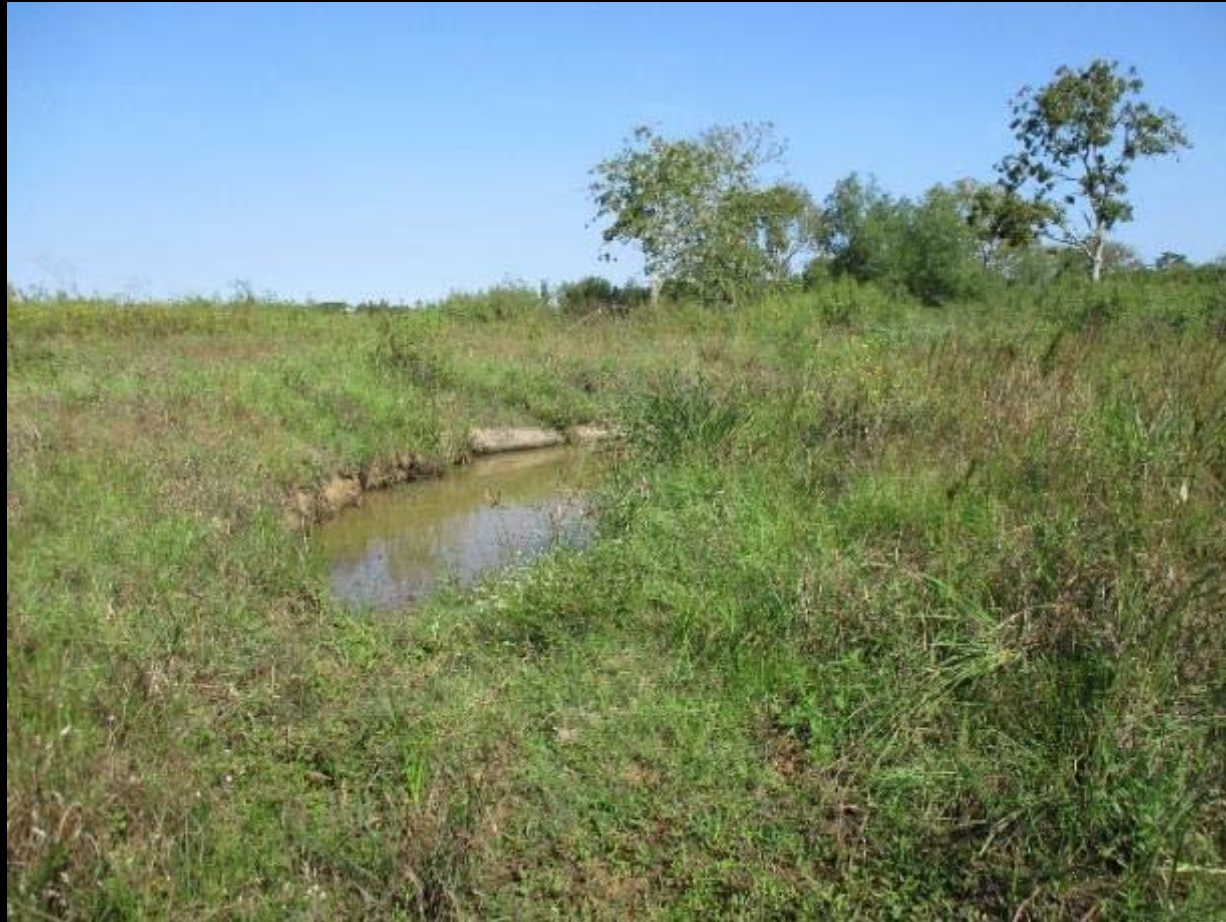
## Photos Station 1 – 2017

An aerial photograph of a vast, green, grassy field. A dark, winding path or ditch cuts through the field, starting from the bottom left and curving towards the top right. In the background, there is a small pond or wetland area with some trees and a line of houses or buildings under a clear sky.

- Importance of Floodplain Access
- Majority of Site Performing Well
- Few Areas in Need of Repair
  - Areas with Difficulty Establishing Vegetation
  - Poor Topsoil Conditions
