# ***Watershed BMPs Reestablish Downstream Baseflows and Attenuate Peak Flows to Improve Stream Integrity***

***EcoStream 2018***

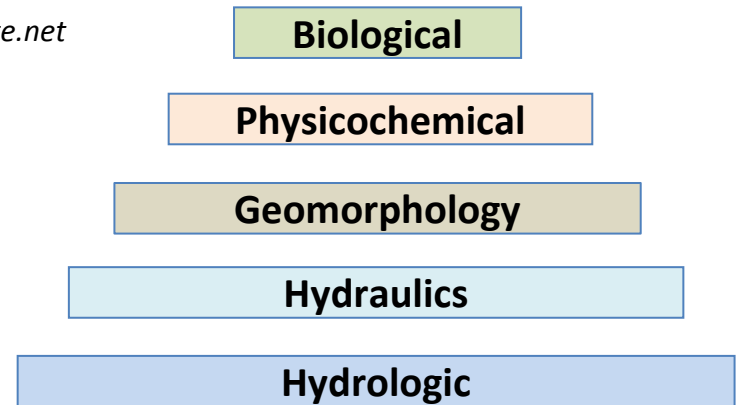
Adapted from Harman et al. 2012

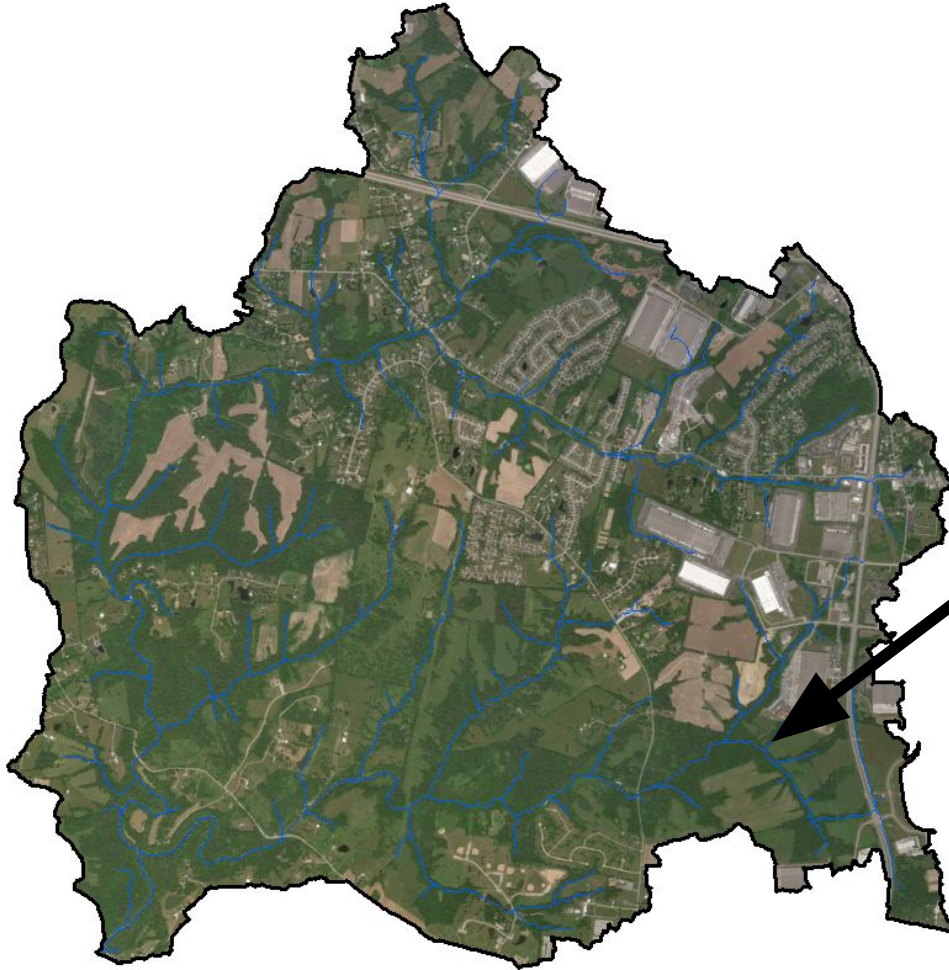
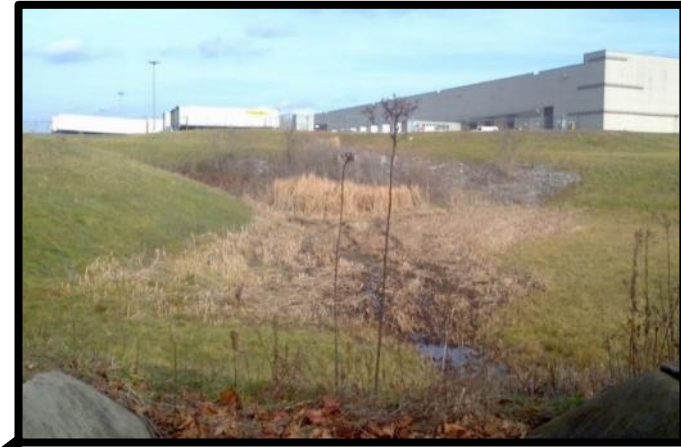
# Simple Detention Basin Retrofit

*Toyota North American Parts Center of Kentucky*

Headwater stream  
with large  
impervious area

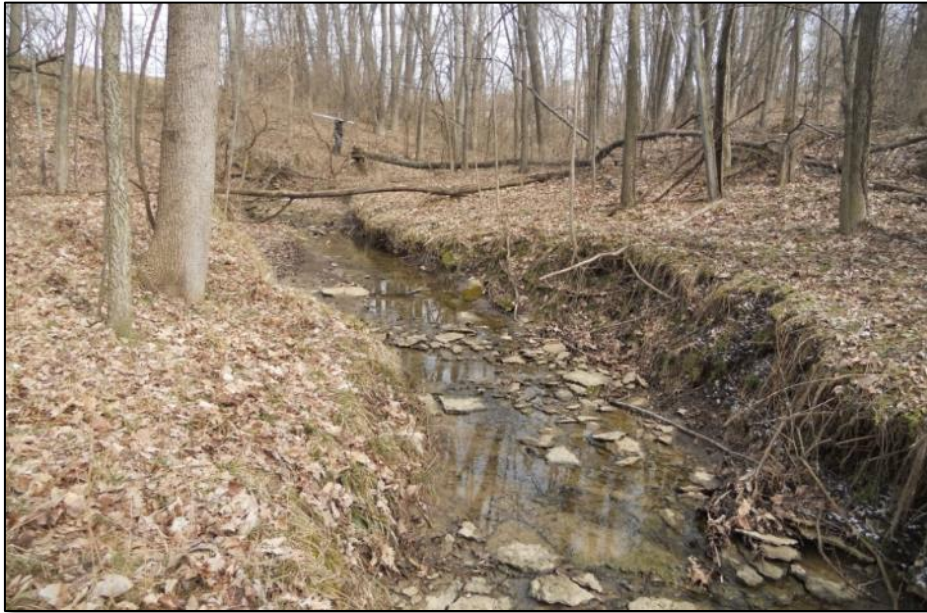
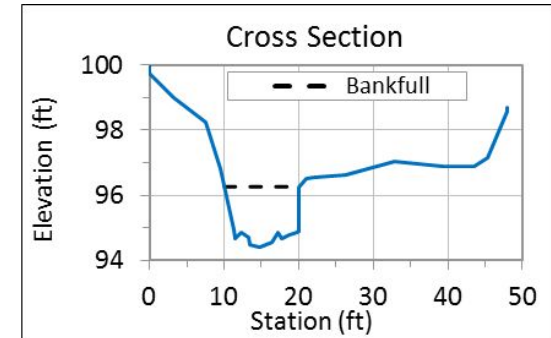
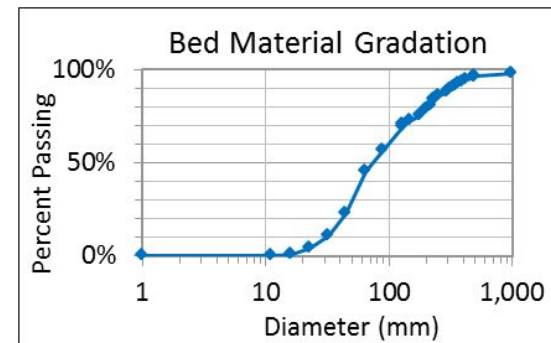
# Retrofit Optimized to Reduce Downstream Erosion Based on Hydrogeomorphic Data

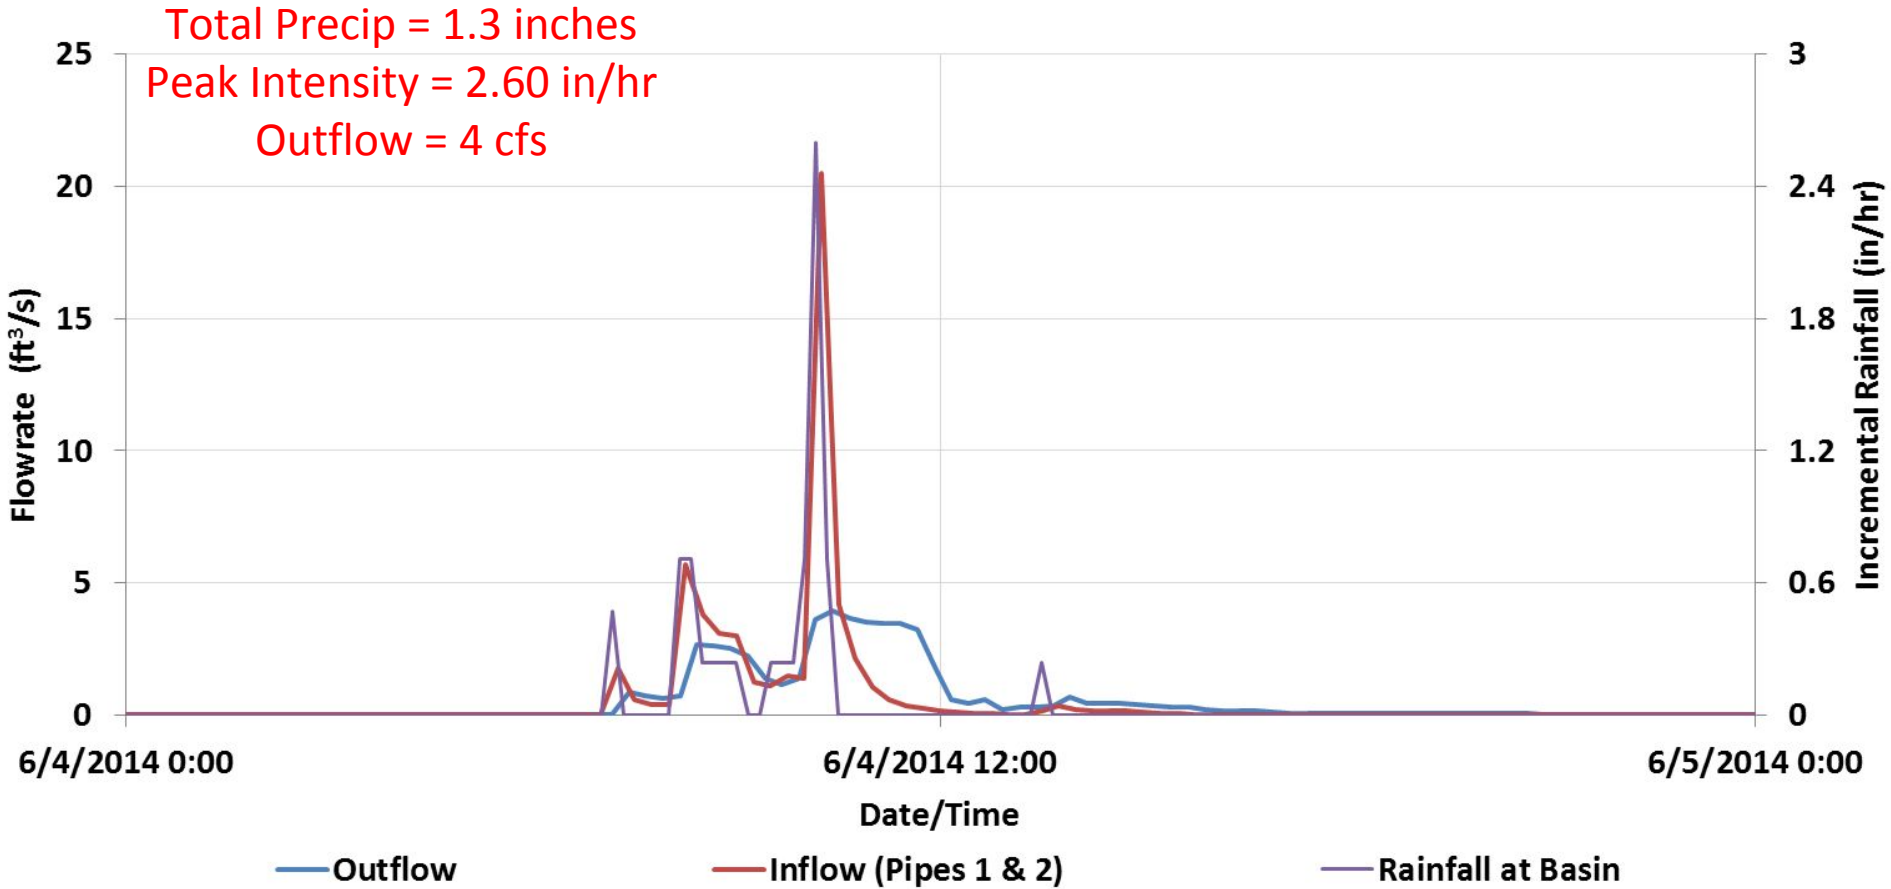
# Detention Basin Retrofit

## Post-retrofit Monitoring

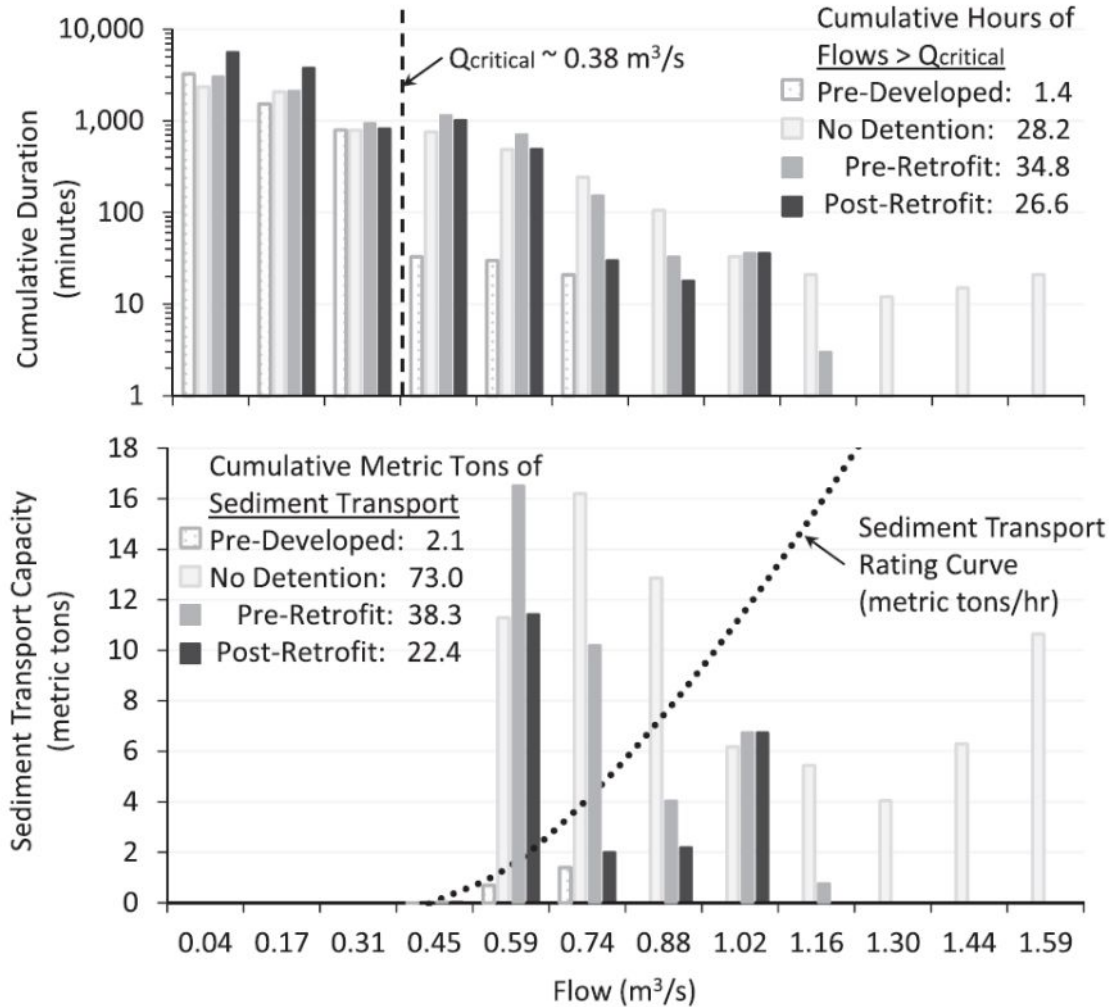
# Reduced Erosive Power

***Reduces the sediment transport capacity by >40%***

*Adapted from Hawley et al. (2017)*

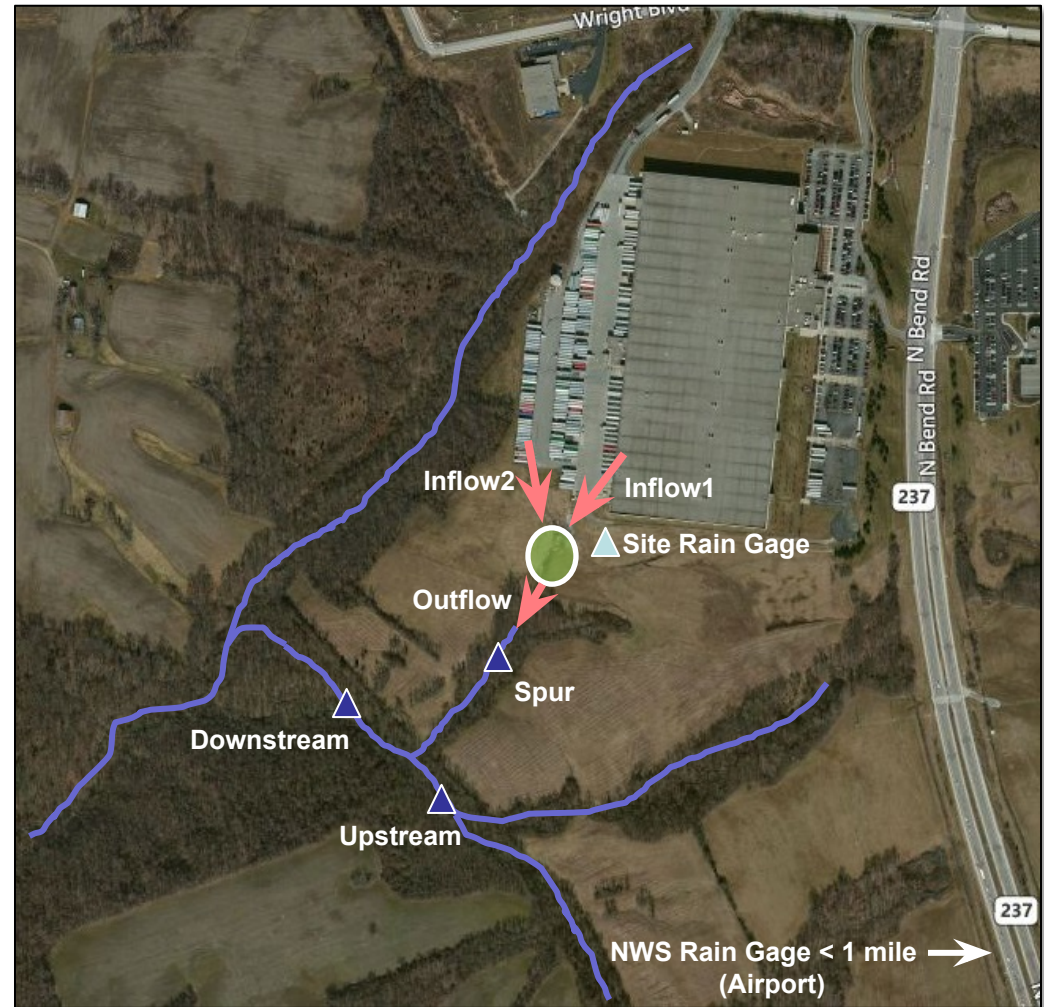
# Monitoring Documents Improvements in the Stream

- Toyota Pond Pipe Flow
  - Inflow 1
  - Inflow 2
  - Outflow
- Precipitation
  - Site Rain Gage
  - NWS Gage (Northern Kentucky/Cincinnati Airport)
- Off-site Stream Flow & Hydrogeomorphic Surveys
  - Spur
  - Upstream
  - Downstream

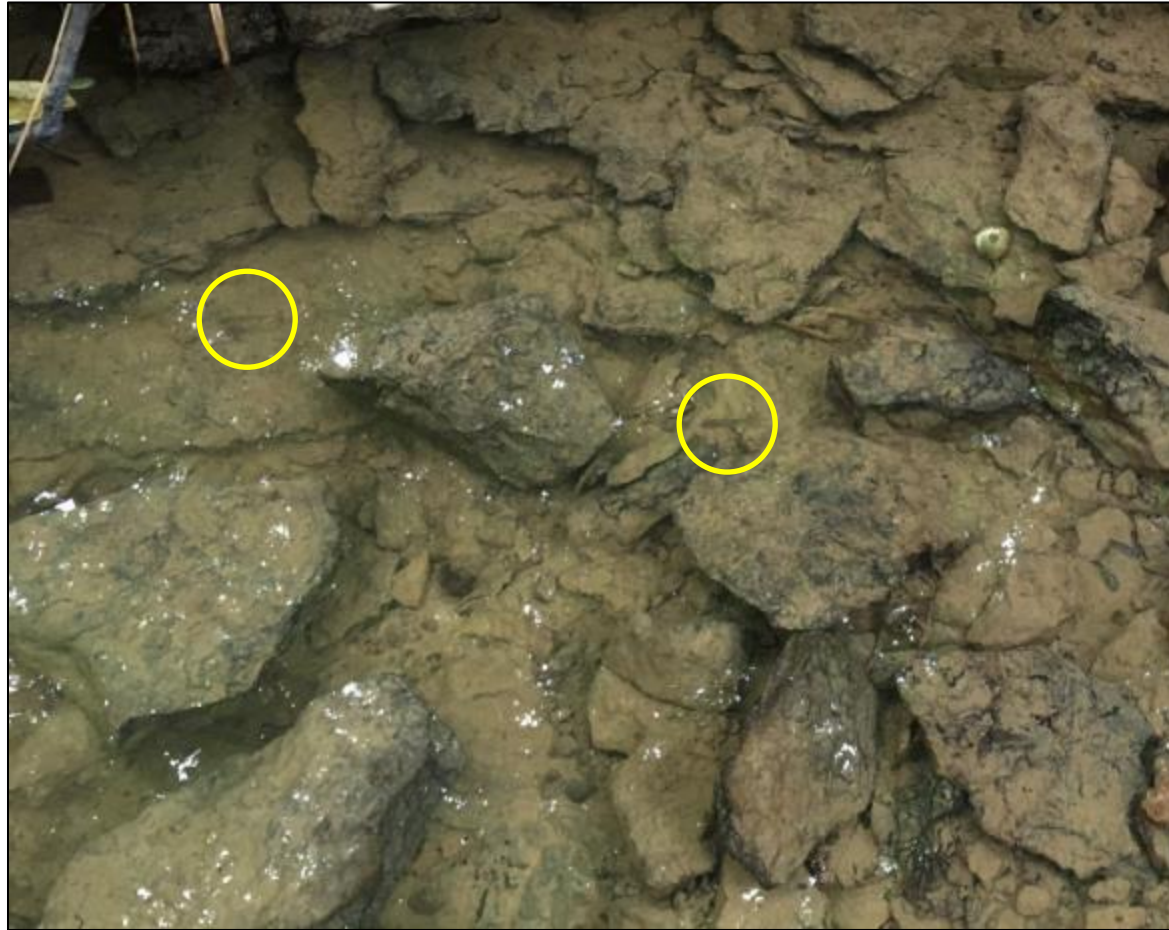
# Restoration of Baseflows Supports Ecological “Lift”

~Dozen native minnows in 1<sup>st</sup> pool immediately downstream of the outfall on 9/16/16 (2 circled). Flow was evident coming out of the basin despite the dry/hot week

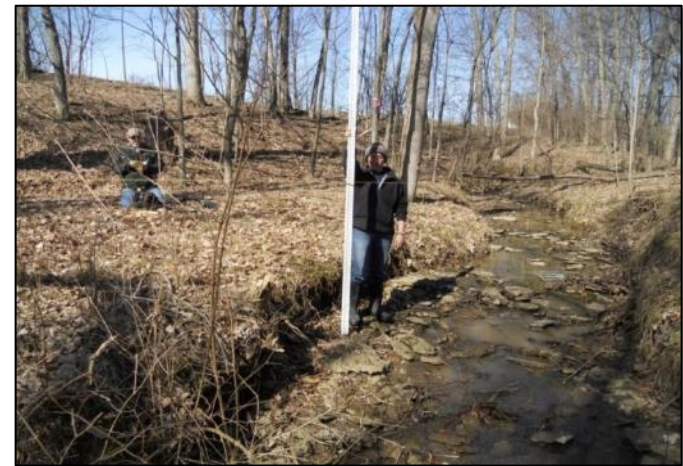
# Restricted High Flows Reduces Streambed Erosion

**Upstream (Control)**

— 12/18/2013  
— 11/30/2016

**Spur (Retrofit)**

— 12/18/2013  
— 7/11/2016

**Downstream**

— 12/18/2013  
— 5/22/2017

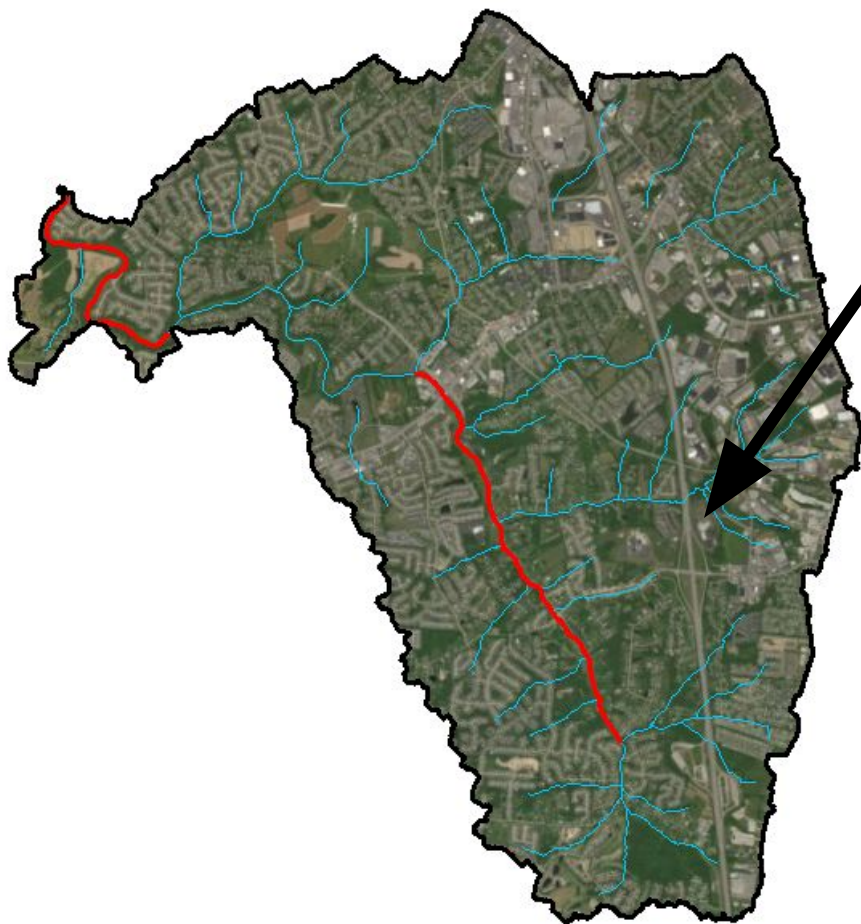
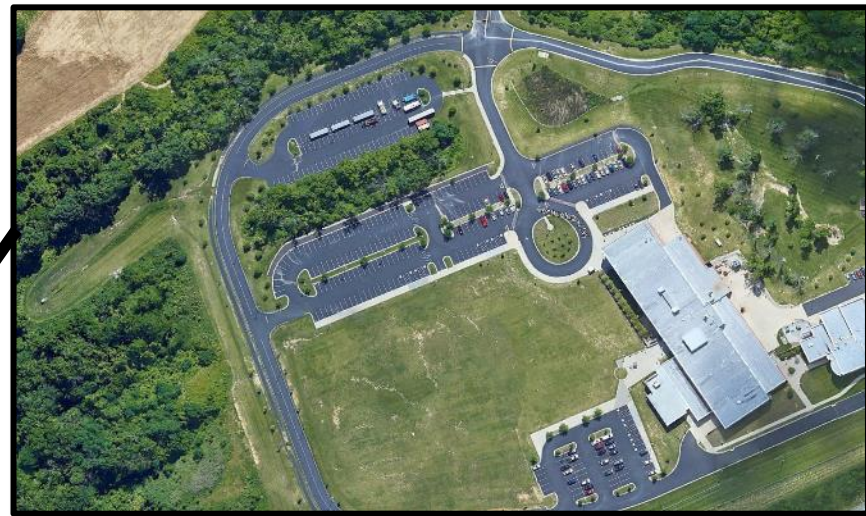
# Complex Detention Basin Retrofit

*Gateway Community & Technical College*

## 2016 303(d) List

- **Sedimentation/siltation**
- **Turbidity**
- Organic enrichment (sewage) biological indicators
- Nutrient/eutrophication biological indicators
- *E.coli*

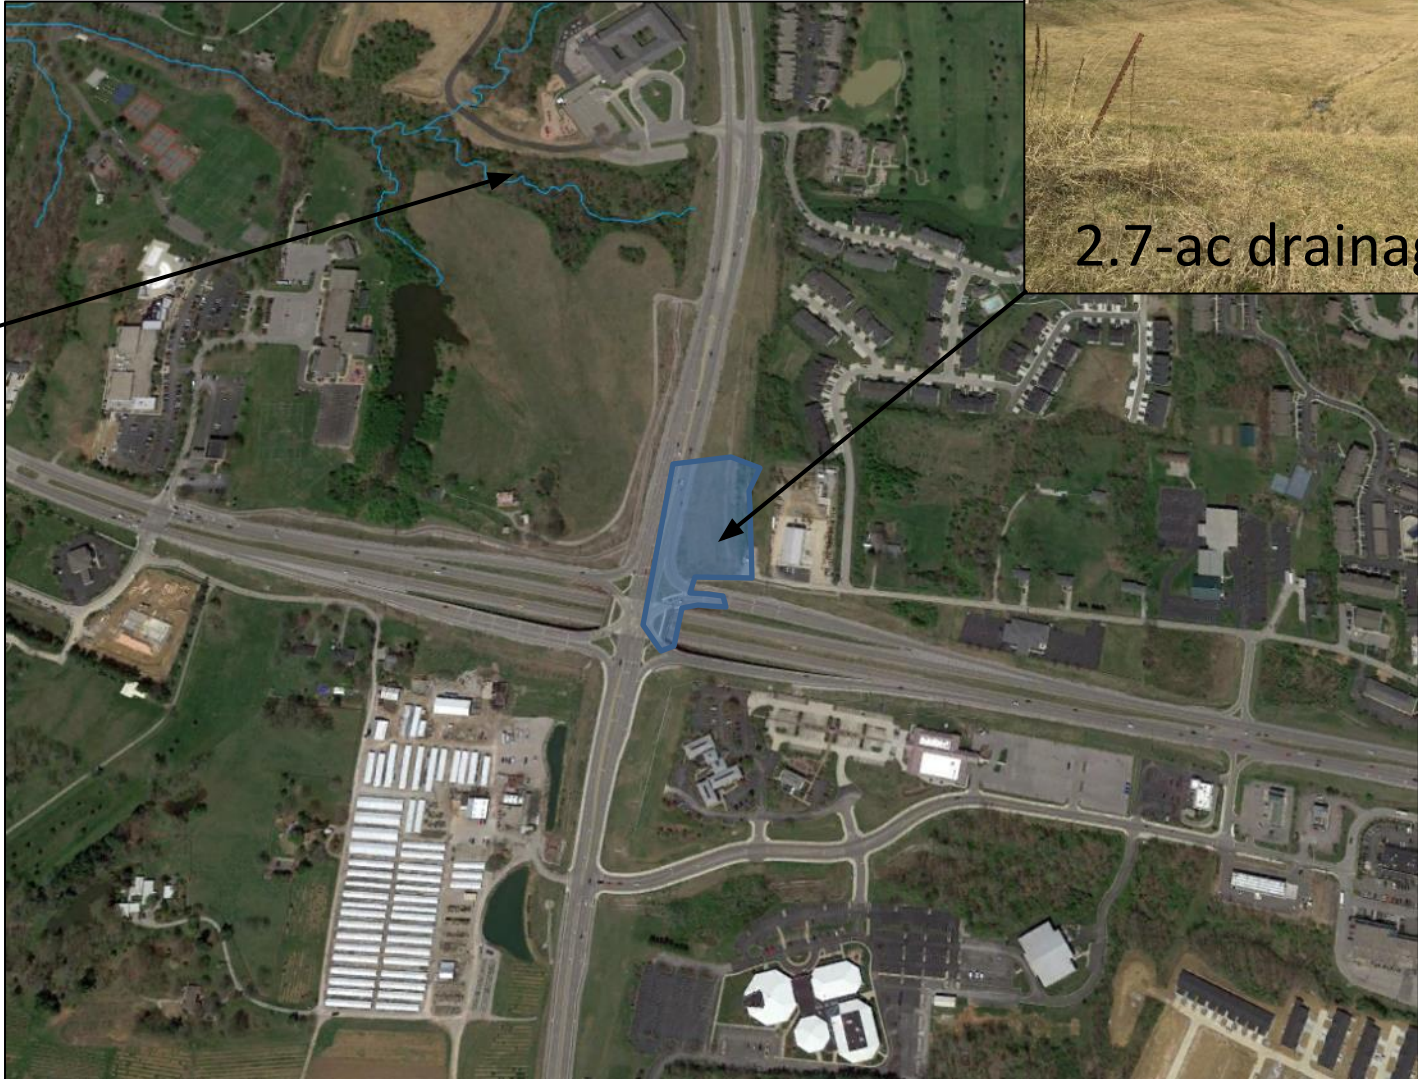
# Bioretention Stream/Wetland Complex

2.7-ac drainage area

Tributary to  
Allen Fork

2017

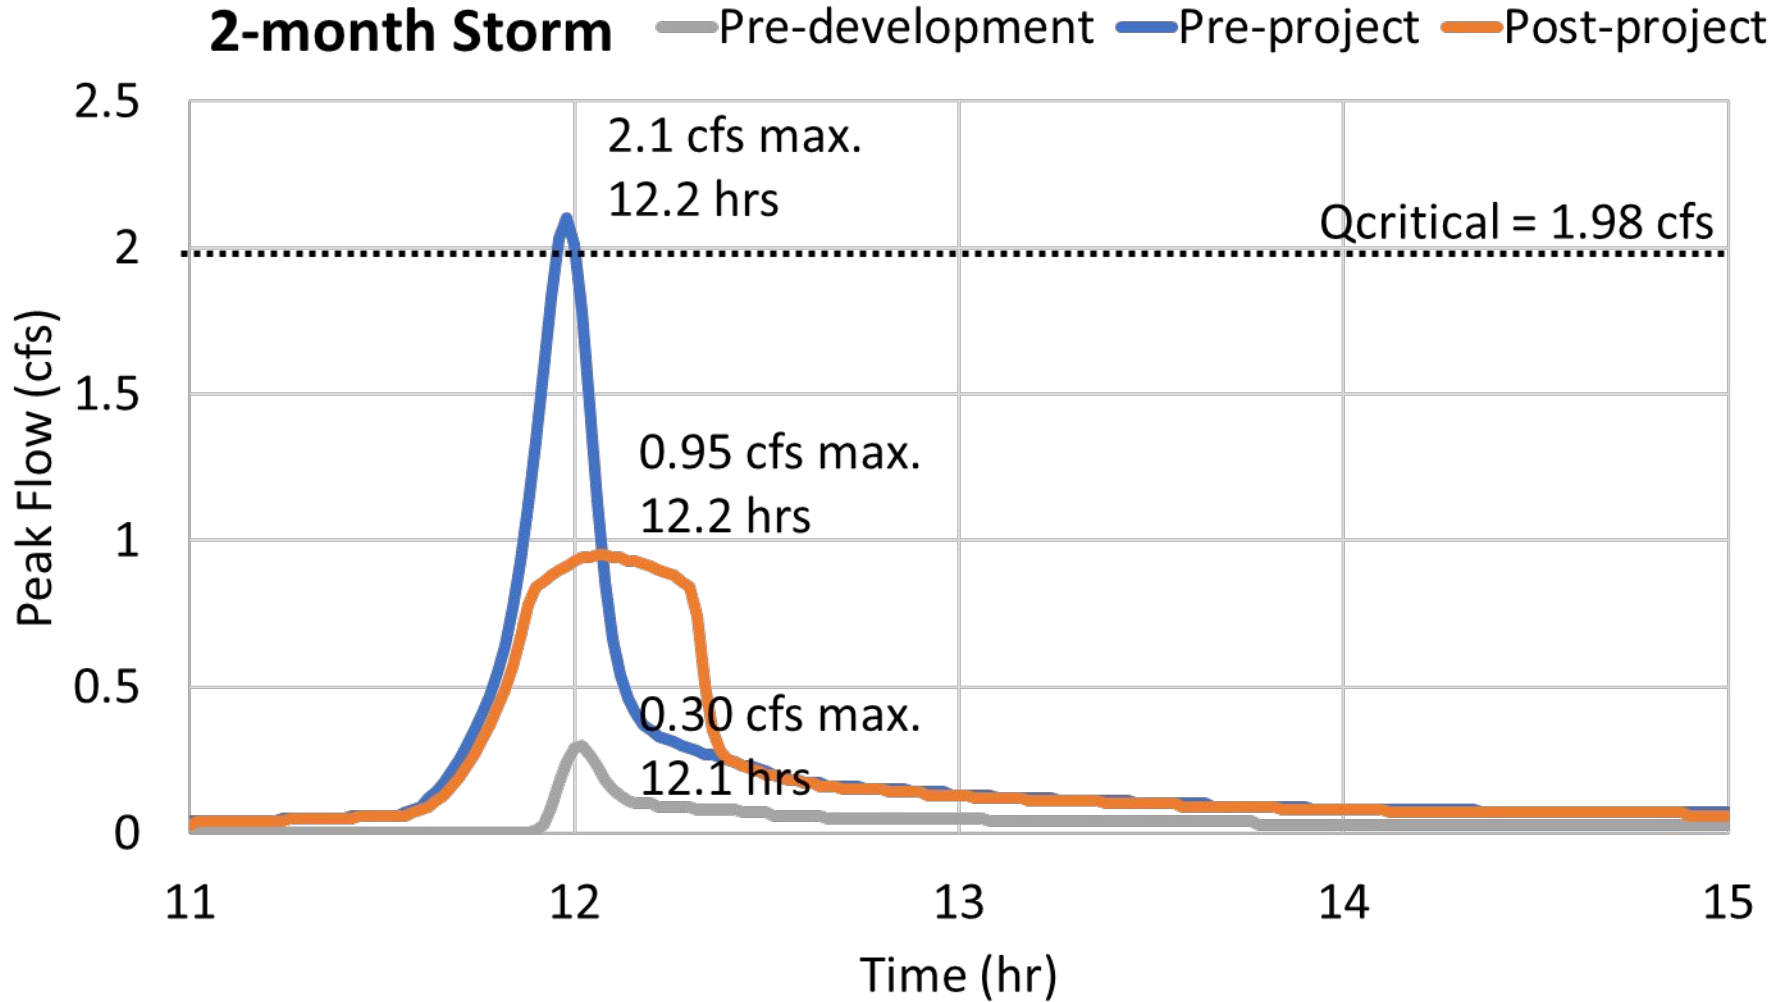
# Reduced Flashiness in Most Frequent Storms

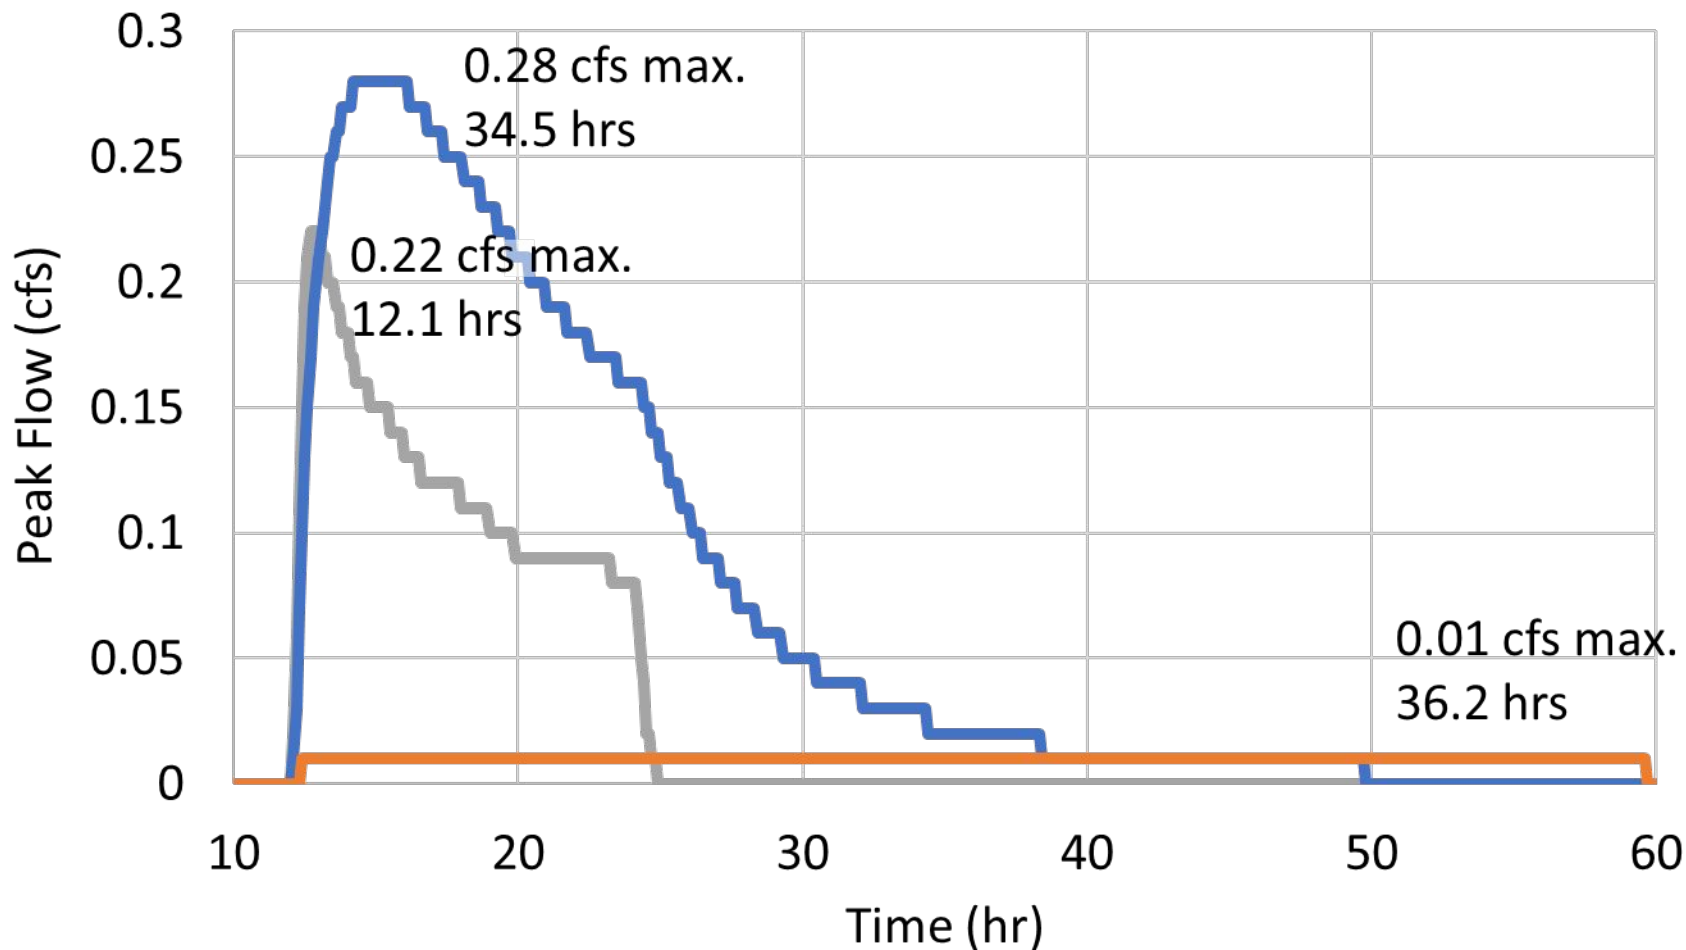
# Increased Storage and Reconfigured Outlet Reduces Flows

2-month storm

— Pre-development — Pre-project — Post-project

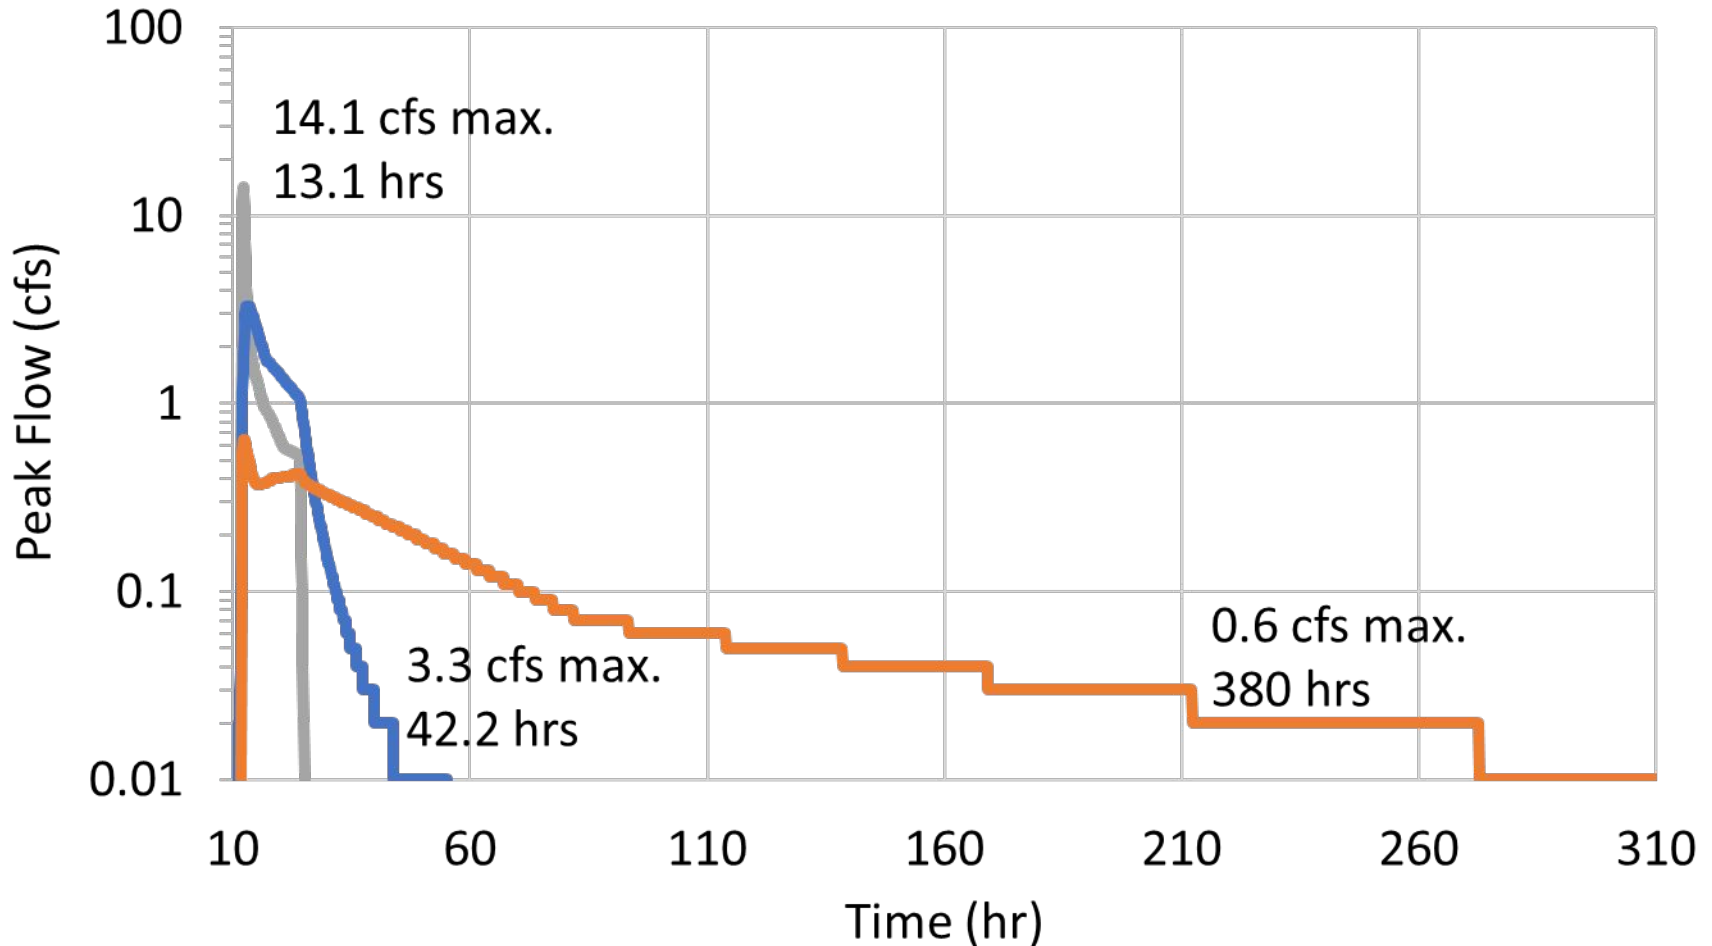
# Increased Storage and Reconfigured Outlet Reduces Flows

2-year storm

— Pre-development — Pre-project — Post-project

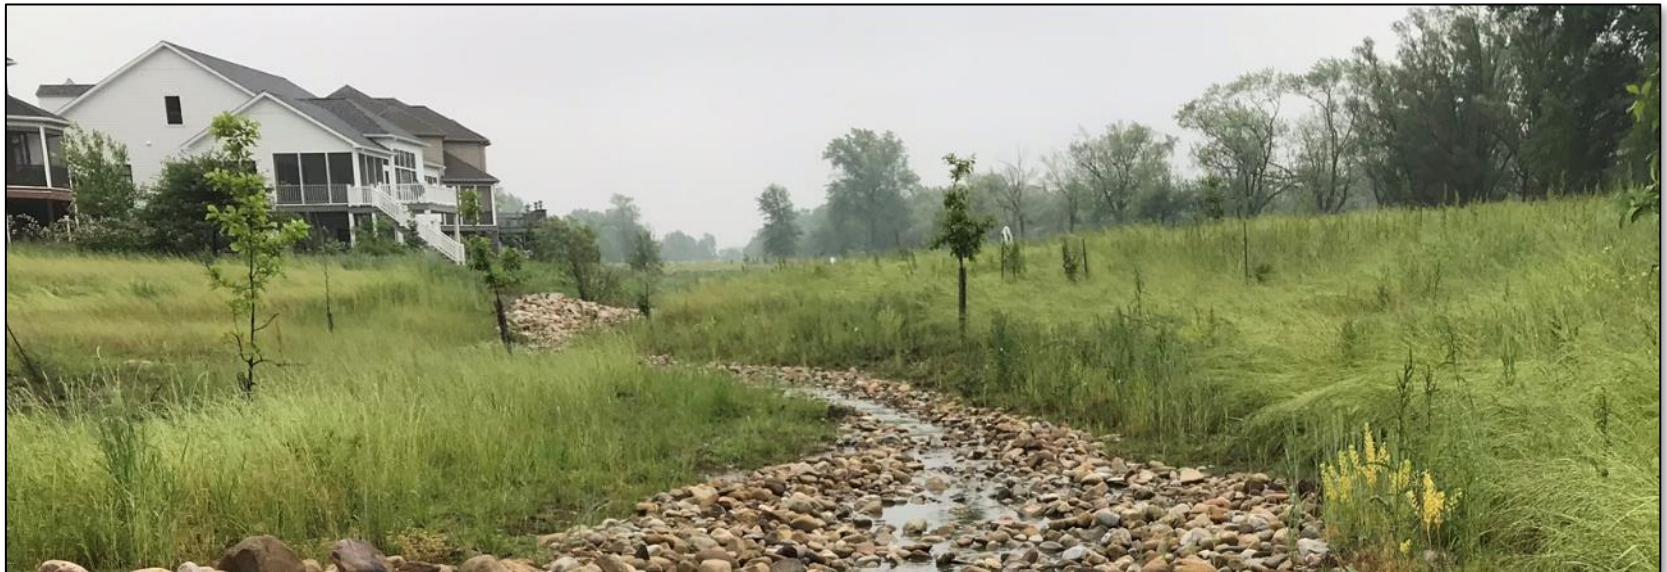
10-100 Year Rainfall
