CITY of CHARLOTTE Pilot BMP Monitoring Program

Shade Valley Pond Final Monitoring Report

January 2007

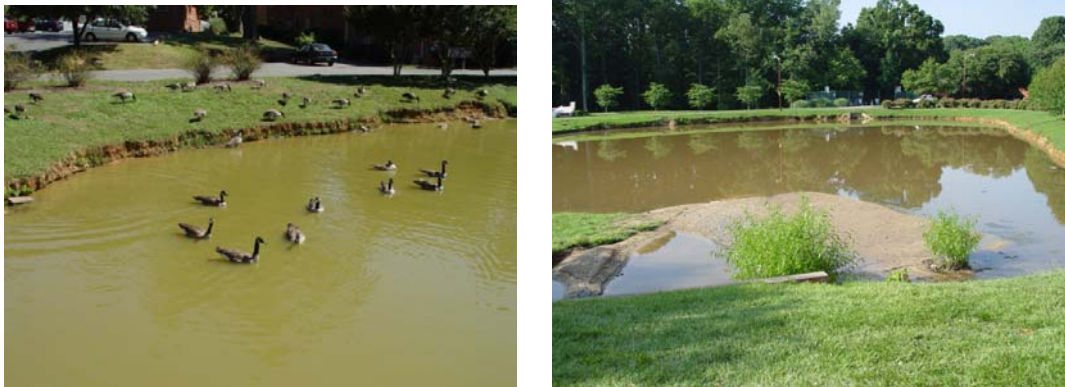
Prior to the summer of 2004, the condition of the pond was very poor. Mowing of the vegetated border of the pond and intense waterfowl activity resulted in a rapidly eroding pond bank. Conveyance structures at the pond edge had collapsed resulting in erosion of the adjacent areas. Sediment deposition at the main inlet of the pond had created an exposed sand bar which nearly encircled the inlet. Fecal matter and feathers were prevalent on the banks of the pond and in the pond itself. Conditions during this time are shown in Figures 1.a and 1.b.

Figure 1.a and 1.b Condition of pond during pre-construction monitoring period.

area with an average depth of 3 feet. The banks of the pond were severely eroded due to the intense waterfowl activity in the area. The outlet of the pond consisted of an undersized 30-inch Reinforced Concrete Pipe (RCP) which went under Shade Valley Road and discharged into a nearby perennial stream. A 6-foot wooden weir maintained the level of water within the pond.

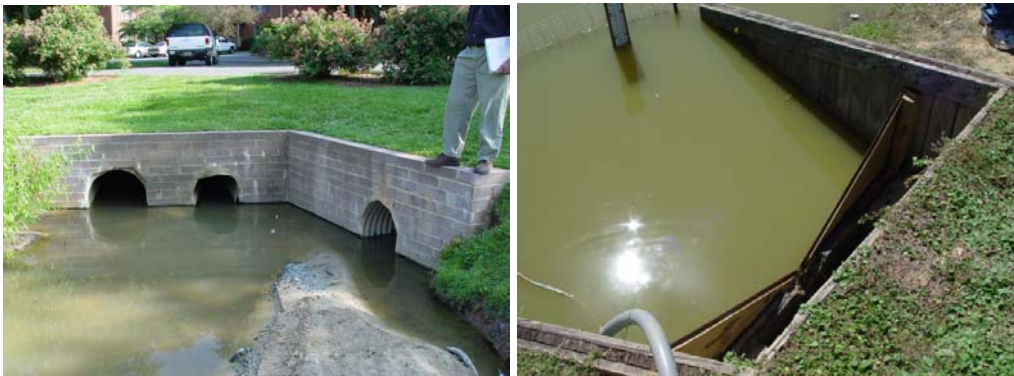
The existing 6-foot wooden rectangular weir would not provide an accurate flow measurement at the outlet. Thus, a 120° sharp crested V-notch weir was attached to the existing wooden outlet weir. The invert of the V-notch was installed at the pre-existing normal pool elevation, so no alteration of pond level occurred.

Figure 2.a and 2.b. Locations of inlet and outlet sample collection

The intake for the inlet sampler was installed just downstream of the convergence of the three major RCP culverts in an area of well mixed flow. Accurate inflow measurements were not possible due to the multiple inlets entering the pond and the hydraulic conditions (submerged) at those inlets. Since the pond had no significant detention component, it was considered a flow through device. As a result, it was assumed that the inflow volume matched the outflow volume.

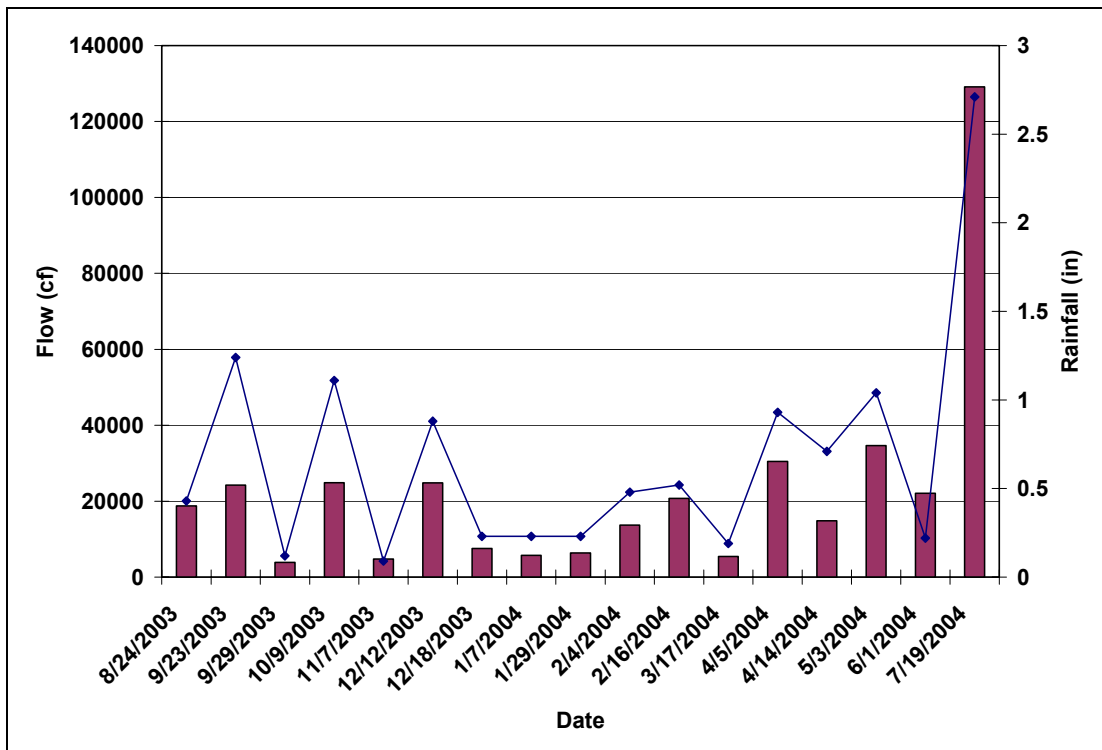
Figure 3: Effluent volume and rainfall depth for each event monitored

As discussed above, the characteristics of the pond inlet were not desirable for flow measurement; thus, an evaluation of variations in inlet and outlet flow data could not be made. Due to the design of the pond outlet, the pond had no detention, thus inflow was assumed to equal outflow. With this assumption, inlet and outlet water quality samples could be analyzed without the need for mass removal calculations. The effluent volume and associated rainfall depth for each storm monitored can be seen in Figure 3. A typical hydrograph (0.5 inch storm – 2/12/2004) from the Shade Valley outlet can be seen in Figure 4.

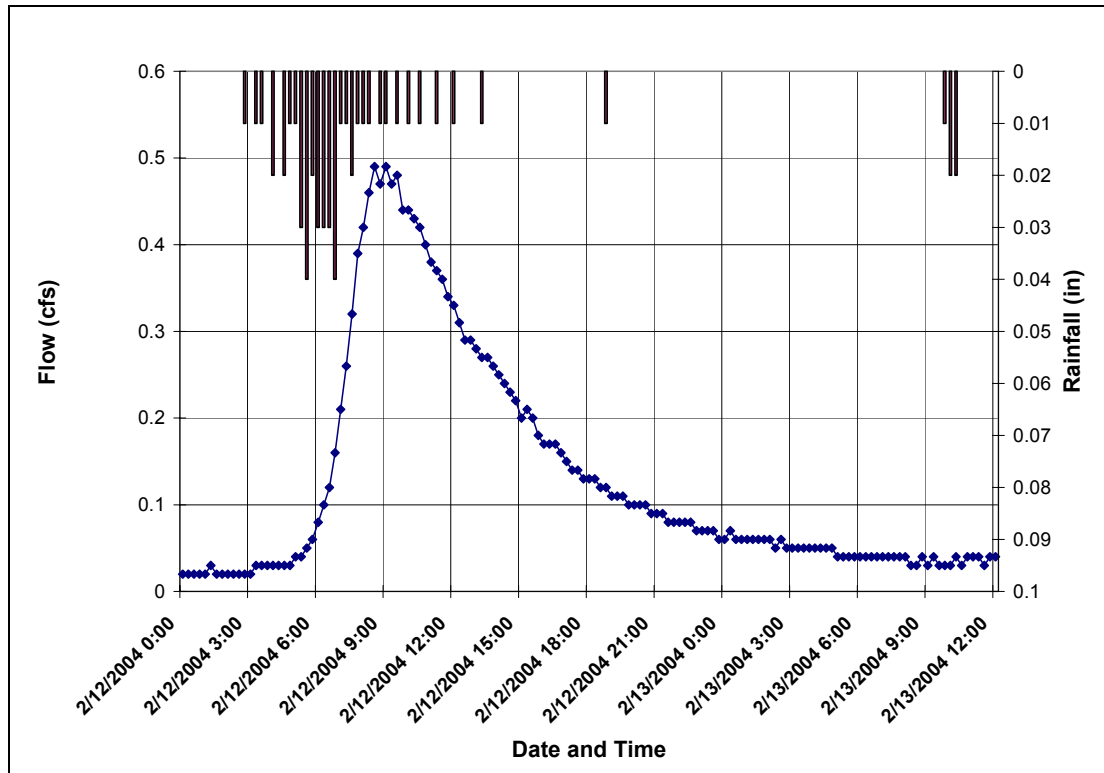
Figure 4: Outlet hydrograph from Shade Valley Pond

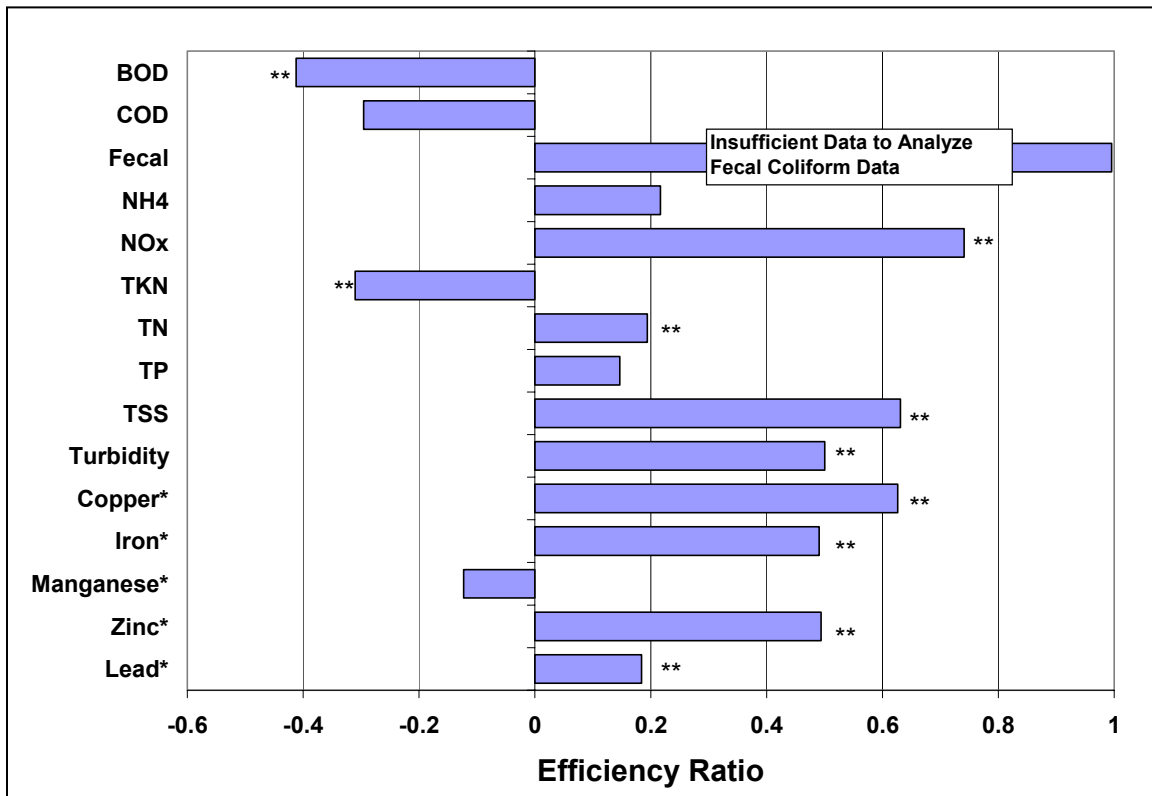
Figure 5: Efficiency ratios of selected pollutants based on inflow and outflow mean concentrations (EMCs) at Shade Valley Pond

* = Grab samples collected to analyze for this pollutant

** = Indicates statistically significant relationship

Table 1 and Figure 5 illustrate the performance of Shade Valley Pond with regard to pollutant removal. The pollutant removal efficiency is described by the efficiency ratio (ER) which is discussed above. A positive ER indicates that the pollutant, which entered the basin as stormwater runoff, was retained. A negative ER represents a surplus of pollutant leaving the BMP, suggesting either internal production of nutrients, or loss of stored pollutant from previous storm events.

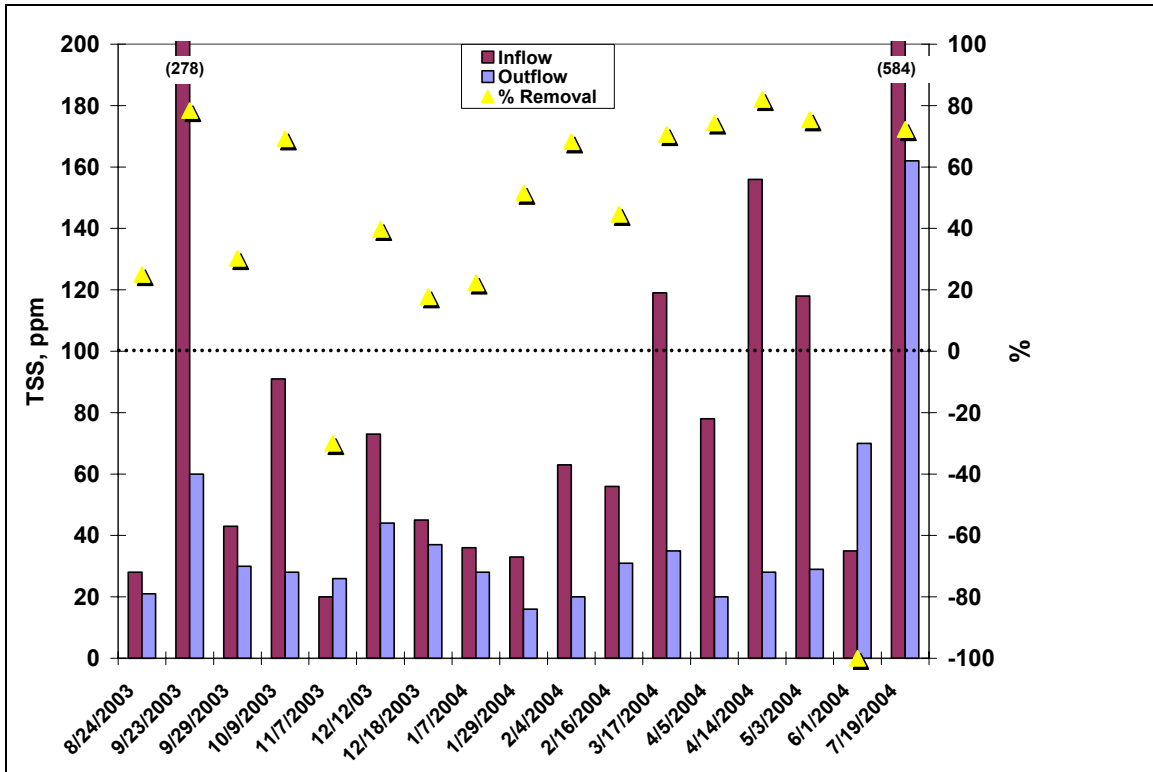
Figure A1: Change in TSS concentration due to BMP treatment by storm event.

The ER for TSS removal in Shade Valley Pond was 0.63. This indicates that a substantial amount of treatment for TSS is occurring in the pond, presumably through sedimentation and filtration. This is likely related to the high ERs noted for other sediment borne pollutants that were analyzed, specifically metals (Vaze and Chiew, 2004). Although state regulations require wet detention ponds to achieve 85% TSS removal, this is unlikely for ponds sited in watersheds with clay type soils. Small particles are not easily removed from a given flow stream. An ER of 0.63 indicates that Shade Valley Pond is efficiently removing this pollutant from the flow stream. Inflow and outflow TSS concentrations for each storm can be seen in Appendix A – figure A1.

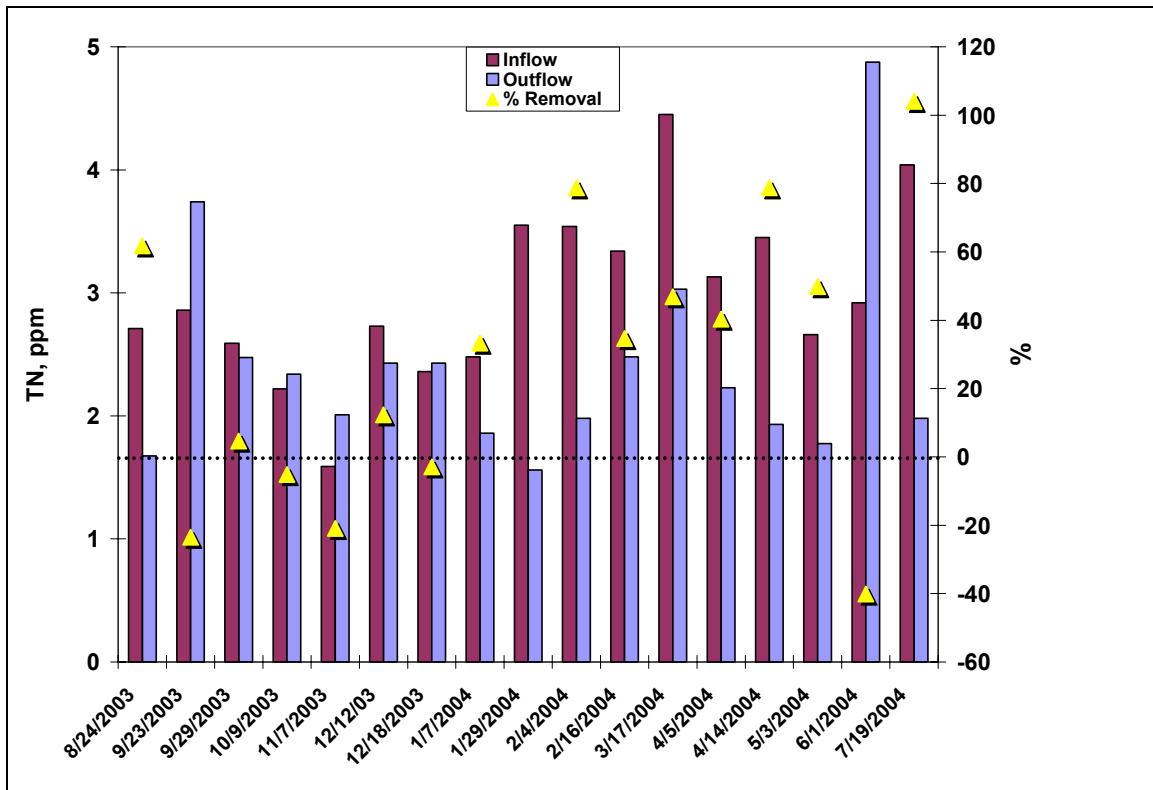
Figure A2: Change in TN concentration due to BMP treatment by storm event.

Overall, the TN removal in the pond was approximately 19%. NCDENR (2006) gives 25% TN removal credit to wet ponds, which Shade Valley falls slightly under. It is possible that the exclusion of water fowl would result in a TN removal efficiency much closer to that in the N.C. Stormwater BMP Manual (NCDENR, 2006). Inflow and outflow TN concentrations for each storm can be seen in Appendix A – Figure A2.

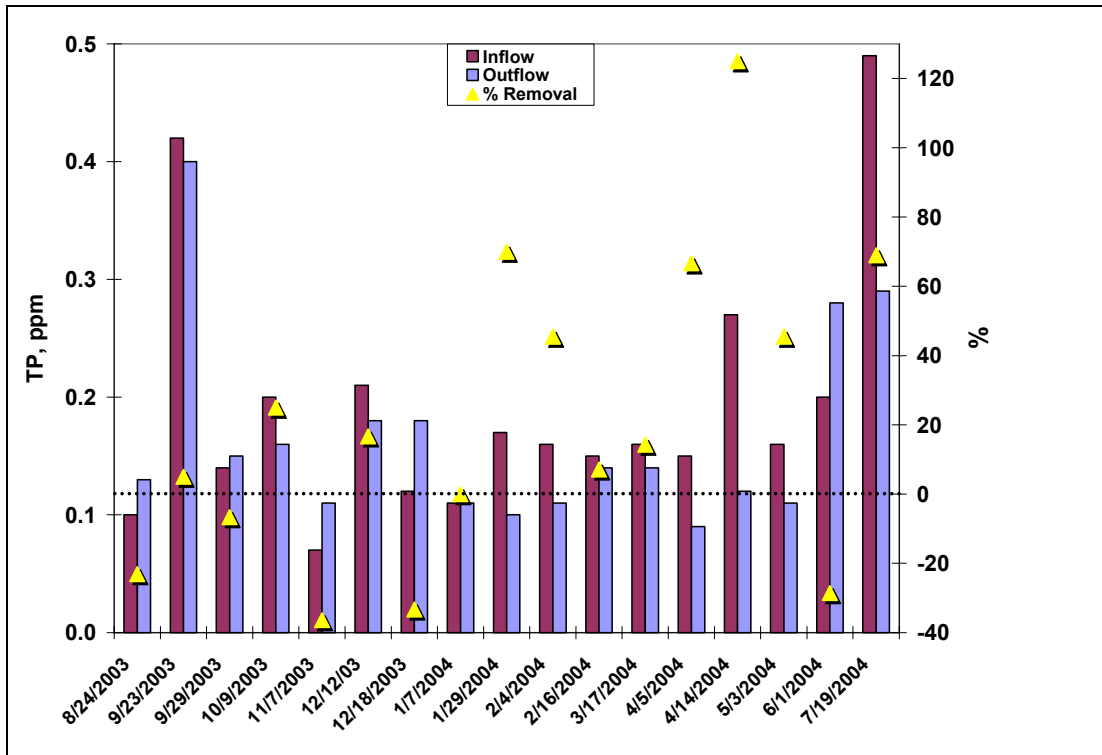
Figure A3: Change in TP concentration due to BMP treatment by storm event.

should be noted that median influent TP concentrations (0.16 mg/L) were very low, thus, a water quality improvement that brings effluent concentrations near to the irreducible concentration may result in an ER that appears low. Inflow and outflow TP concentrations for each storm can be seen in Appendix A – figure A3.

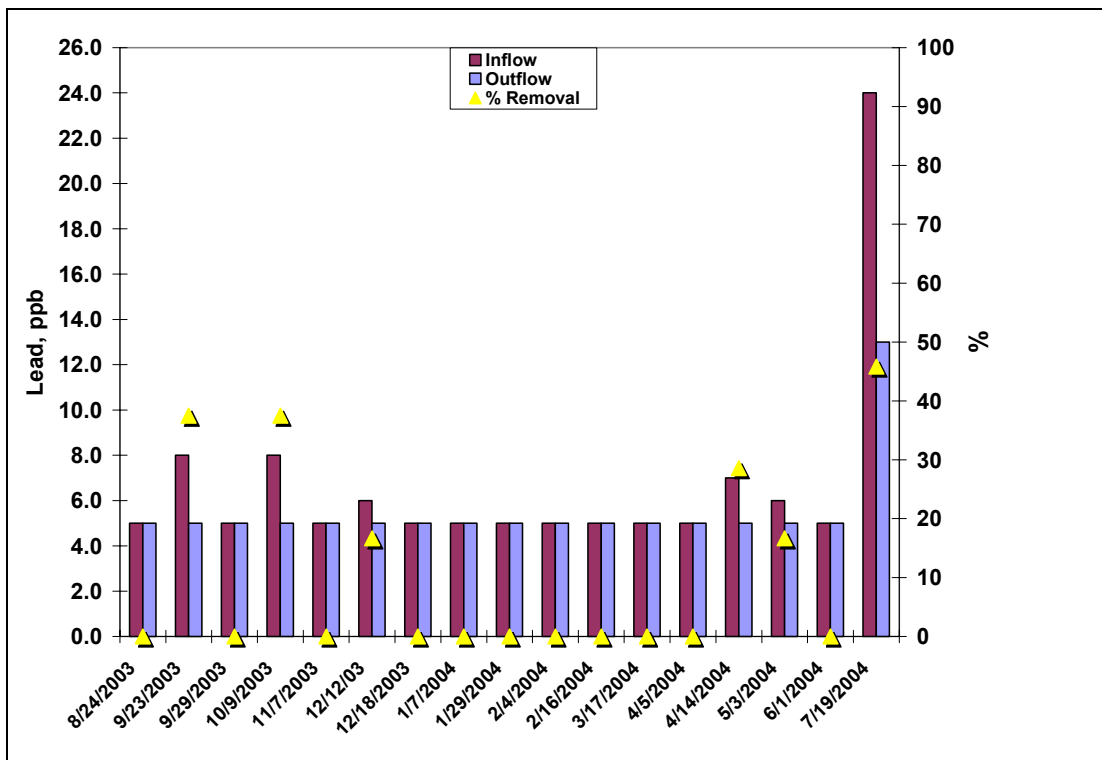
Figure A4: Change in Lead concentration due to BMP treatment by storm event.

It should be noted that for many storms (11 out of 17 storms), influent and effluent lead concentrations were at or below the detectable limits ($5 \mu\text{g/L}$), resulting in 0% removal (See Appendix A – Figure A4). Low influent concentrations during many storms likely reduced the zinc removal efficiency. It is also possible that lead had accumulated in pond soils over time and is now leaching out of the considerably aged pond. Lead inputs would likely have been high in previous years, particularly before the use of unleaded gasoline.
